## **RICS HomeBuyer Report:**

Address of Purchase Property

## **RICS Home Surveys RICS HomeBuyer Report**

**00-00-0000**

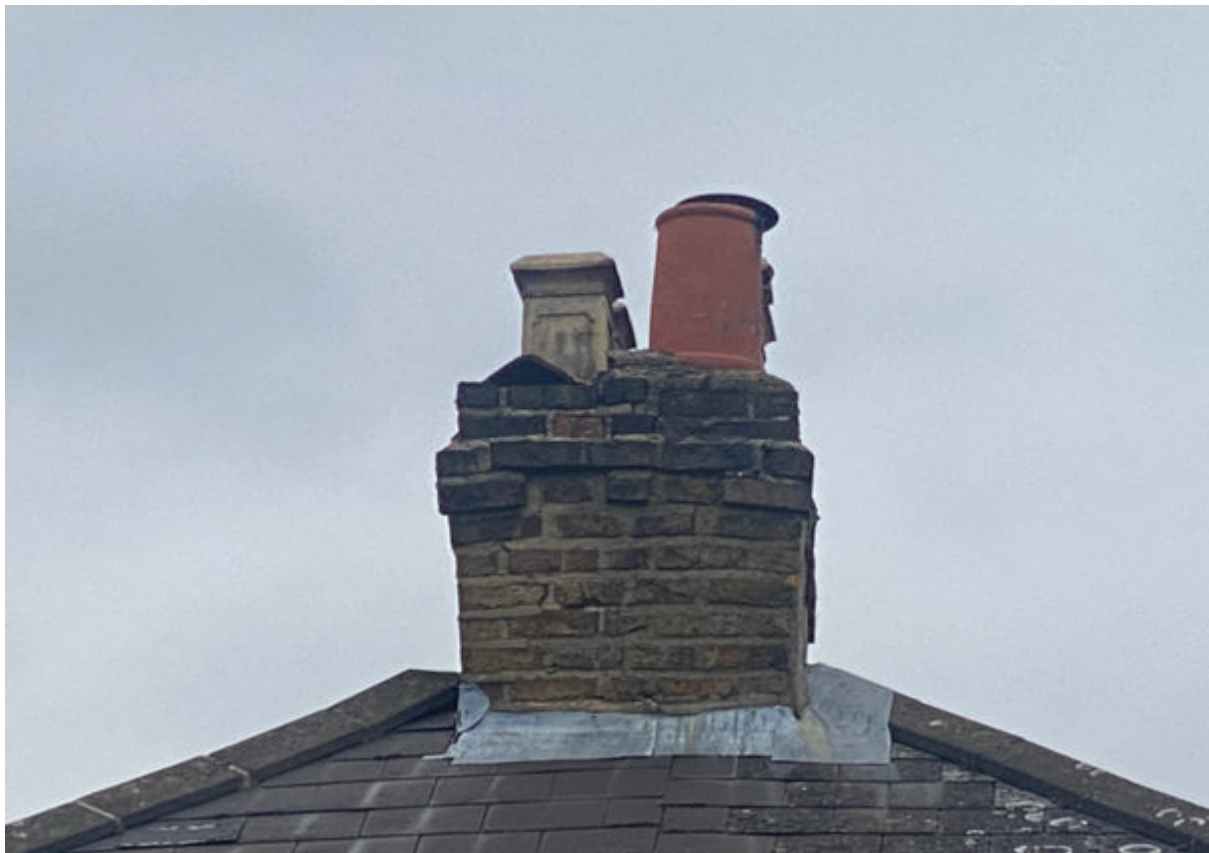
Brickwork, London stock solid construction. The front face of the chimney stack appears to have been partially repointed at some point in the past. There are also signs of undulation and movement towards the upper section of the stack itself where it adjoins the flaunching.

The chimney stack movement is a relatively normal thing as they tend to get the full brunt of the weather. In this case, while there are historic signs of issue, it doesn't appear to be untoward and would be relatively normal considering the age of the property.

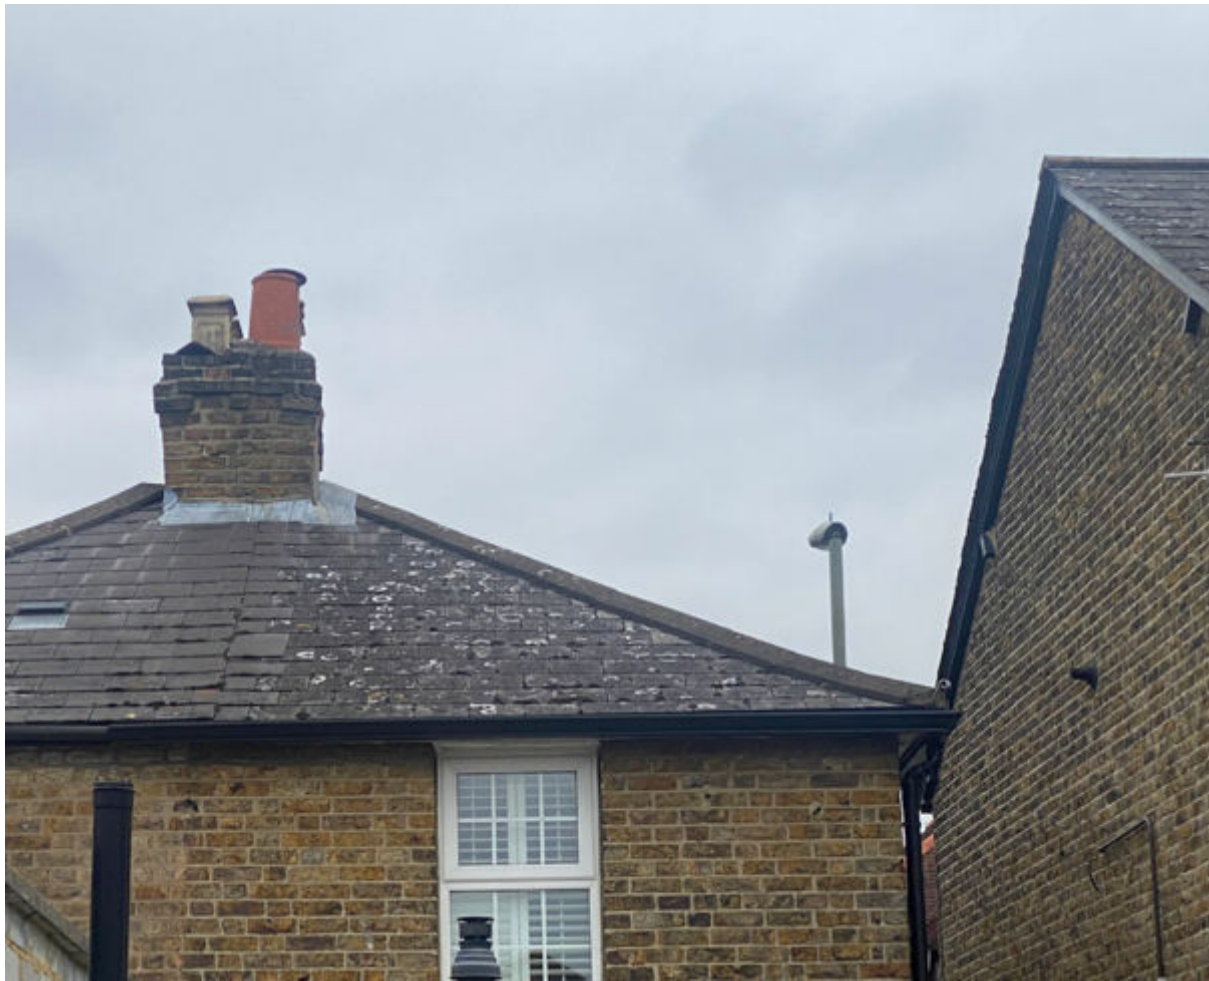
The slate tiles are severely weathered with signs of moss and lichen growth noted throughout. The tiles also appear to be showing signs of delamination throughout, and it is my opinion that the tiles have likely reached the end of their useful life.

I would advise budgeting for replacement of tiles shortly after the sale of the property, as it is likely they are at the end of their useful life and will require action in the immediate future.

I would advise that in advance of the purchase, that a roofer puts a roofer's ladder up there so a full inspection can be undertaken to ascertain if it is any worse condition than the front and rear pitches.

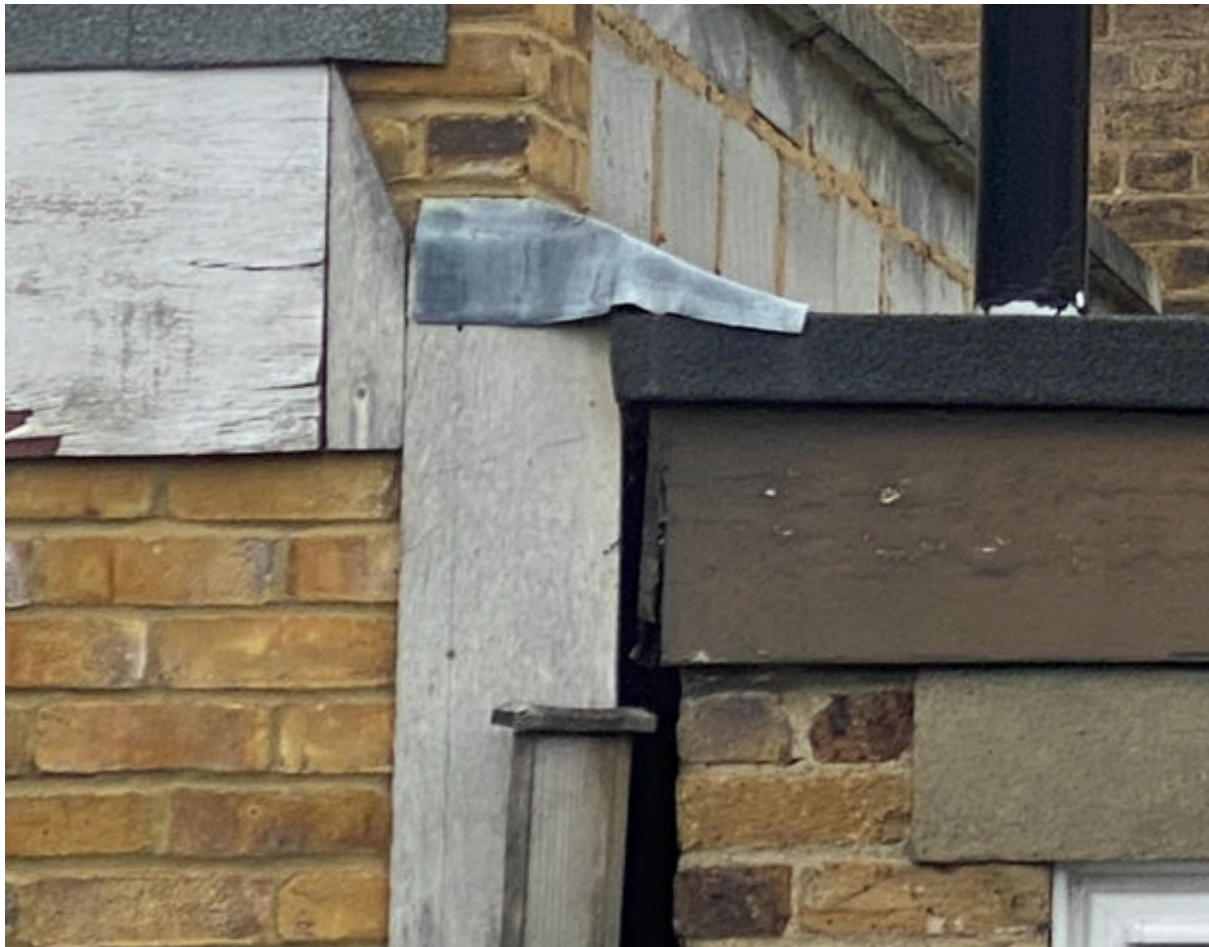
The roof to the rear extension, the fascia board towards the flank of the property itself, where it adjoins the semi-detached property, is showing signs of weather ingress and the fascia boards themselves are also showing signs of blistering and peeling paint throughout.

This will need to be partially cut away and replaced with new timbers, or potentially replaced in the entirety of the fascia board to ensure longevity and a waterproof finish.

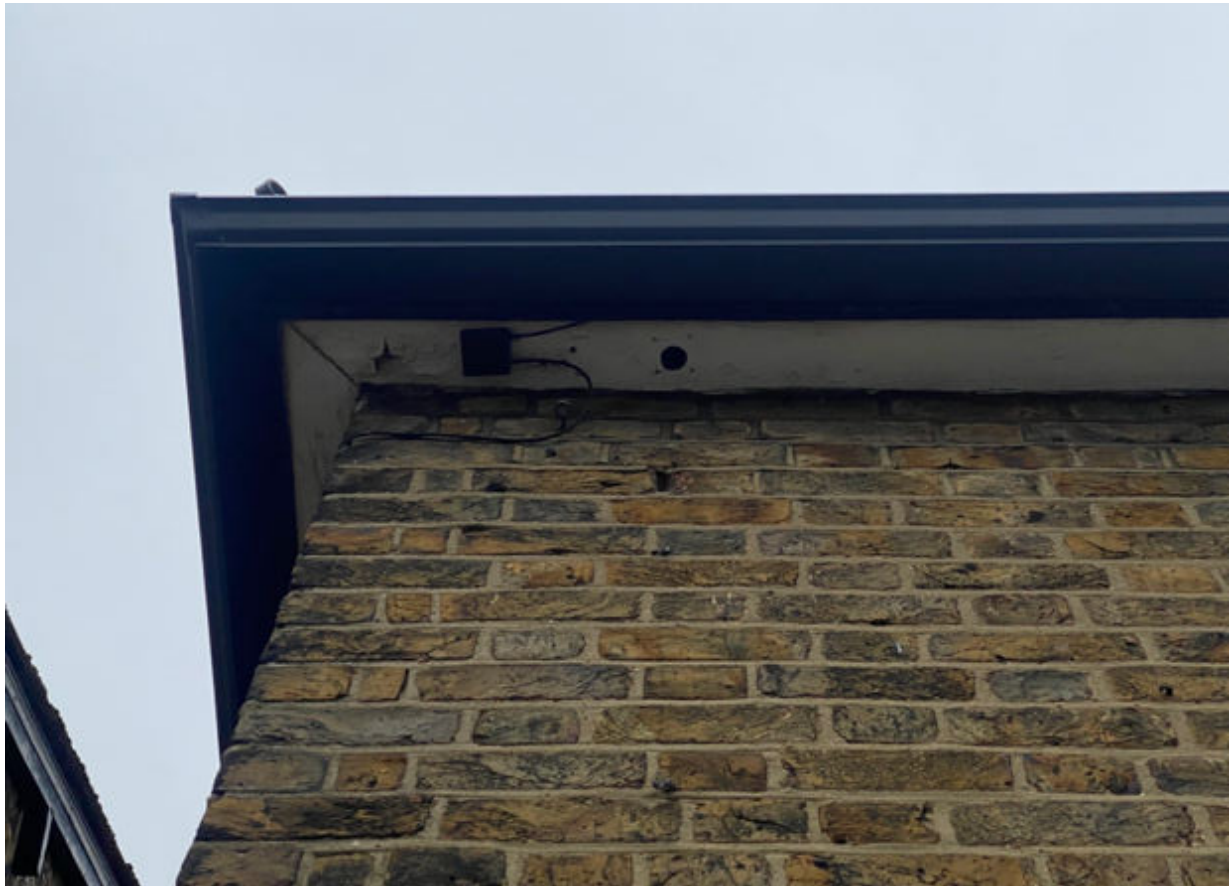
The rear rainwater gutter has been installed whereby it rests under the gutter to the other semi-detached property.

This is not an ideal solution and will likely result in water pooling or pouring off the gutter itself, which could likely result in damp ingress.

I would suggest that this is inspected by a competent roofer to advise further as to a suitable solution with regard to this.

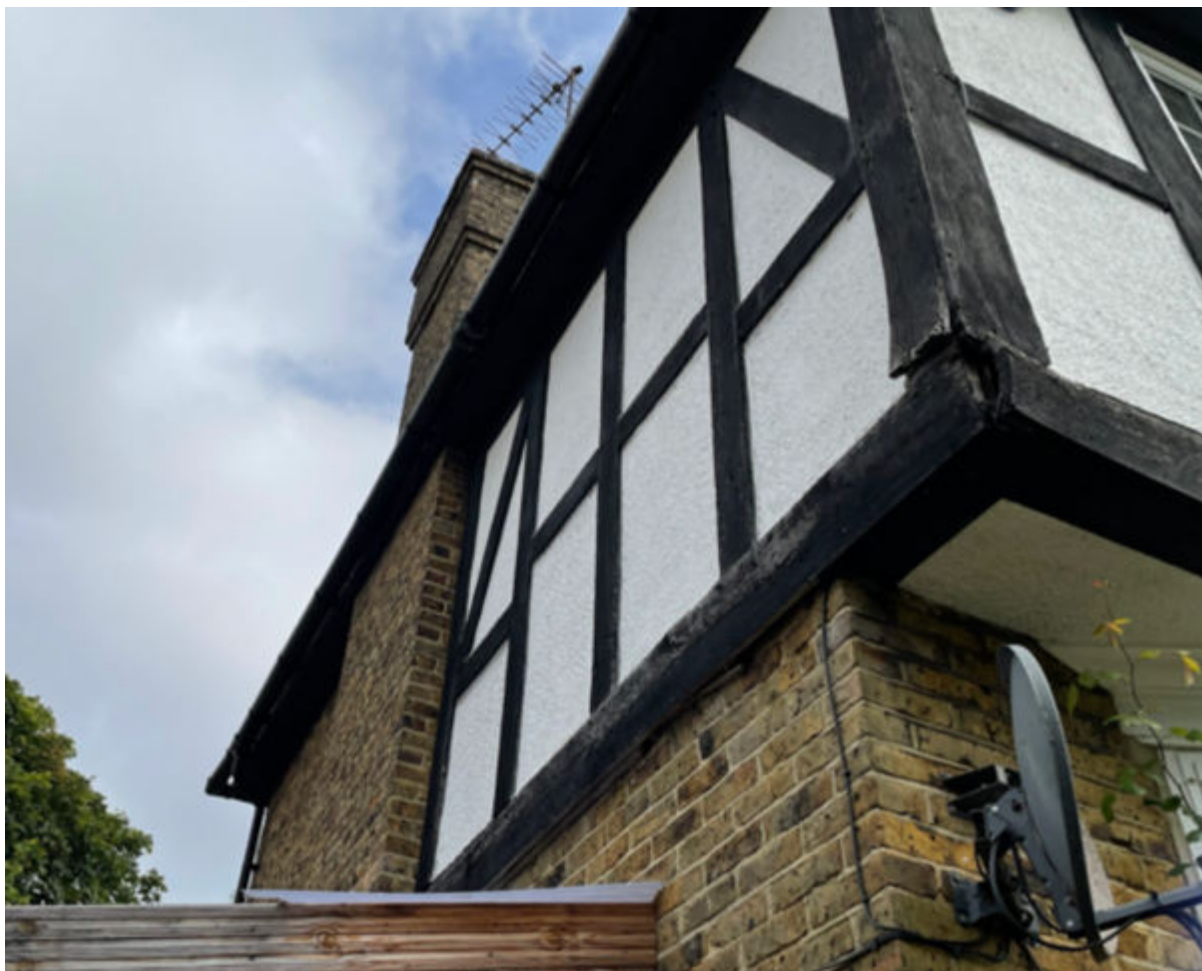
Main walls are brickwork London stock solid construction.

The brickwork appears to have been repointed with a weather struck style of pointing which is appropriate for the type.

To the flank wall there appears to be an area of replaced brickwork, whereby it would appear a new window has been installed. This could have also potentially been a door in years past, and you may want to enquire with your solicitor as to whether any structural alterations have taken place within the property.

The window itself has a concrete lintel above and appeared to be in a fair and reasonable condition at the time of inspection and free from any defects. You may wish to enquire with the Local Authority and Building Control to ensure that if this was an addition, that it has the necessary Planning and Building Control sign off.

The rendered plinth on the flank wall is weathered, and at the front section of replaced air vent, it is debonding and splitting/stripping away. This will need to be replaced in the immediate future and necessary budget should be taken into account for this.

I would recommend that a retrospective injection damp-proof course is installed along the perimeter of the walls or alternatively, the ground towards the flank passage of the house is lowered to ensure a minimum of 200-300mm gap, thereby ensuring that damp and water cannot penetrate on the internal property itself.

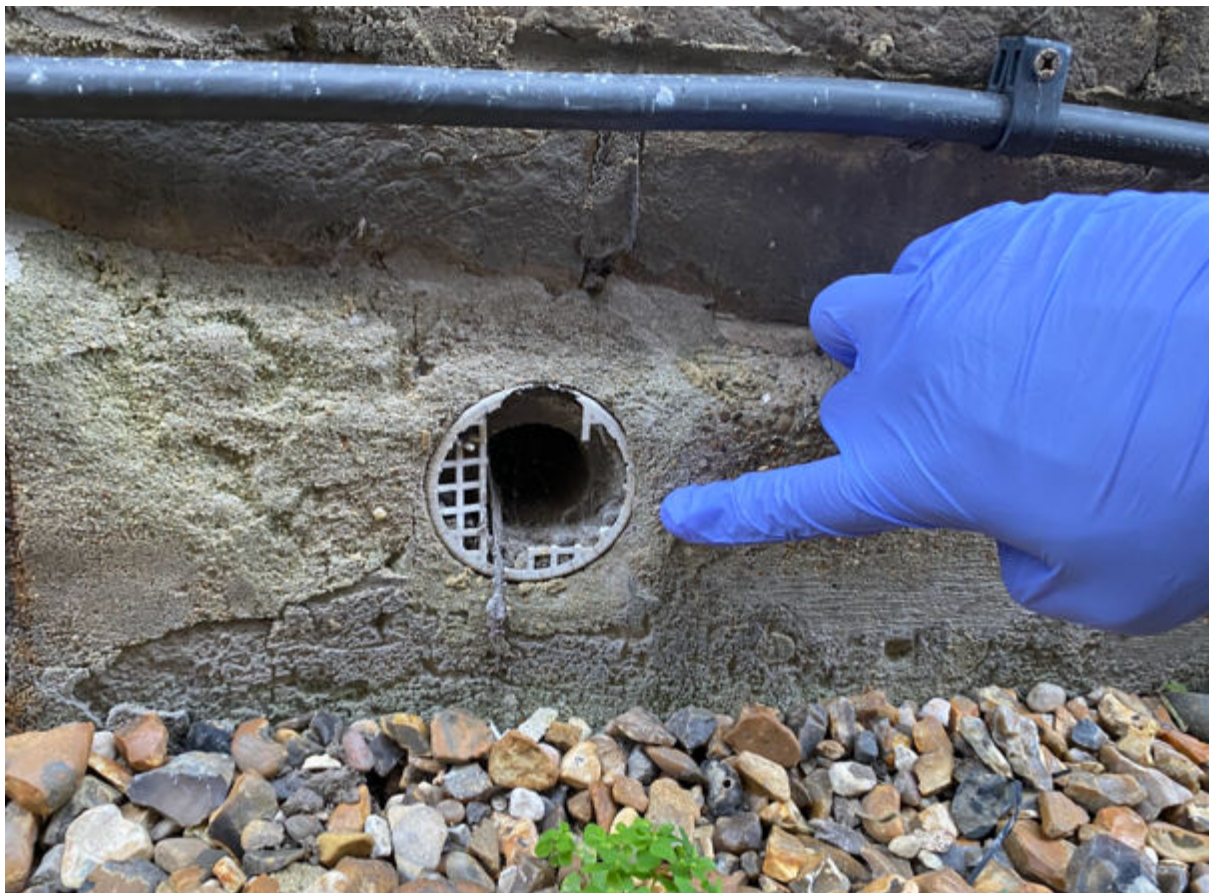
There appears to be a number of retro-fit circular core drilled air vents that have been inserted into the front and flank walls of the property.

These would not be original and do not appear on the neighbouring structures, and it is my opinion that this is likely a retro-fit attempt to increase the airflow to the property, and reduce the chances of damp.

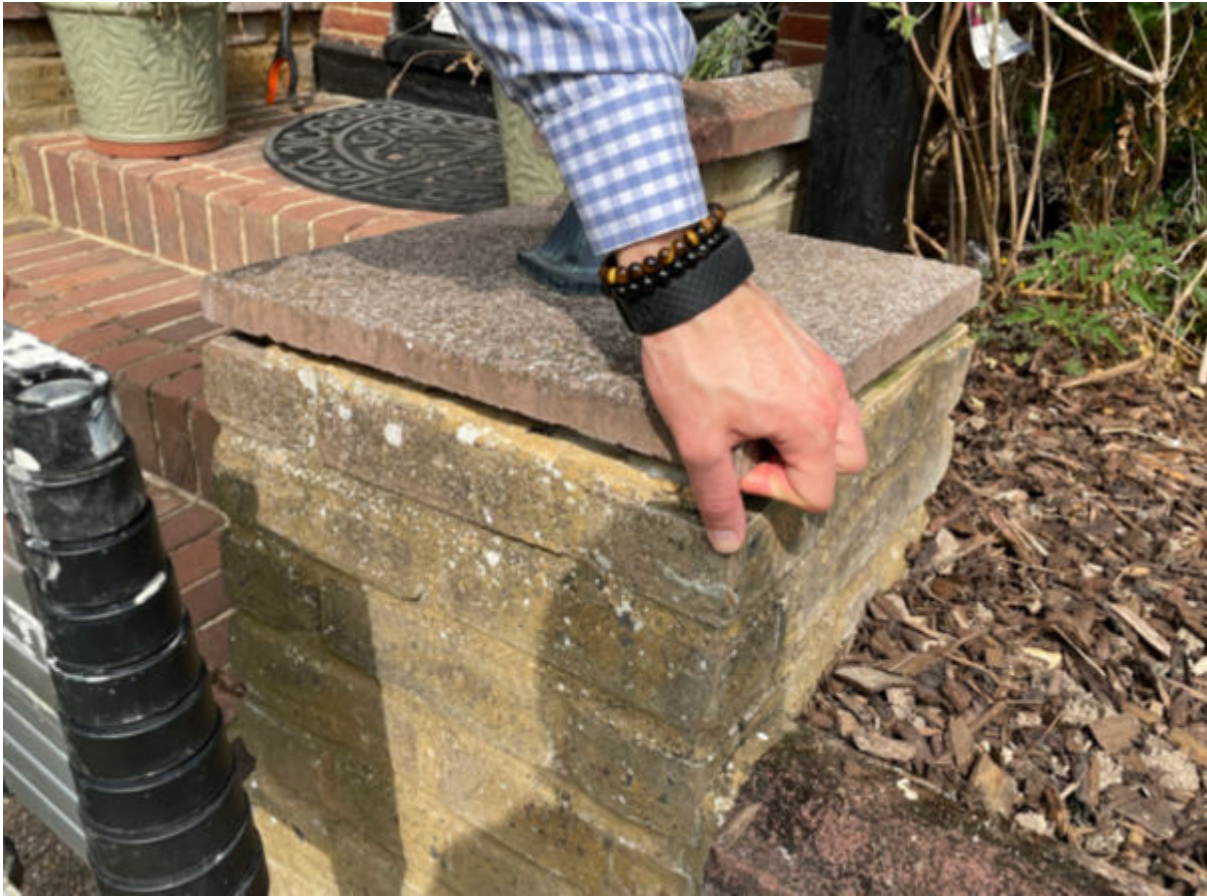
There is a brickwork London stock single skin construction wall, this is significantly weathered. While the wall does have four respective buttresses, which given its length will provide sufficient support. It is showing signs of significant weather ingress throughout, lichen and moss growth throughout, and will likely require some maintenance and repair immediately.

The metal railing to the midsection of the wall is also significantly weathered, with the paint having blistered and peeled off.

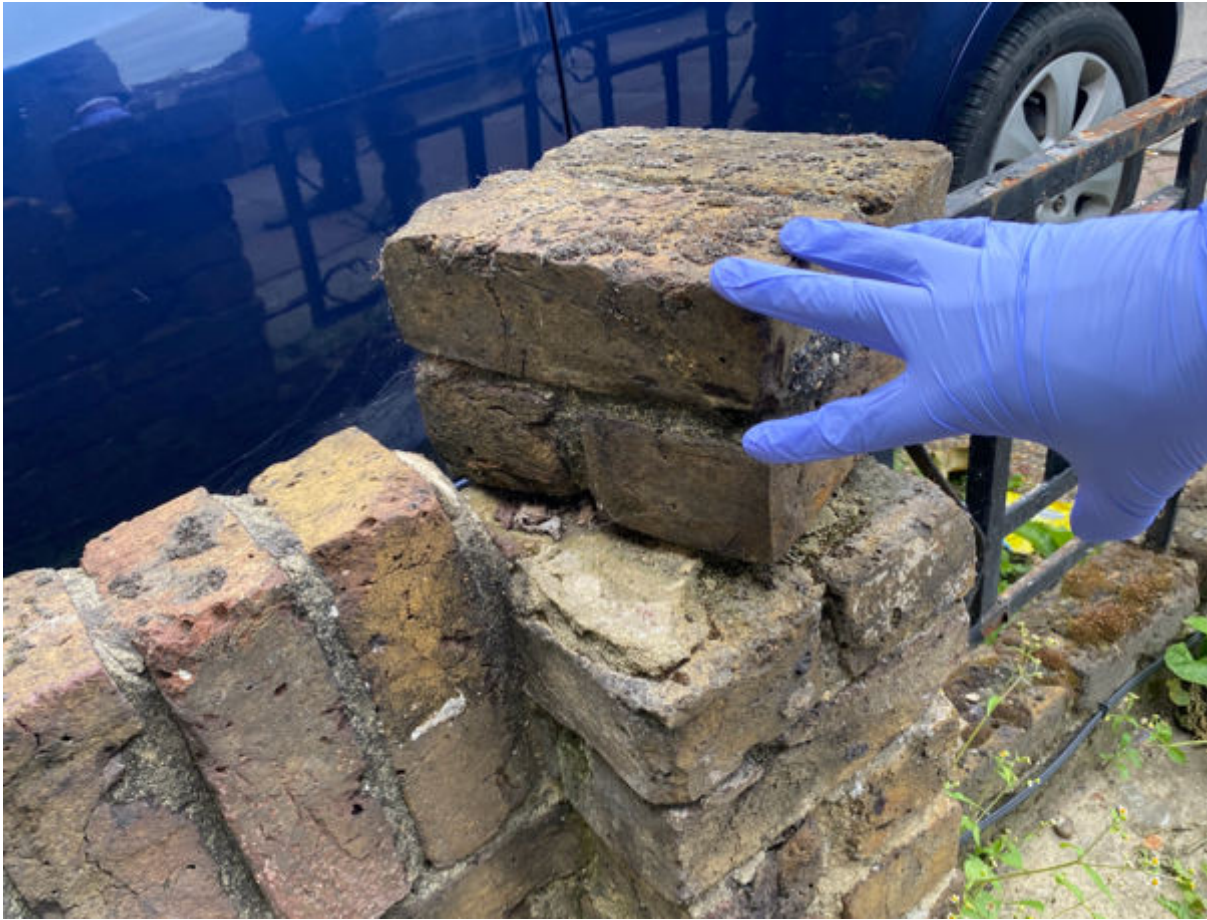
The central pier/buttress, the upper section of the brickwork is loose when tested and is not held in place firmly. This is a danger and will need to be bedded in with suitable cement.

At the rear, there are timber fences with a mix of concrete posts, and timber posts to the left and right of the garden. These have been stained. The fence to the flank of the summer house is severely weathered and is seemingly installed to ensure that the tenant's pet doesn't escape the rear of the property.

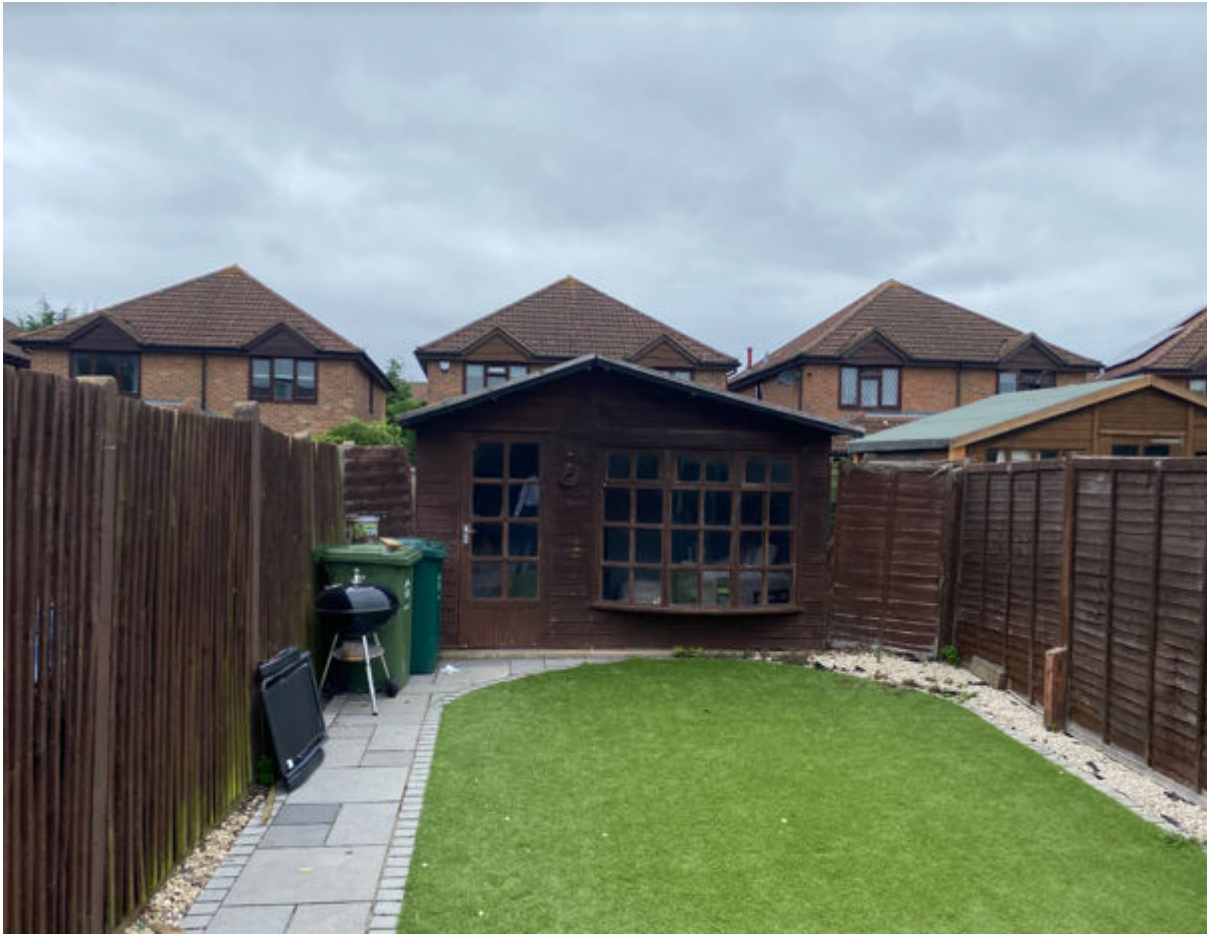
The fence beyond that point has fallen over and has reached the end of its useful life. This will need to be replaced in due course, and would therefore advise budgeting for the costs of an experienced contractor or fencer to visit and correctly install any fence.

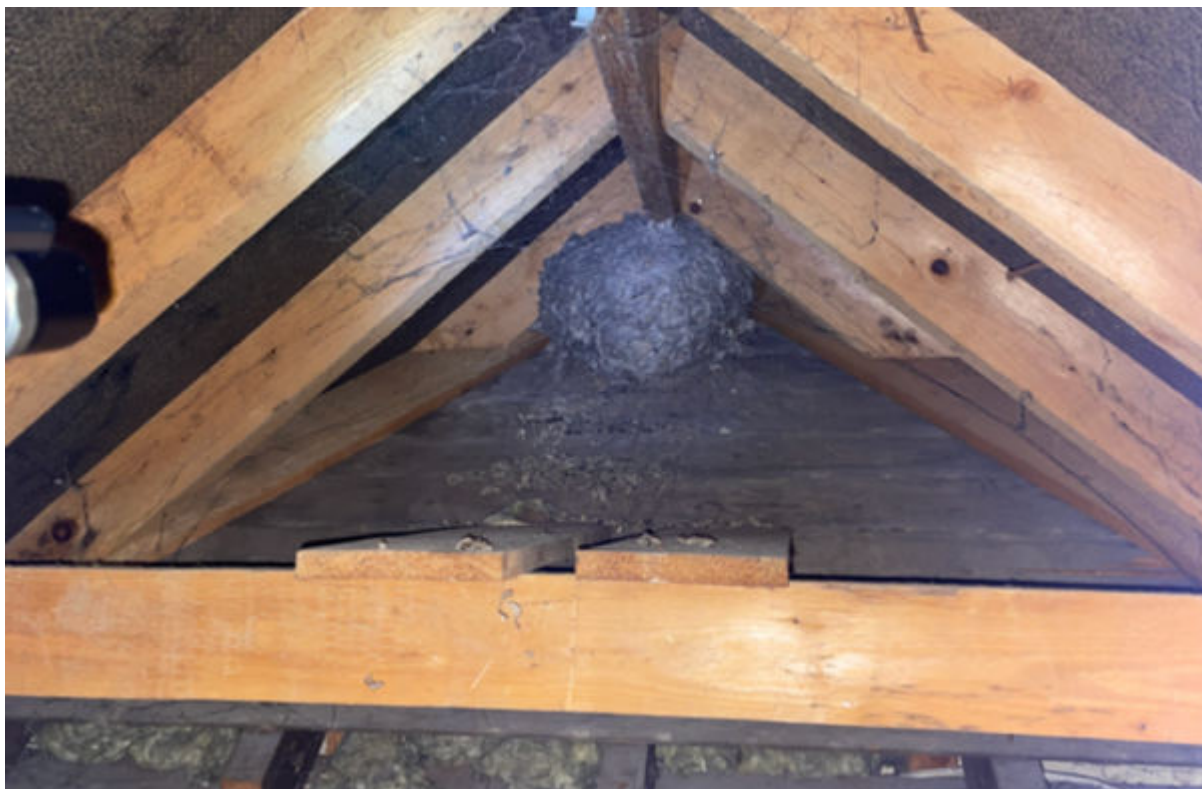
I did note a couple of different wasp's nests within the loft area which is normal for a property, however, it is worth noting that wasp's nests are seasonal and a nest will be used once and therefore this could be an ongoing issue. It is also worth noting that I did locate a wasp on the first floor level which was dead and that is usually a sign that there is an ongoing wasp/pest problem.

The roof itself has insulation, however this is of the old fashioned type, and outside of a head and shoulders inspection, I was unable to fully inspect this area as it would not be safe to walk on the ceiling joists as safe inspection would not be possible given the density of the insulation itself.

Where visible, the roof does appear to be free from any defect, and there are certainly no signs of any water staining noted on any of the timber members, the party wall or any of the sarking felt.

The sarking felt is firmly fixed, and there doesn't appear to be any signs of rucking noted.

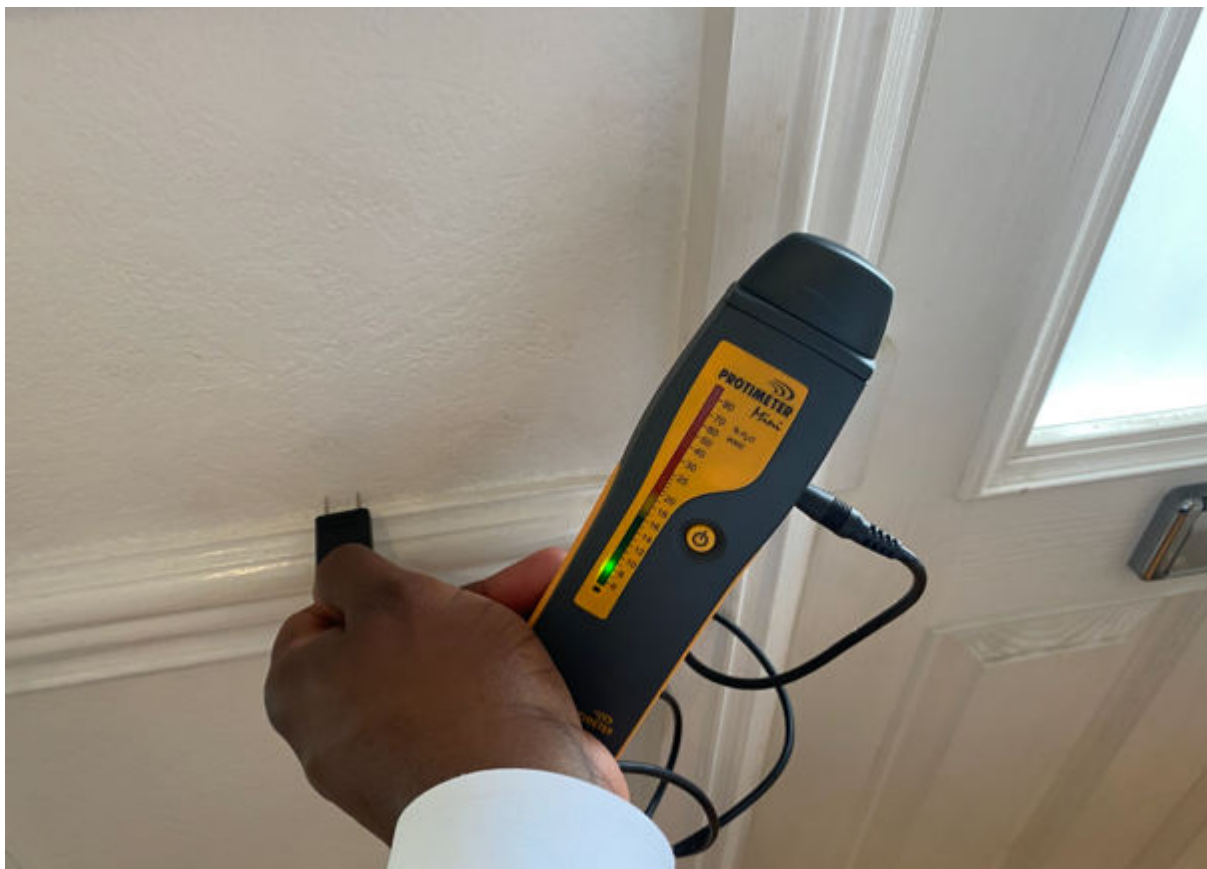
Damp meter tests were taken to the perimeter of the property and walls throughout, at low, mid and high level. All readings returned with a green reading, which is effectively a dry damp meter reading, and the result we would look for as surveyors.

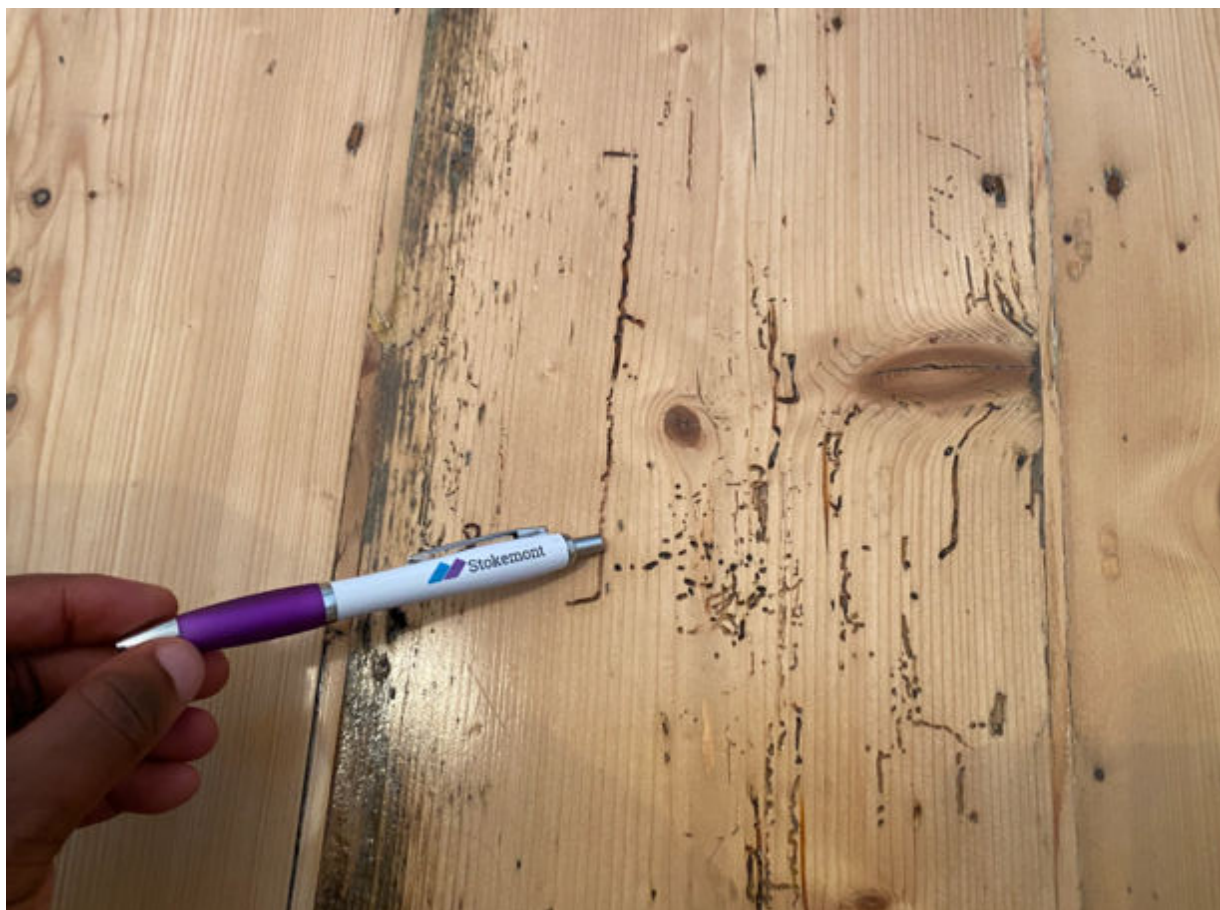
On all timber floors, predominantly on the first floor level, there are signs of historic infestations, whereby it appears to have been some form of woodworm, or woodboring

beetle, or weevil problem. It is hard to tell whether these are historic issues, or whether this is live, as there was no sign of any frass or signs of it being a live infestation.

In advance of proceeding with the sale, I would advise that a timber specialist is appointed to give you sound and firm advice as to whether this is a historic or live infestation and whether the matter has been resolved.

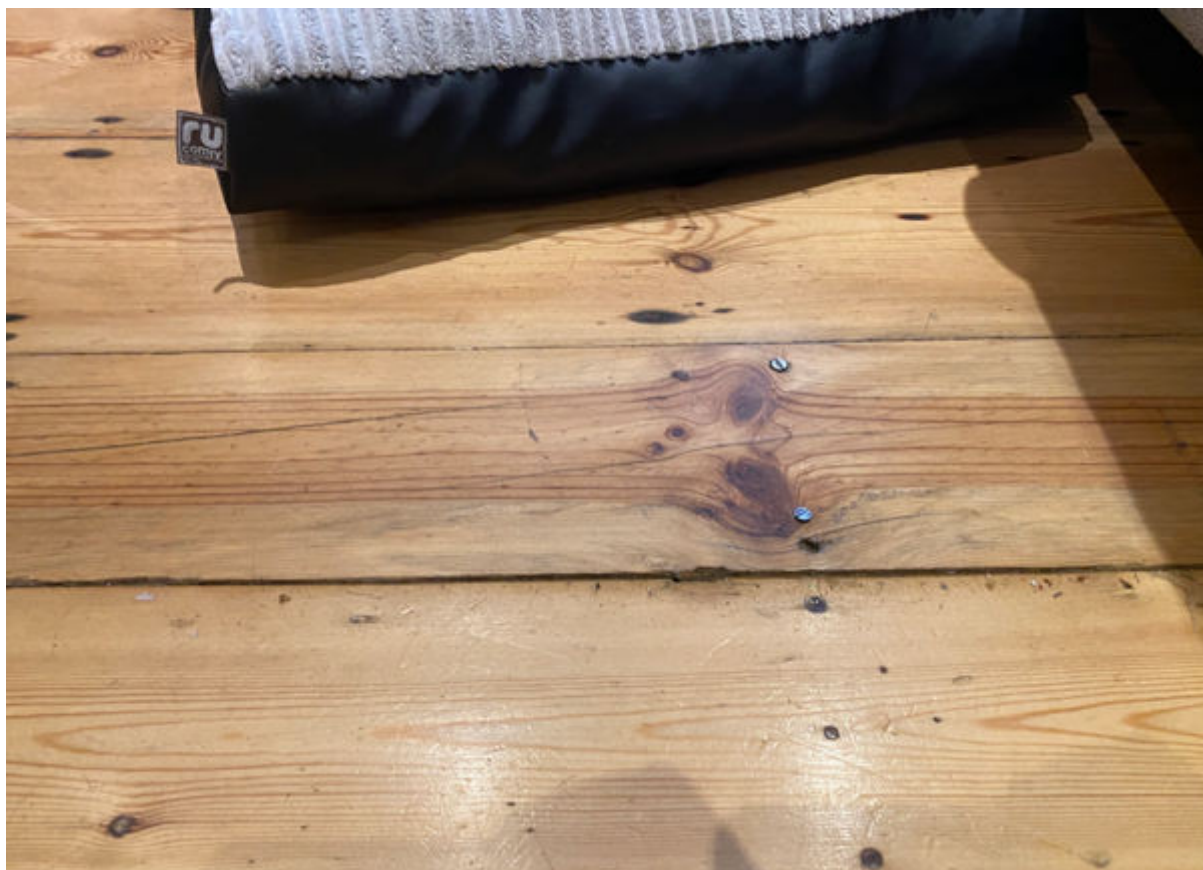
To the ground floor, the central wooden board, approximately 2.5m from the junction of the entrance, has been screwed down, and the screws themselves were sitting proud from the ground. These are a safety hazard and you could easily catch your toe on these, and I would advise, that if you do proceed with the purchase, that these are recessed into the board itself and infilled to ensure a smooth and neat finish.

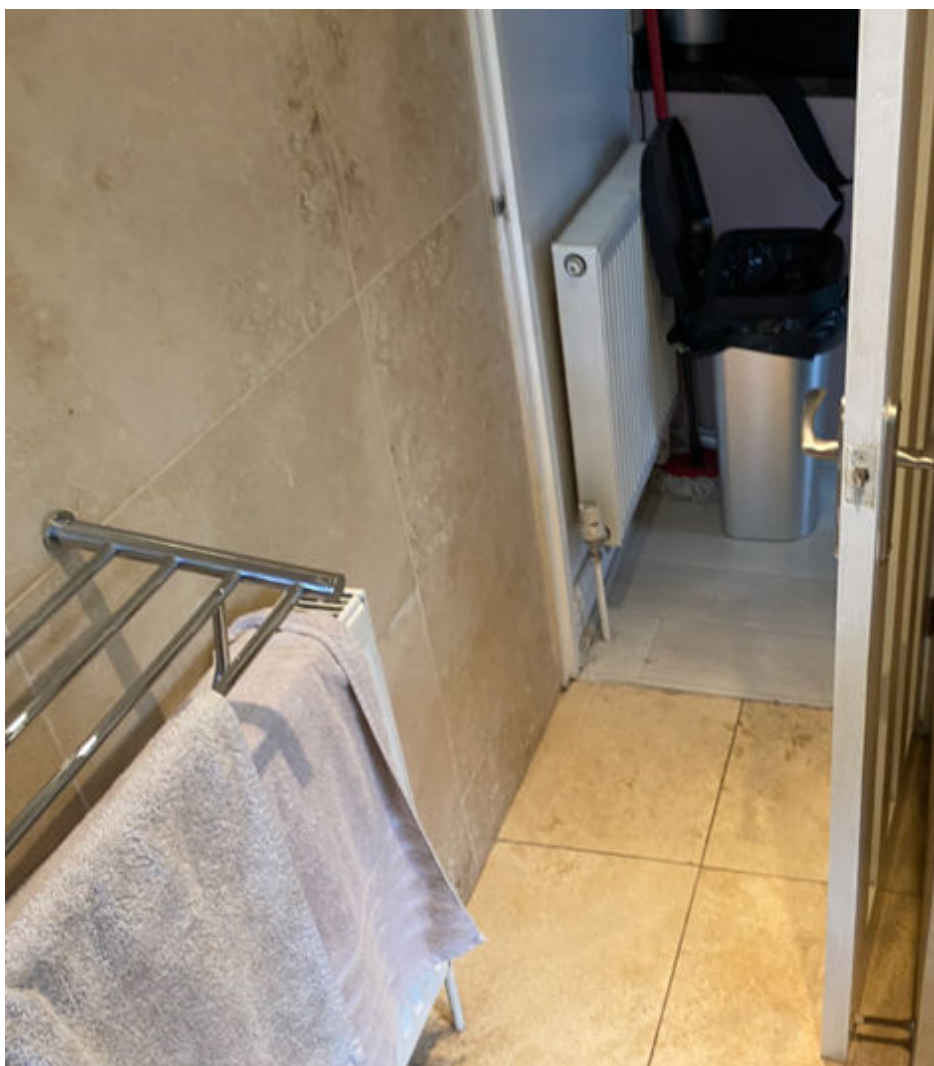
The bathroom is a modern, decorated type. The pressure was tested on the tap, shower and bath respectively and appears to be of a suitable standard. All taps also provided hot and cold water when tested. The toilet seat is broken and detached at the junction where it meets the toilet basin and will need to be repaired or replaced.

The towel rack that is wall hung above the radiator, projects into the entrance of the room itself, beyond the radiator. So as you walk into the room, it is likely that in the dark, you could catch yourself on the towel rack. The rack itself was wobbly and detaching from the wall and I suspect it is likely to be due to being bumped/knocked through normal use of the bathroom.

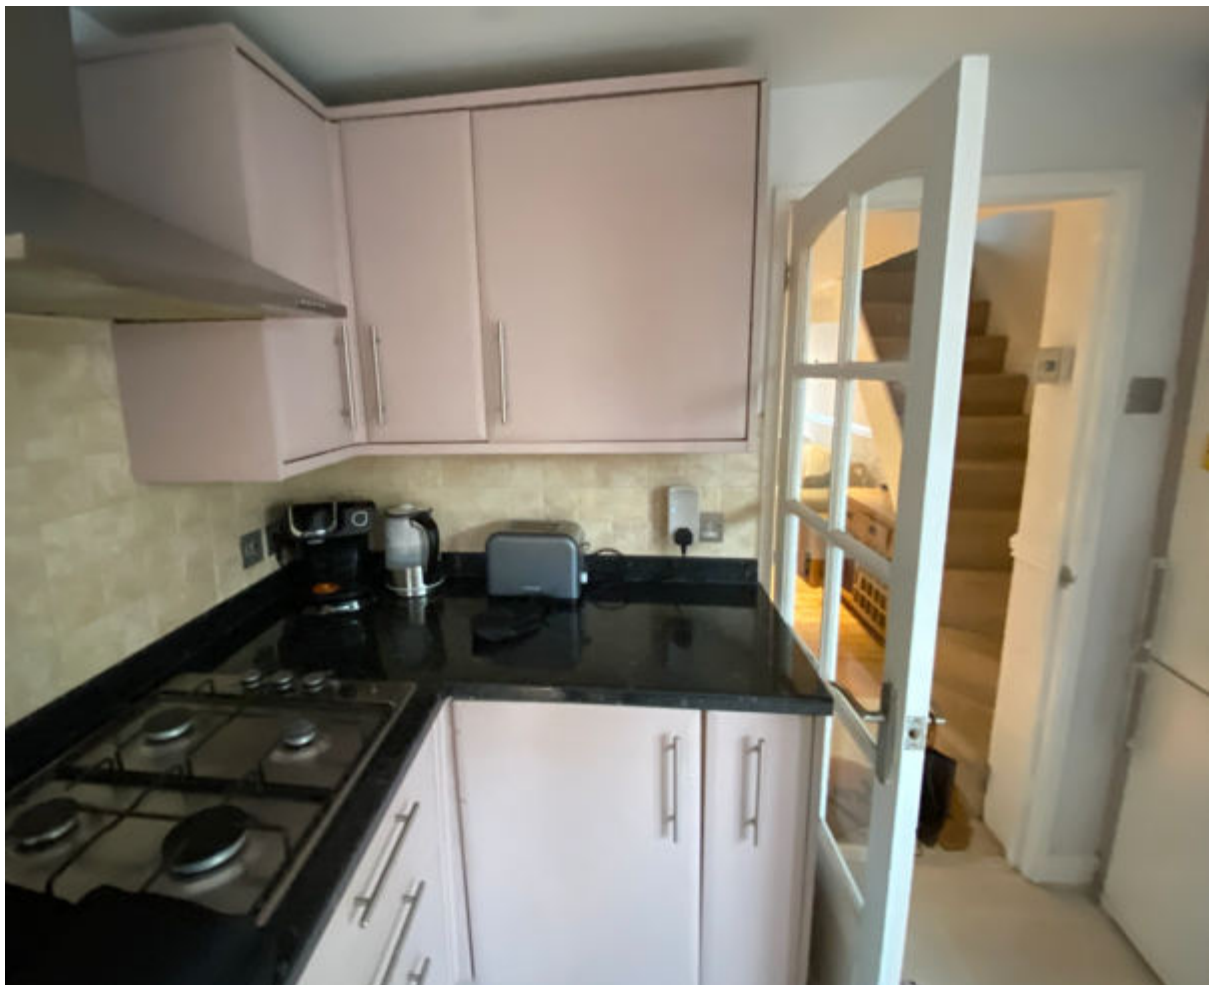
Ground floor kitchen door is a timber framed, single-glazed type. The glazing does not appear to be safety type. Safety glass is recommended as it is tougher and more robust than normal glass and prevents shattering and smashing which can be used through the normal operation of the door.

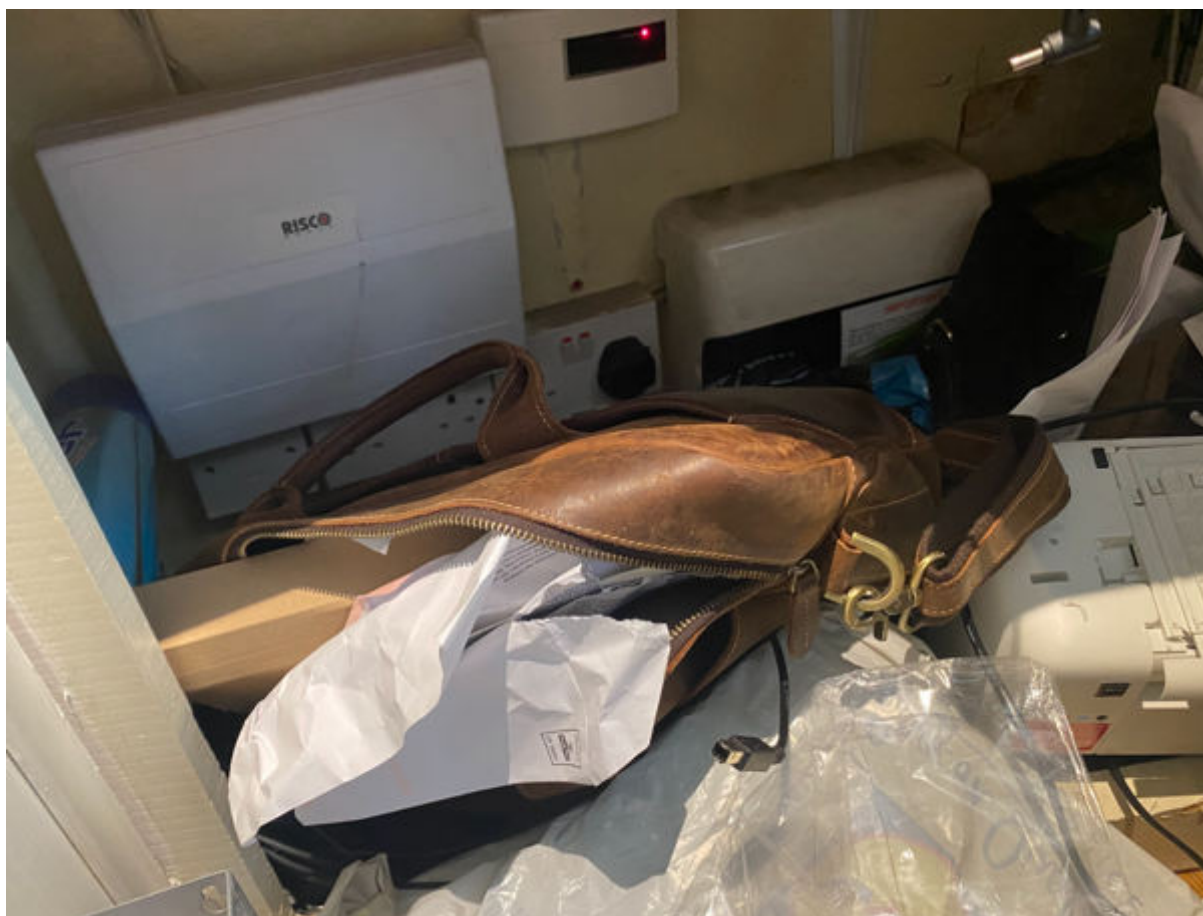
The electricity meter and RCD unit are located to the right of the ground floor chimney. At the time of inspection, this was heavily obscured by stored goods. The door to the unit itself, whilst it opens and operates smoothly, it does bind on the chimney hearth, which could prevent full access for a service engineer.

I would suggest that this cupboard is kept clear of stored goods, as effectively, if there is an issue or emergency, you will want to be able to access this quickly and without delay.

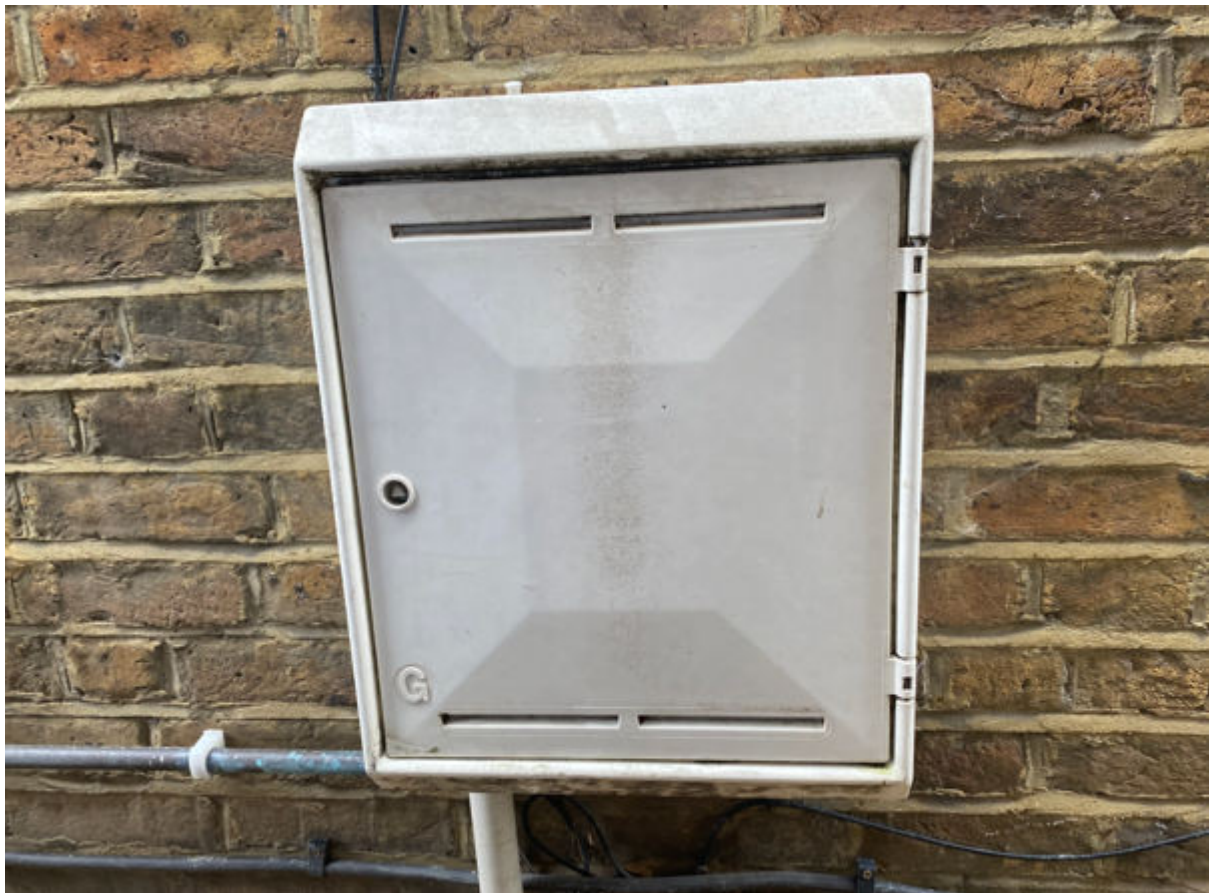
The gas meter appears to be located externally, on the flank of the building.

At the time of inspection, the meter cupboard was locked and we were unable to open this. I would advise that prior to proceeding with the property, you have the gas services inspected by a Gas Safe Registered Engineer to ensure they are operational and free from any issue, whilst also ensuring they are also in accordance with current Health & Safety and Building Regulations requirements.

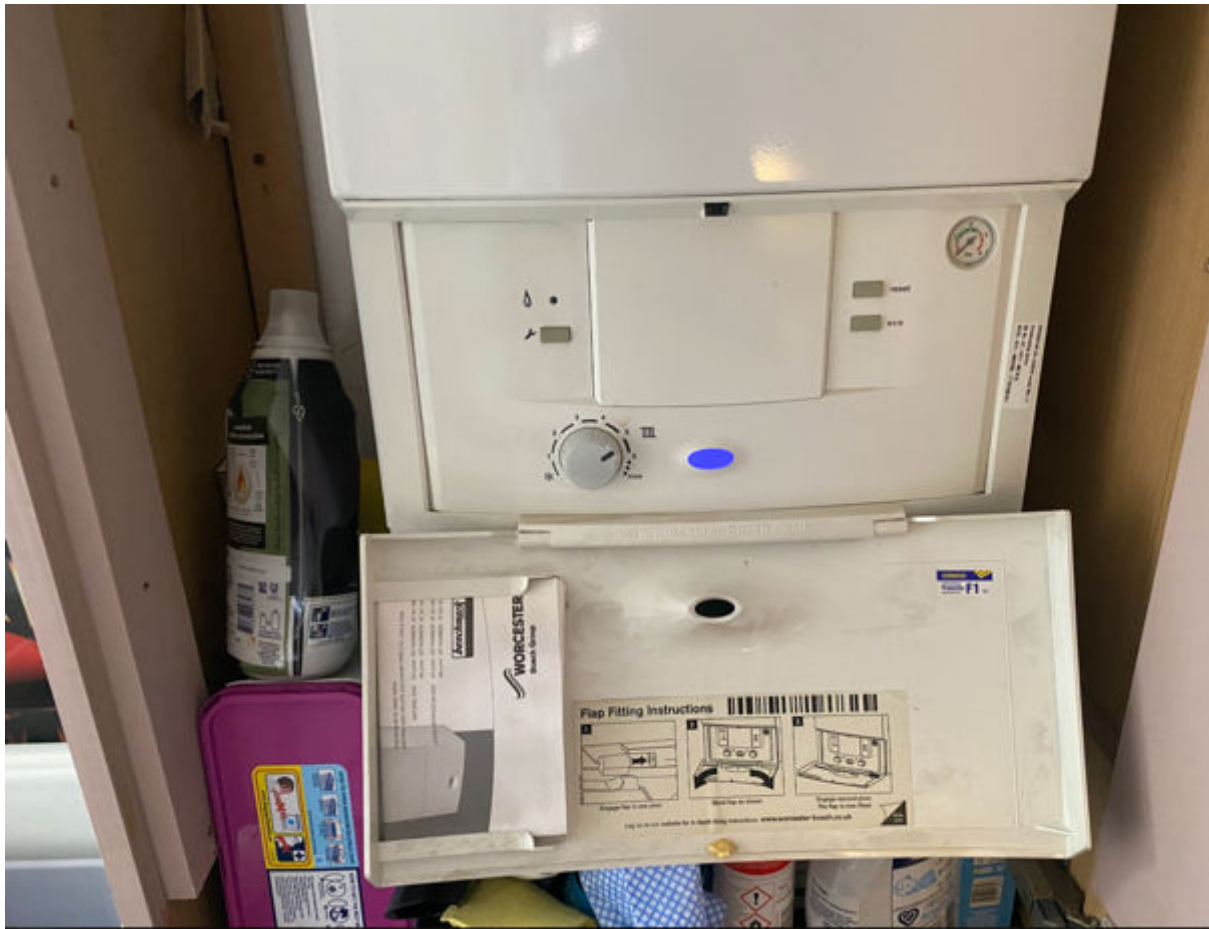
Heating is provided by a Worcester Bush boiler which was located in the kitchen. The boiler was hot and when tested, did provide hot water, and all radiators were operational. The pressure bar of the boiler was on zero at the time of inspection, and there were no service records present.

I would advise that you have a Gas Safe Registered Engineer fully inspect the boiler to ascertain that it is indeed fully operational and free from any issue. There is a Hive thermostat located to the flank of the kitchen door.
