## **RICS HomeBuyer Report:**

Address of Purchase Property

## **RICS Home Surveys RICS HomeBuyer Report**

**00-00-0000**

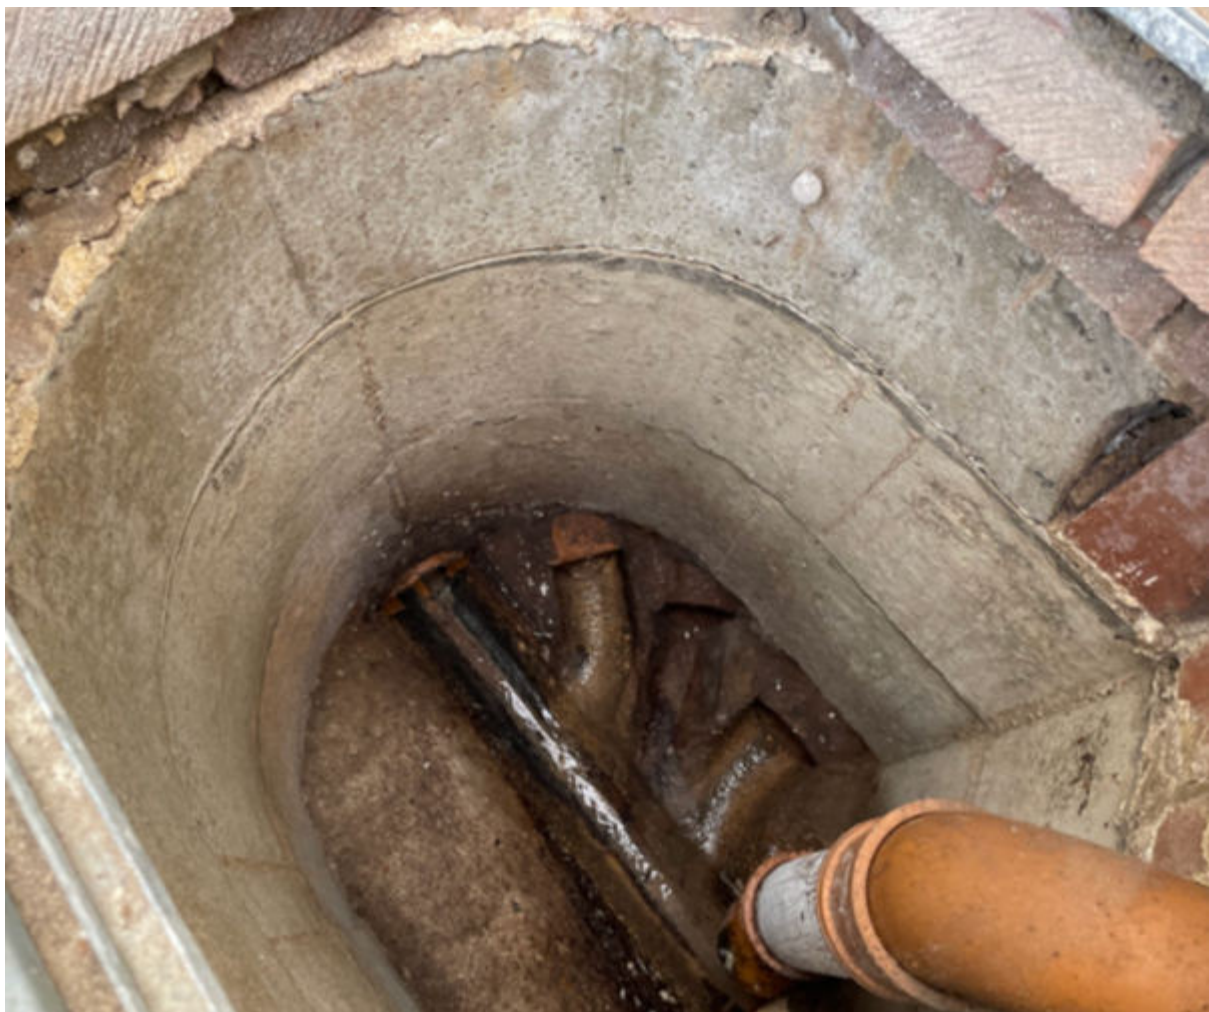
All taps were turned on and water appeared to drain efficiently, without any build up. It may be sensible to have a CCTV drain survey undertaken in advance of proceeding with the purchase to ensure that you are fully aware of the condition and state of the drains, thereby ensuring there are no ruptured issues.

The bathroom drain, when emptying, did return with a gurgling sound. You may want to have this inspected by a plumber to rectify the issue.

The bathroom toilet, when the flush is operational, it does not appear to be that strong, and it could be that the cistern is defective. You may wish to consider having a plumber look at this to ensure that when the toilet is in operation and use, that there is sufficient pressure to remove waste.

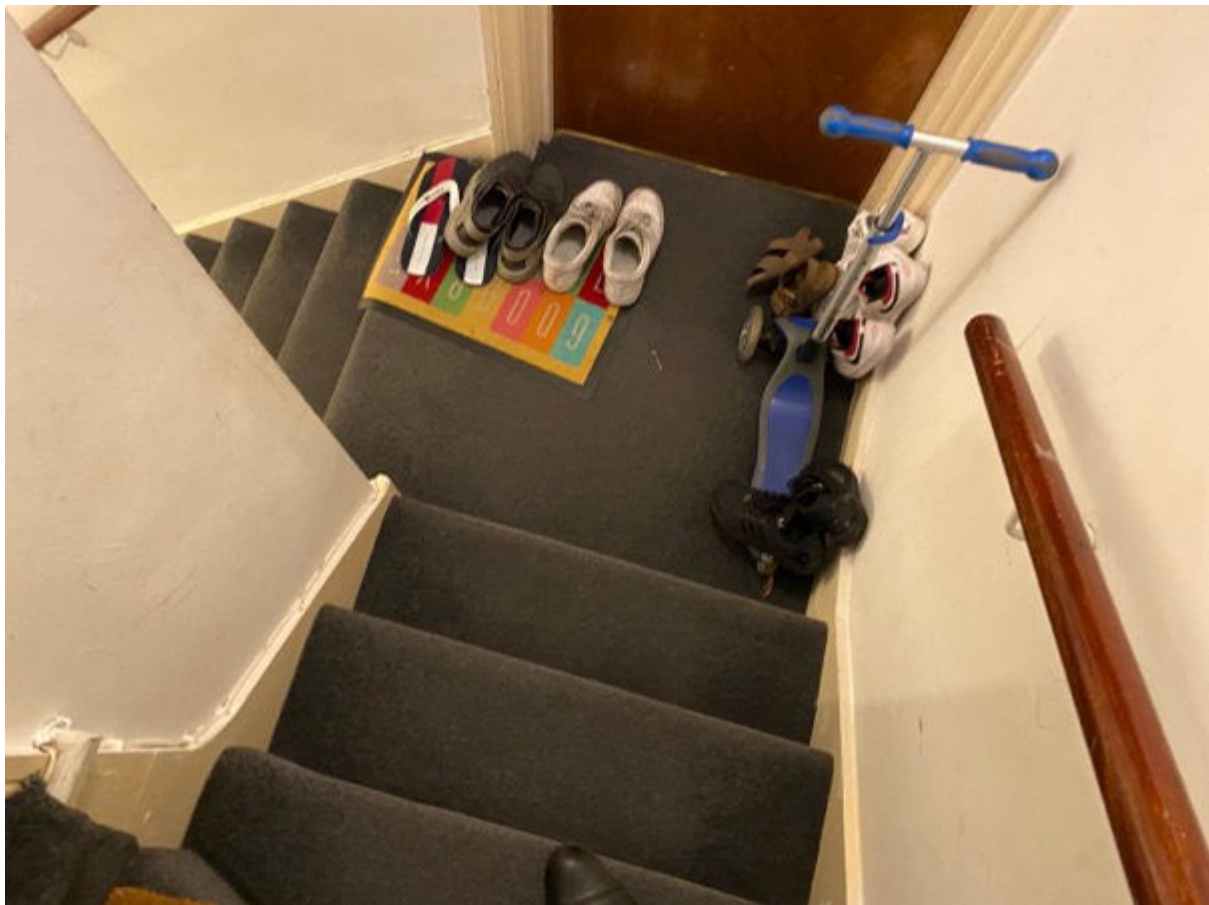
Within the communal areas running up to the flat itself, there were a number of other flat and occupant items including shoes and bicycle scooters. I would advise that you make enquiries as to whether these have the right to be there, as dark at night it could be a sign of a tripping hazard, as well as generally being towards the unsightly end of the spectrum.
