Building Survey Report

Building Survey Report Contents:

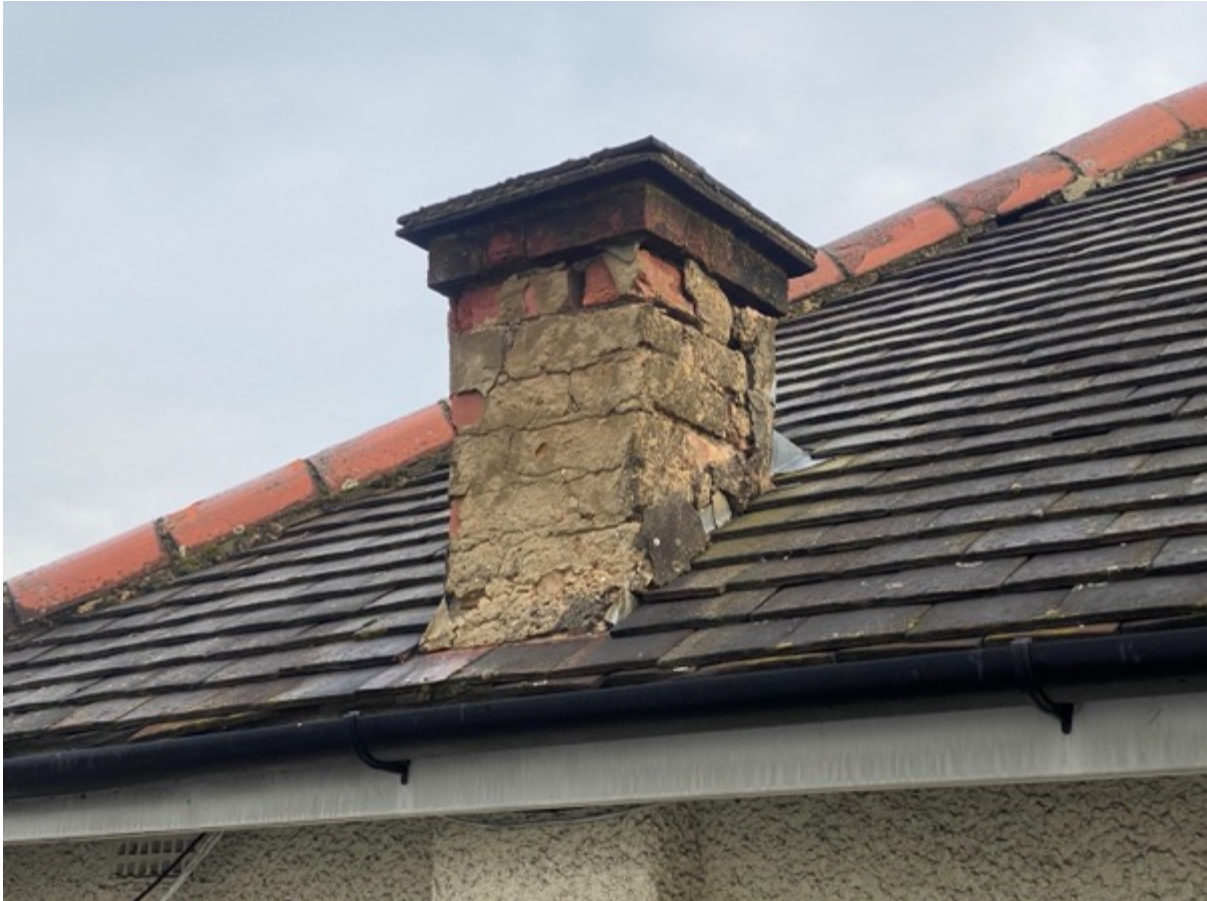
The chimney stack is of brickwork London stock solid construction. There are a total of eight pots on the stack shared with the adjoining property.

It is worth noting that there is a television aerial attached to the chimney stack itself. This can be an issue in windier weather and during the time of the inspection the street itself was relatively windy so in very strong days of wind this could be a potential hazard and could peel away or be blown off the chimney stack.

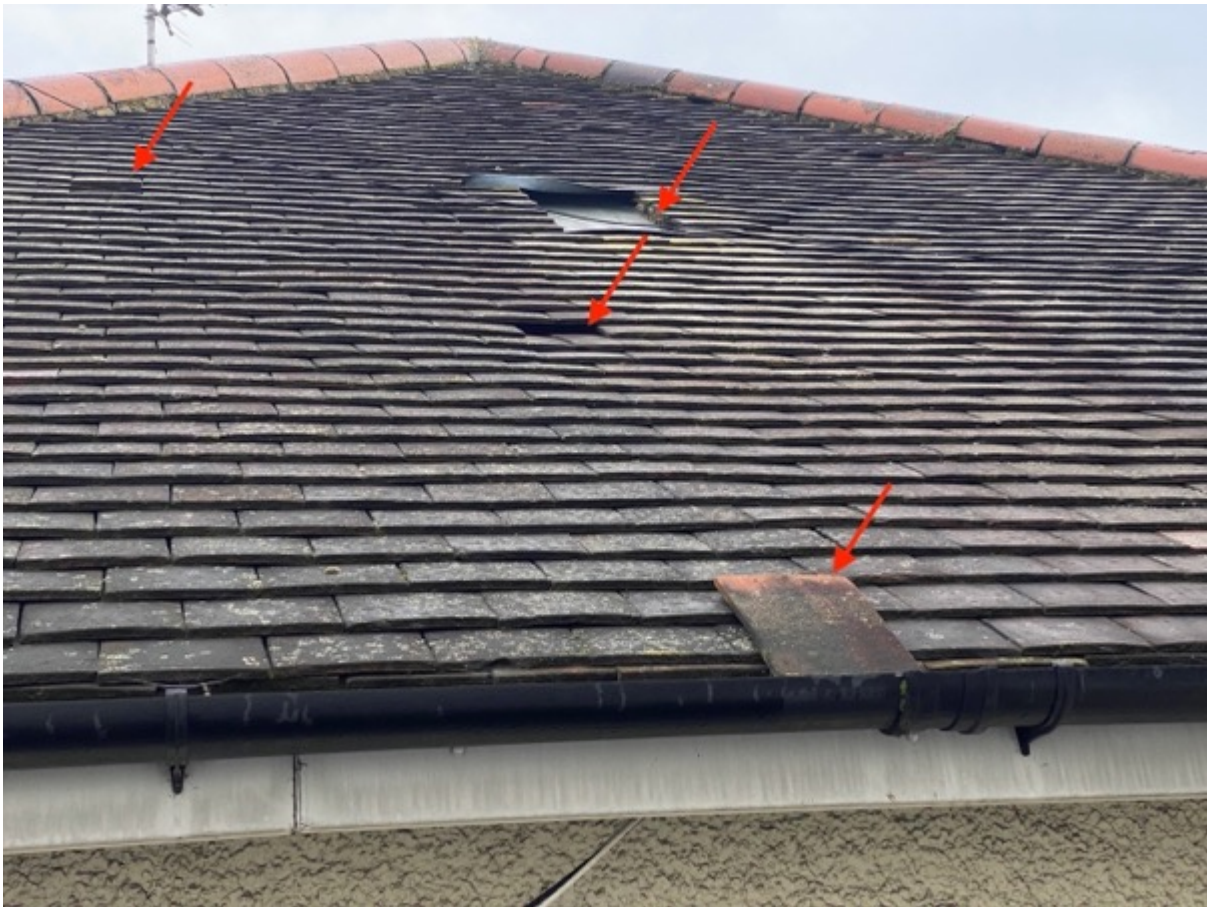
The coverings themselves have lichen and moss growth noted throughout, however, overall, there did not appear to be any signs of lifting or disrepair of tiles.

To the rear of the property the roof is fully covered with a loft dormer. The dormer itself appears to be clad and painted timber, however, it is worth noting this could be a uPVC cladding.

The upper level of the dormer appears to have a mineral felt covering. The covering itself, where visible from the rear garden, does appear to be showing signs of fading which is usually indicative of failing of the roof covering.

I was unable to inspect the upper level of the roof itself as there is no safe way to gain a vantage point on it and therefore, I would advise that, prior to proceeding with the property, it may be advisable for you to have a roofer look at the dormer roof itself to ascertain the condition and the longevity of the roof covering.

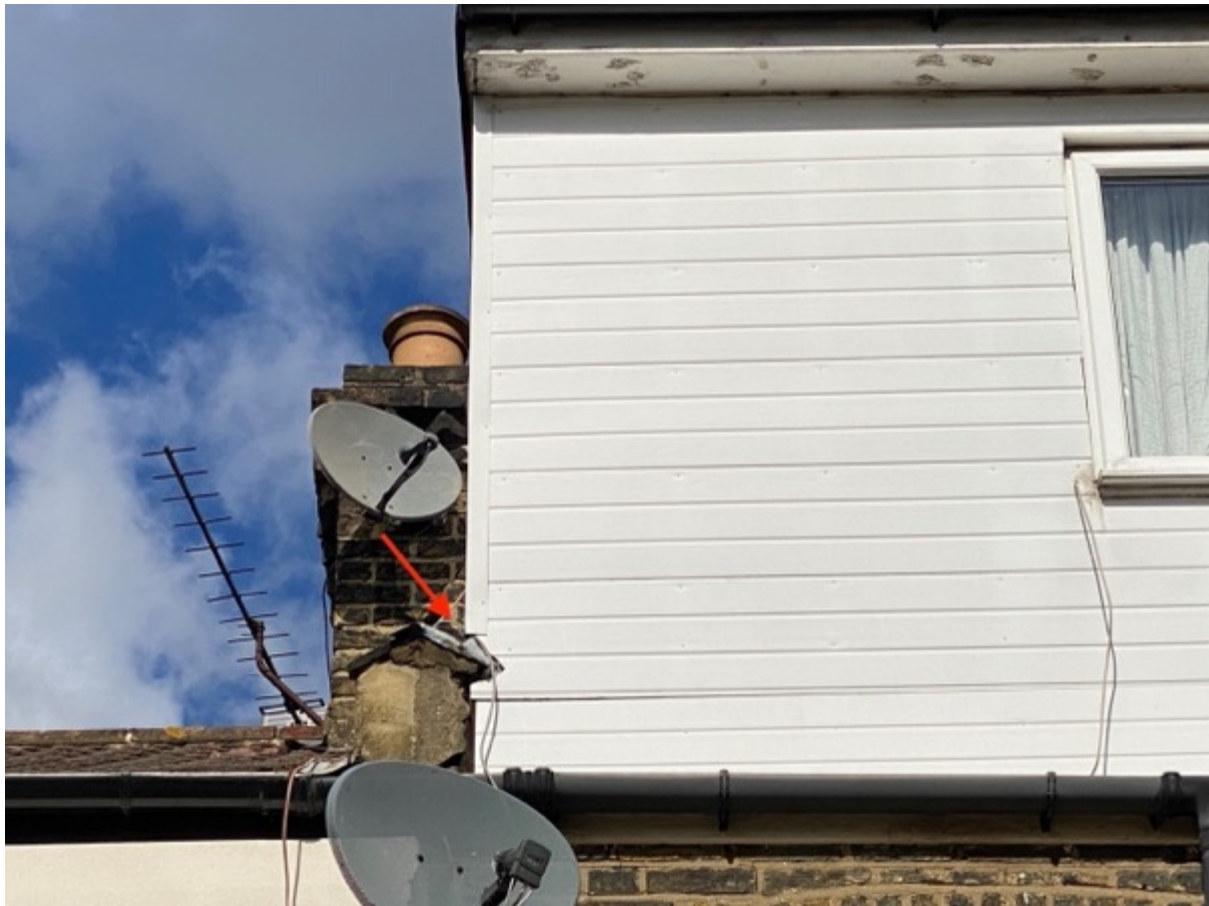
Generally speaking, this is a poor installation, and the conventional way would have been to remove the ridge tile and have a lead flashing dressed onto the party parapet wall itself with some form of considered final finish.

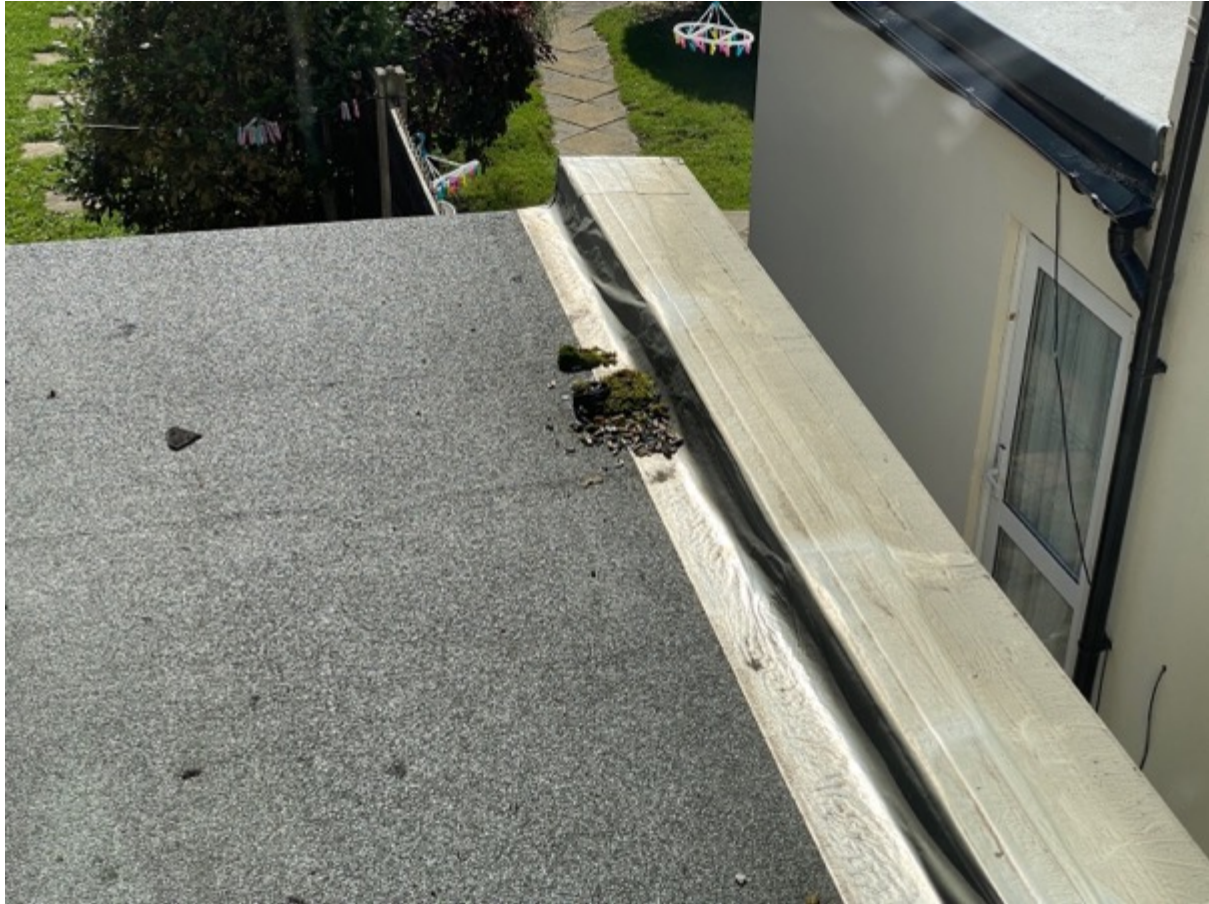
Flashband, generally speaking, has a very short lifespan and ideally this would have been done with a lead flashing which increases the longevity of the abutment itself.

Towards the rear of the roof covering there is an area of damp staining noted at one of the junctions of the mineral felt.

This is an indication that the Flashband could be failing, and water could be starting to pool. In the colder months of the year, I would expect this to freeze, and you could have a freeze/thaw effect whereby the imperfections in the roof covering are widened and expanded as a result of the water freezing and thereby reducing the longevity of the roof covering.

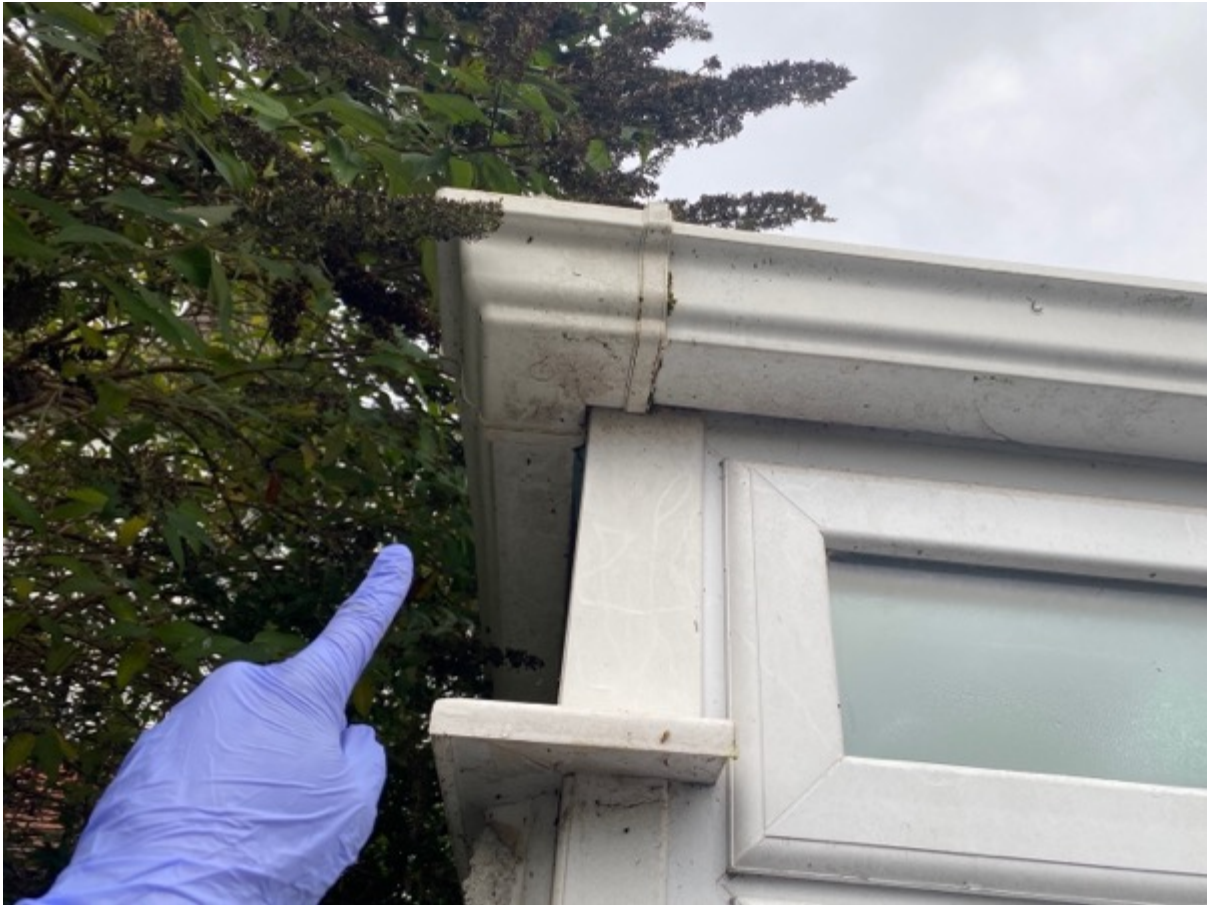
Towards the front of the property the gutters are uPVC half moon type. These appear to have been recently installed. All gutter clips were intact and neatly spaced.

As there was moss growth noted to the roof it is likely that some of this moss may have fallen into the gutters themselves and could be causing a build-up of detritus within the gutters and therefore, prior to proceeding, I would recommend having a competent roofer inspect the gutters to confirm if they are blocked or have a build-up of detritus and arranging for them to be cleared respectively.

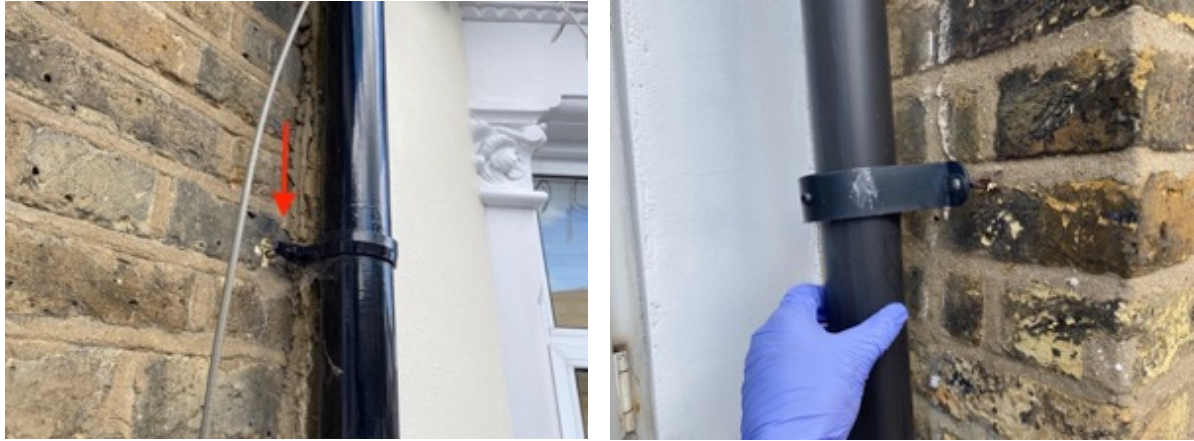
The upper clip screws have pulled loose from the wall itself and this will need to be re-secured to ensure that it is firmly screwed against the wall itself so that in the wetter months there is not an overspill of the gutters or that the gutters do not miss the hopper head and discharge water onto the wall itself.

To the rear of the property the gutters are uPVC half-moon type. The downpipe towards the rear flank is detached from the wall. The clip itself has completely fallen away and this will need to be re-secured.

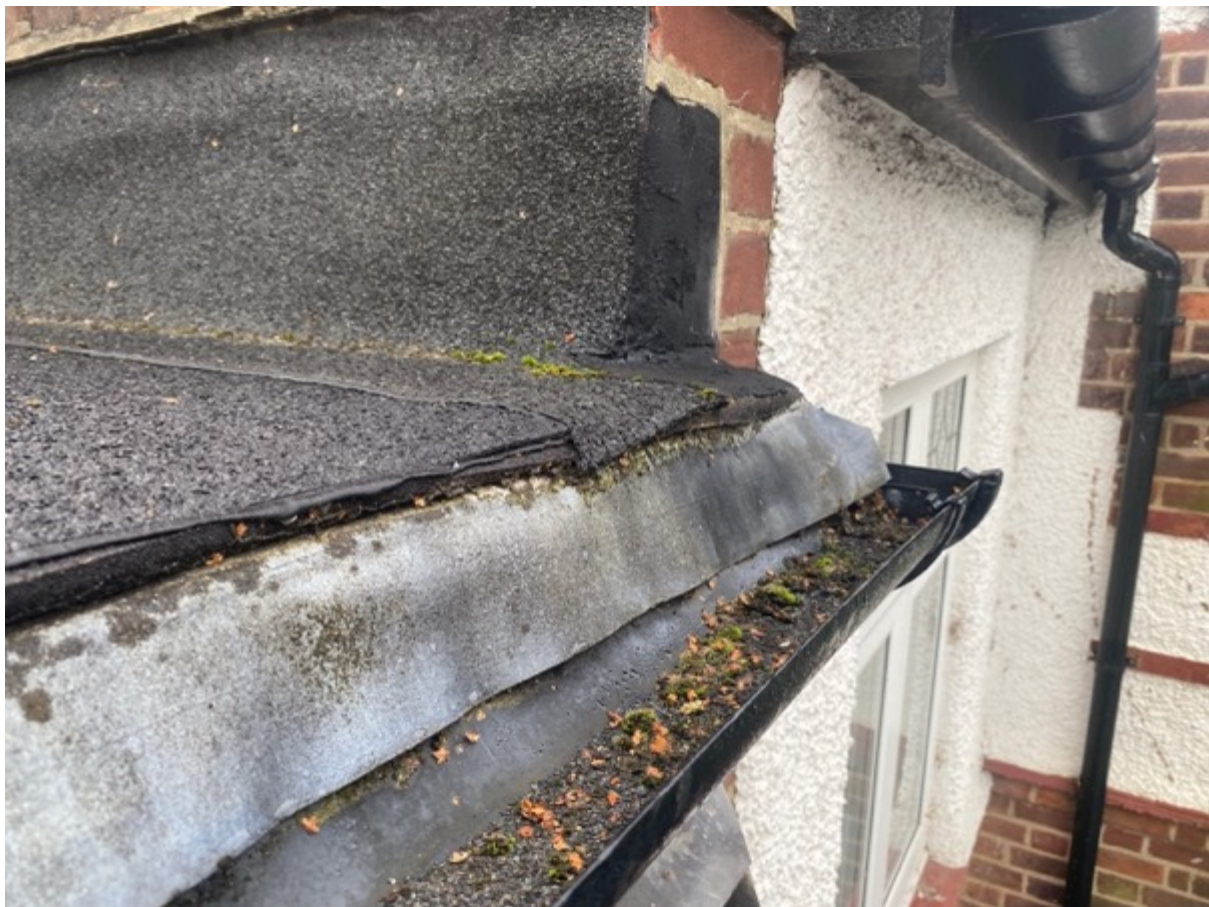
The gutters towards the rear of the ground floor extension are showing signs of moss growth and are unlevel throughout and I suspect in periods of heavy rain this could likely be spilling onto the fascia and rear extension itself.

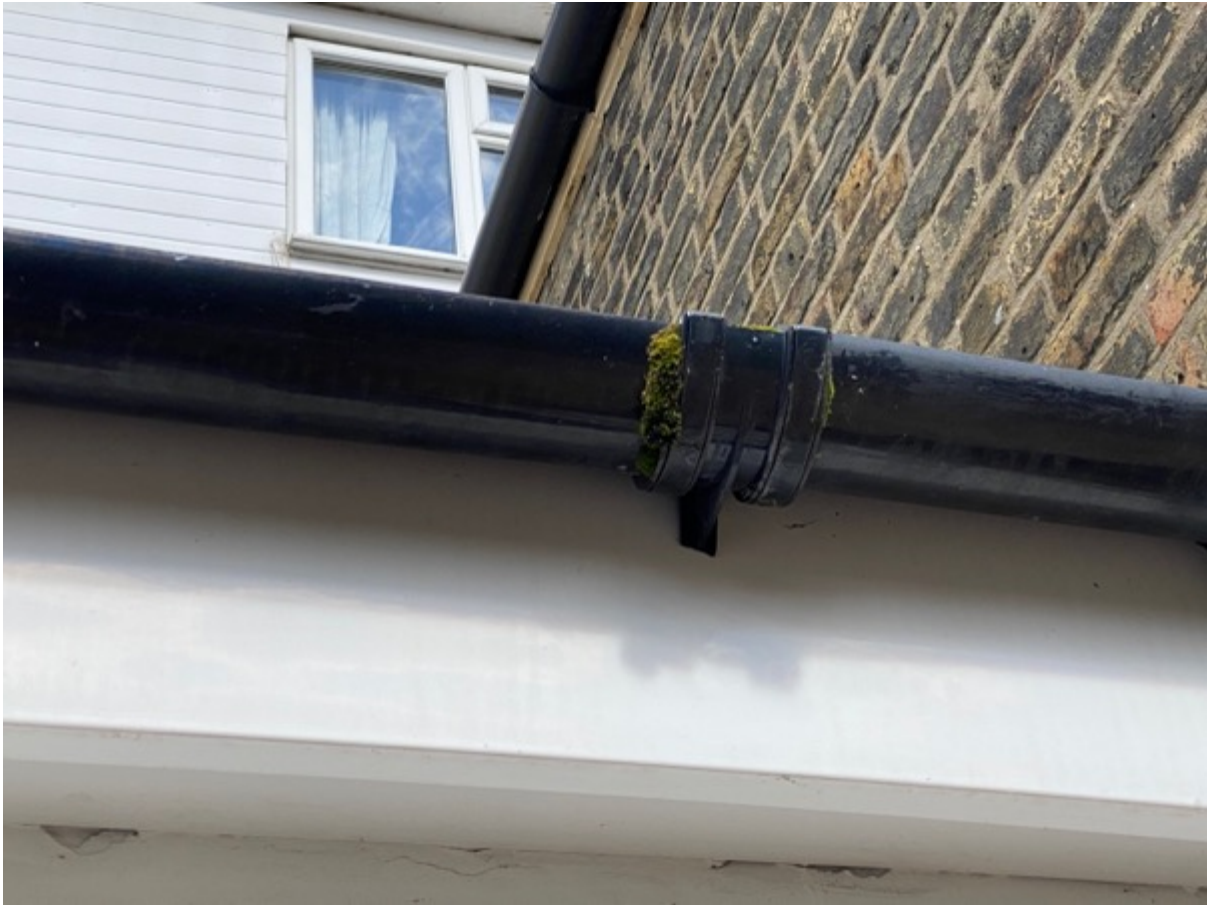
The rear wall of the rear addition has a large diagonal pipe which runs from the upper level and down towards the centre of the rear drainage gulley.

This is an unconventional installation, and I would advise it is modernised to ensure that there is a more properly considered solution.

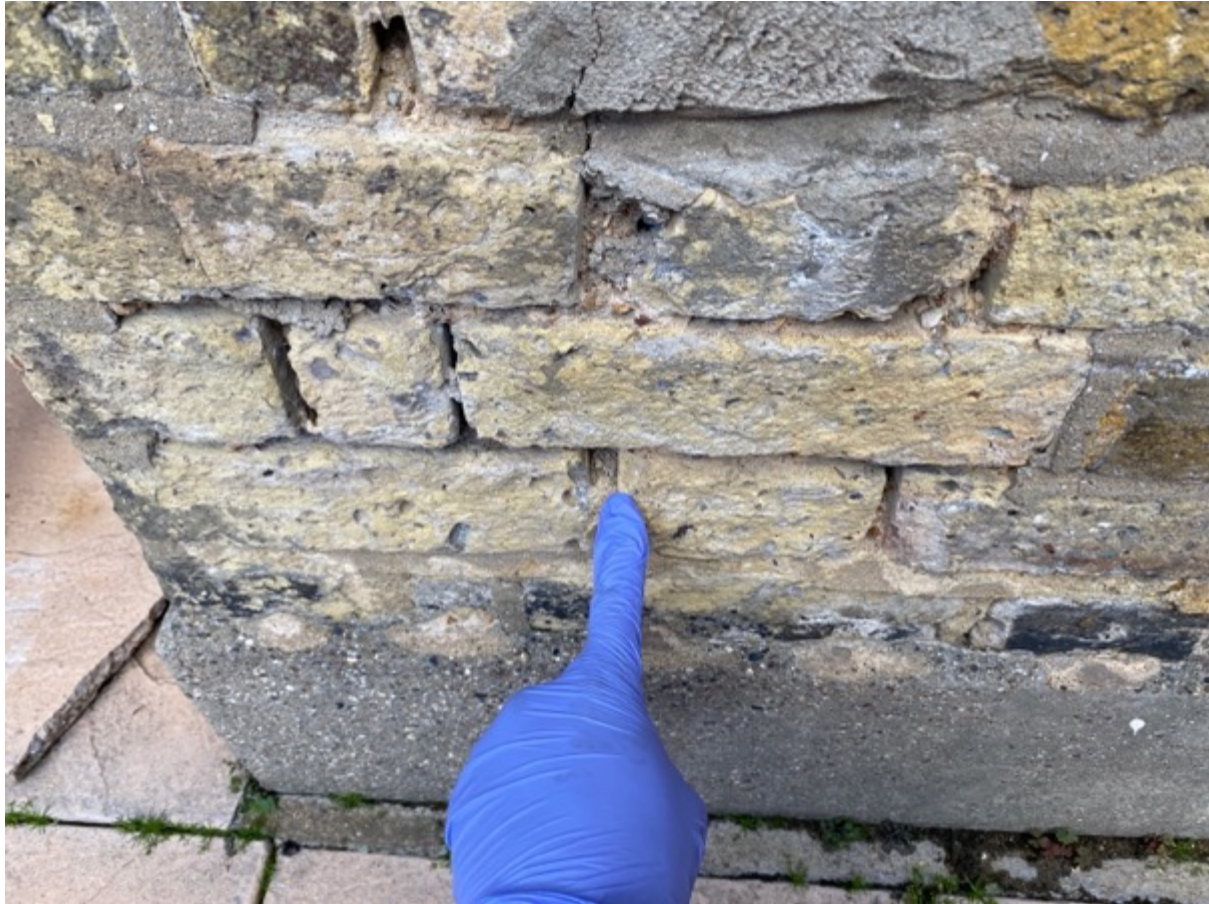
The brickwork to the rear elevation has been re-pointed at some point in the past, however, towards the lower section above the rendered plinth there are areas where the pointing is completely missing and further areas where pointing is popping or chipping away.

Generally speaking, this is usually a sign that the pointing that has been done is insufficient and I suspect in due course defective pointing will need to be raked out and filled to ensure that there is a sound weather break between the external areas of the property and the internal walls themselves.

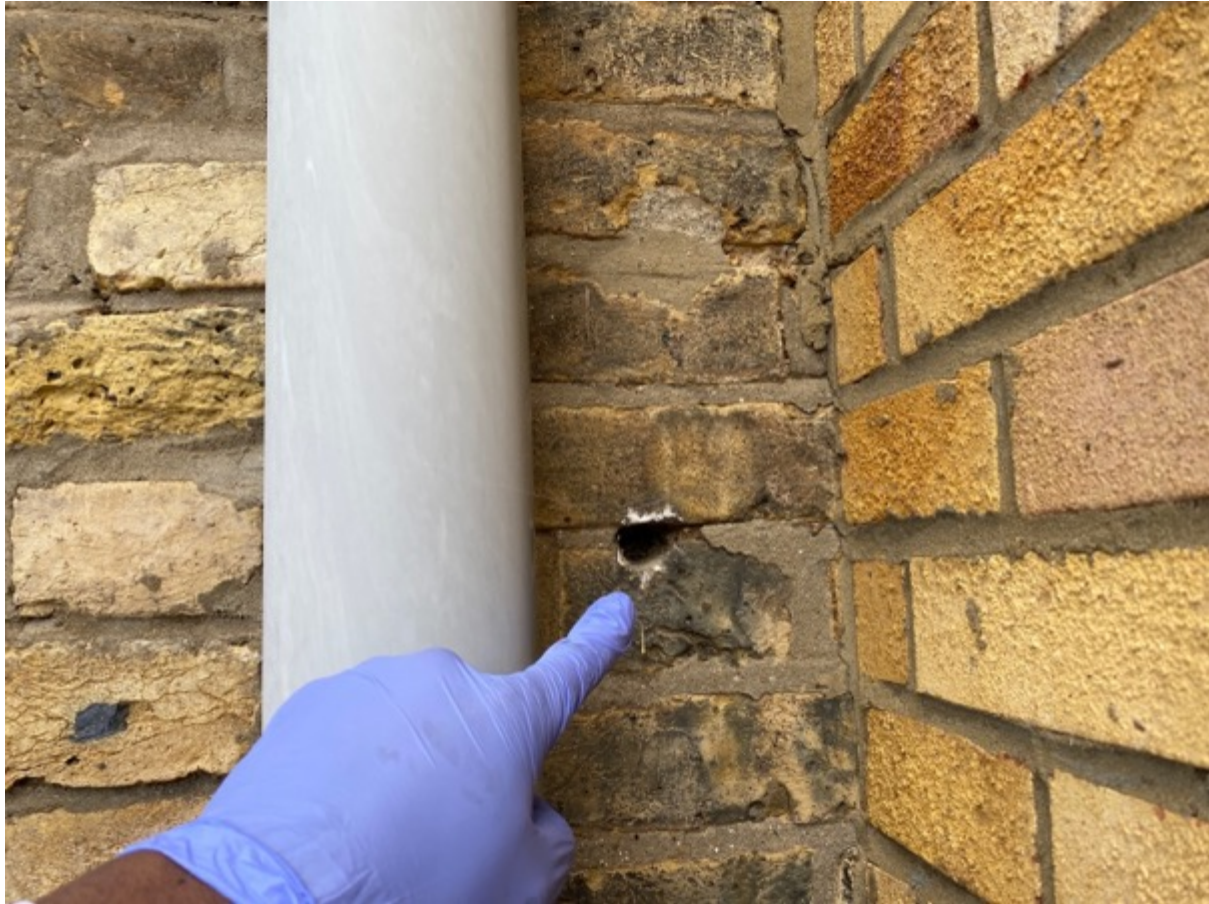
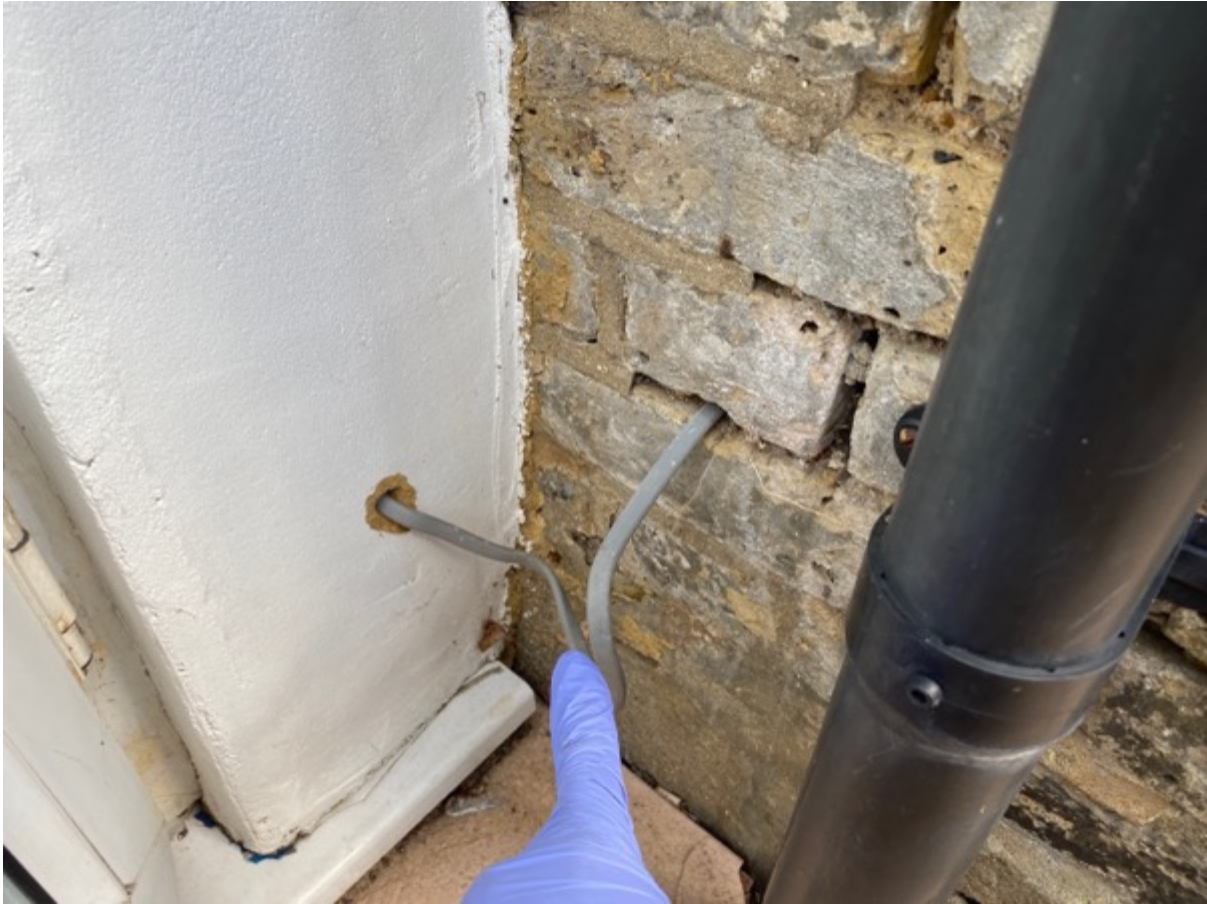
It is also worth noting that on the rear wall of the rear addition there is a drilled pole through the lower right corner whereby a wire is protruding and then running back into the flank wall of the kitchen itself.

This would not be Health and Safety or Building Regulations compliant as the wire can be pulled and moved, and I would advise that this is either boxed in, trunked in or the conventional wires are run through the internal voids of the property.

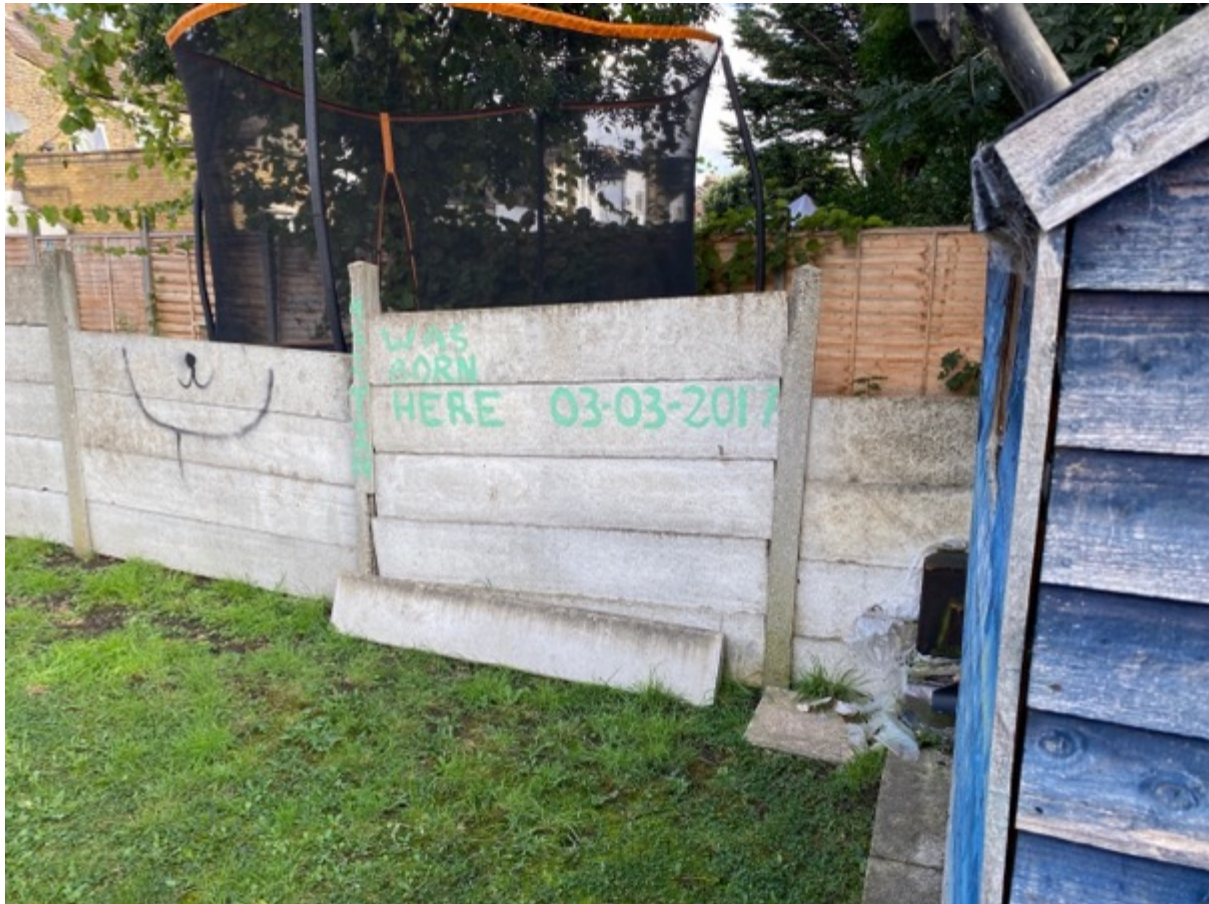
Fences towards the rear garden are a mix of concrete panels and concrete posts and concrete posts and timber panels. Overall, the fences themselves are out of alignment and with a number of panels having failed.

The fences to both the left and right sides appear to also meander both on and off the boundary wall and I would therefore advise making enquiries as to whether there have any boundary line disputes in the past.

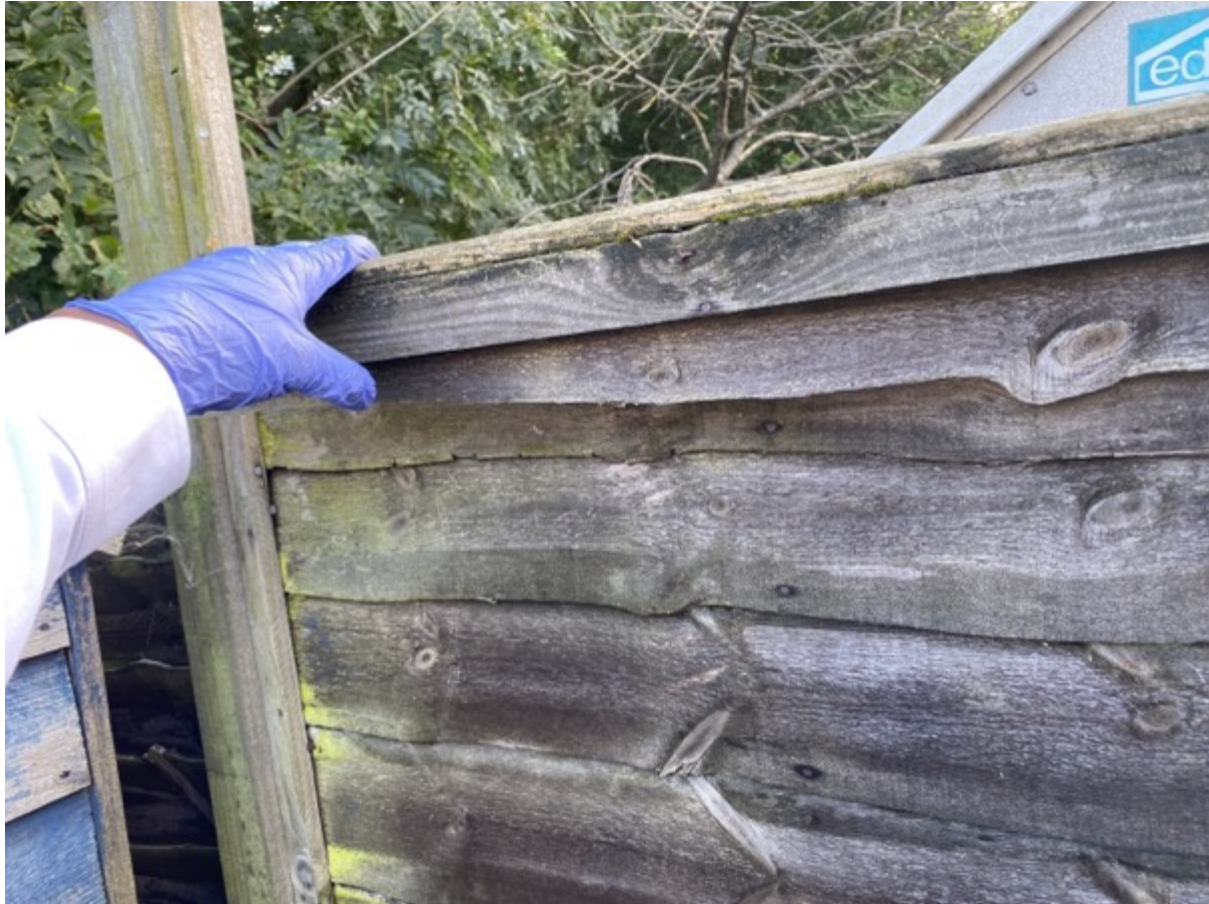
The fence panels themselves have completely failed and are significantly suffering from weather ingress, these will need to be replaced in the immediate future.

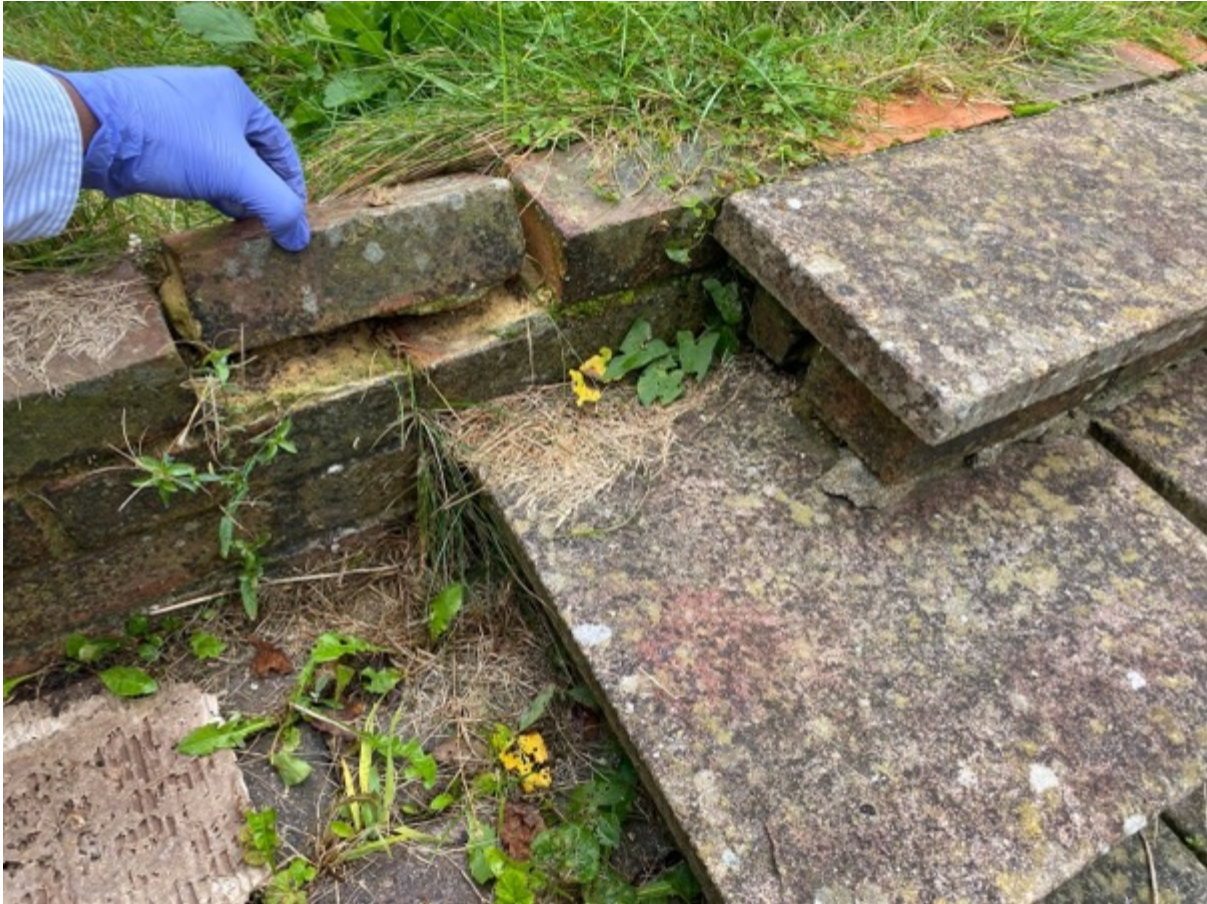
Towards the front of the property the boundaries to the left and right are set out by a single skin brick construction wall.

The wall itself appears to be out of line with the boundaries, there is also an historic timber fence which is completely weathered and suffering from wet rot and will need to be replaced.

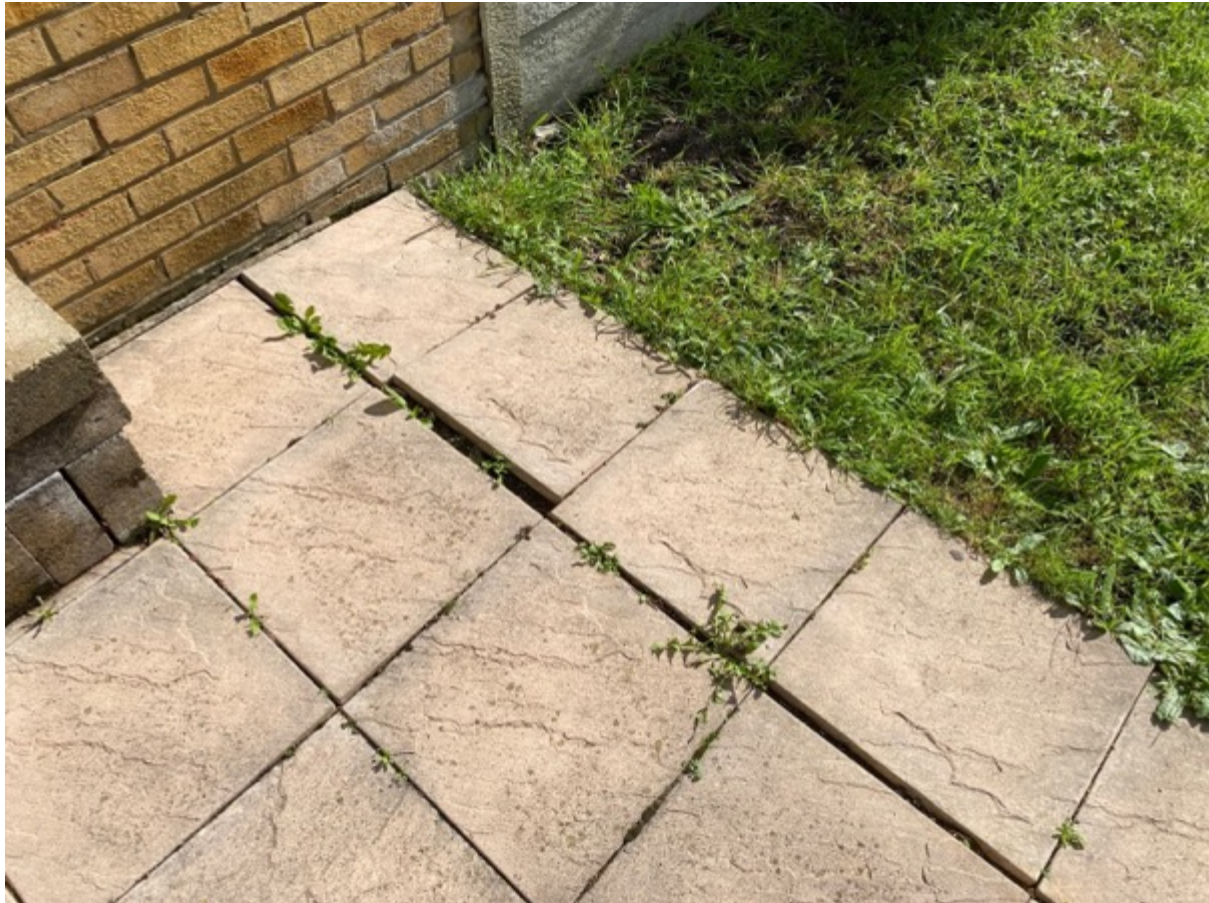
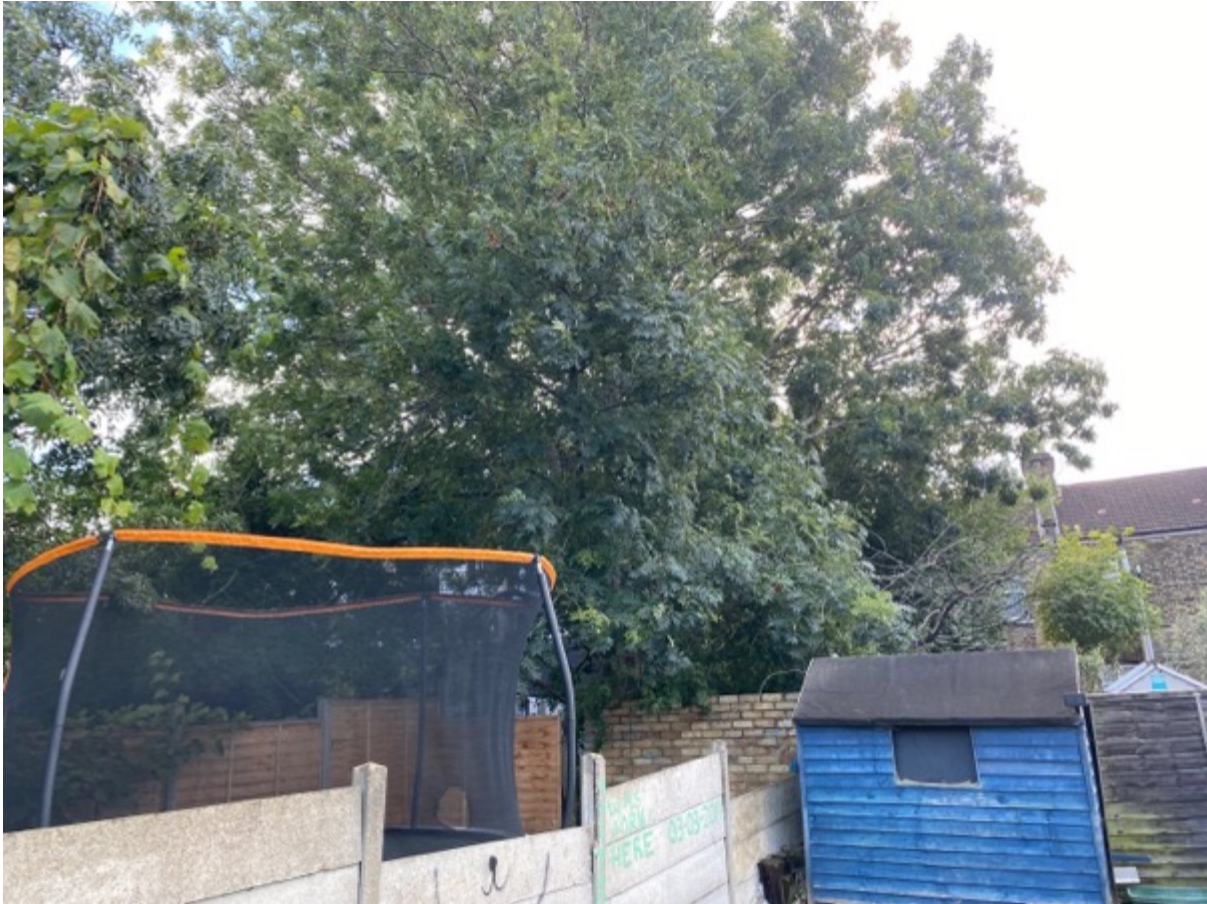
It is also worth noting that there is a very large tree towards the rear of the property's garden to the left of the subject property.

A tree of this height and stature will likely be drawing significant levels of moisture from the soil each and every day and therefore, should you proceed with the property, I would advise that you make your insurer aware of the presence of this tree so that they can take that into account.

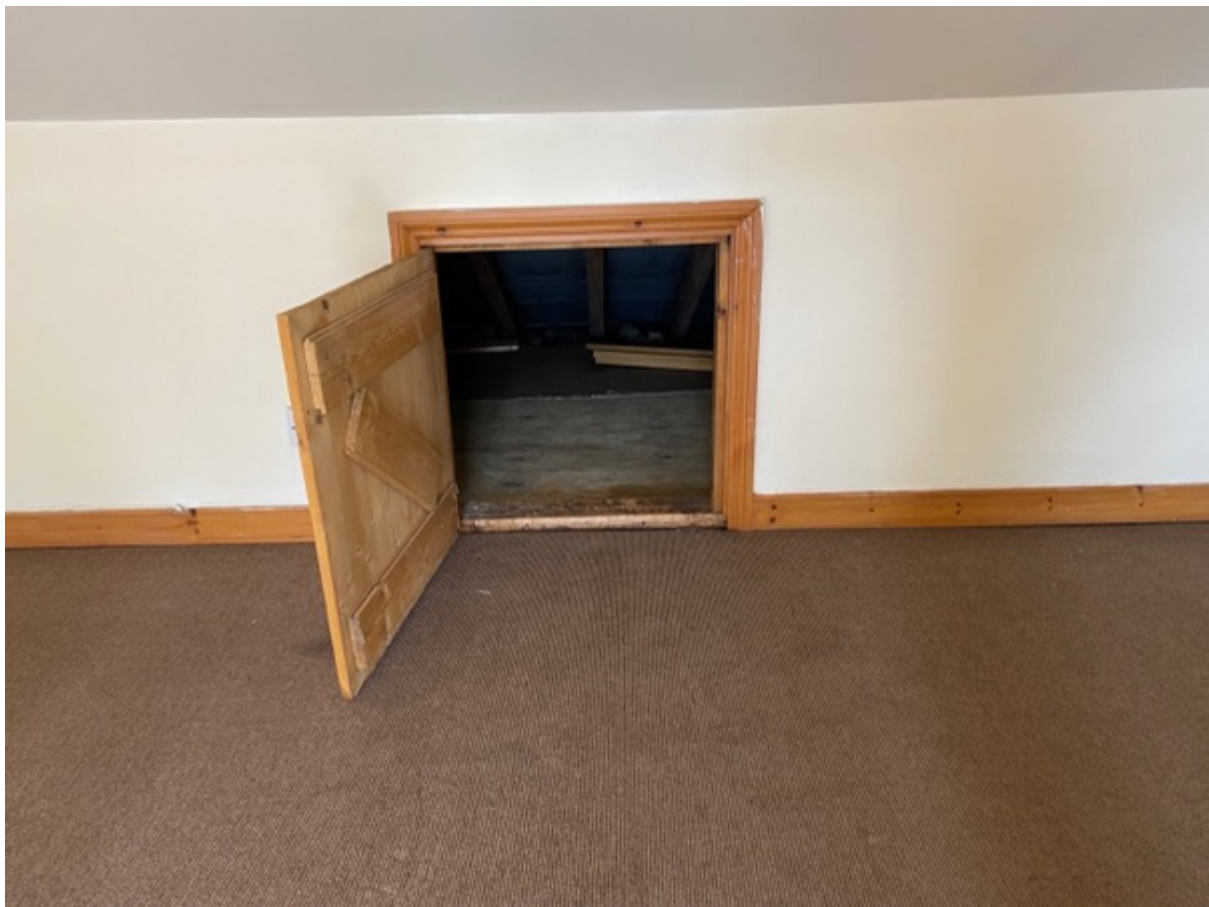
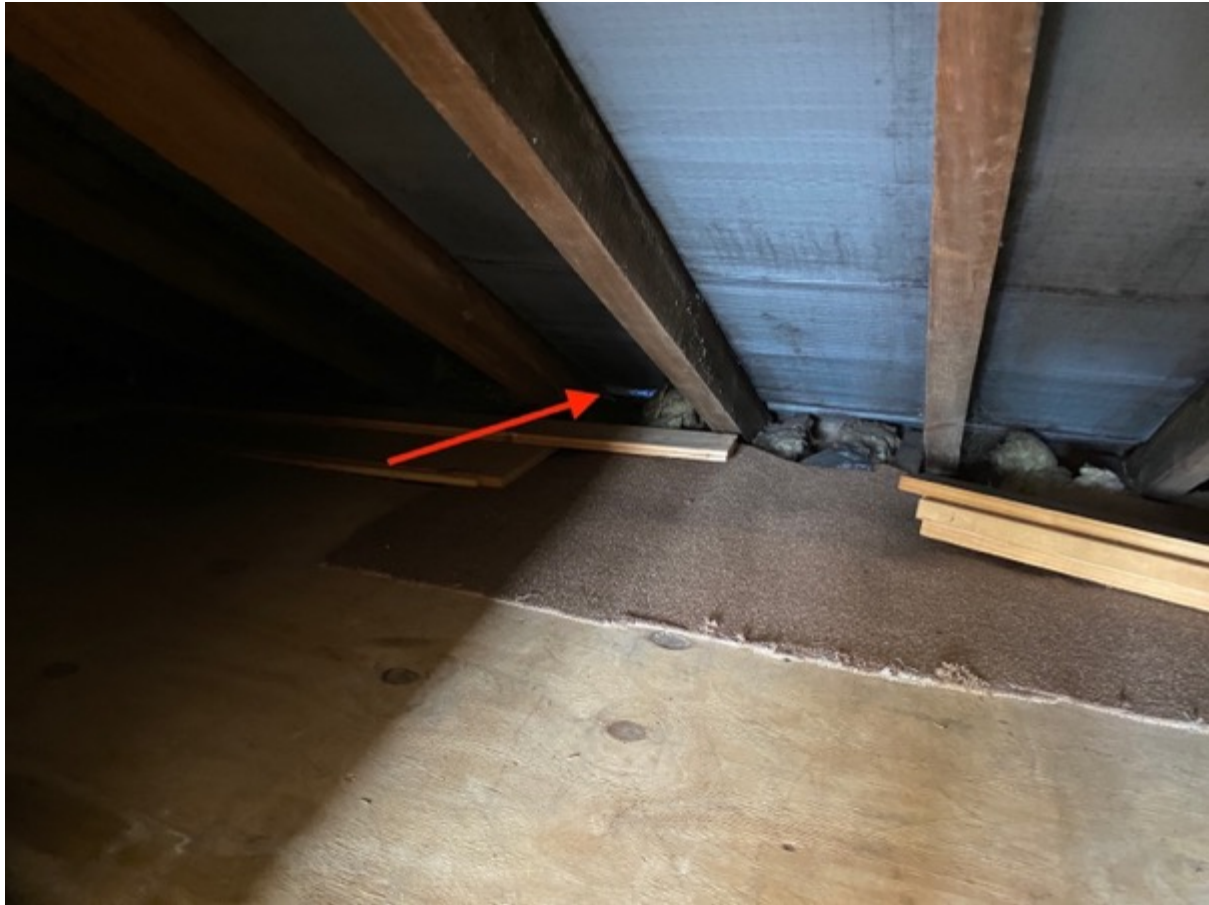
Within the eaves itself I was able to note that there is a sarking felt beneath the tiles and there were also signs of light coming through which is not ideal as it likely means that some tiles have become undulated and are sitting proud.

This could result in pest ingress and weather ingress and therefore I would advise that a competent roofer inspect this area to ensure that the tiles are properly laid and level throughout.

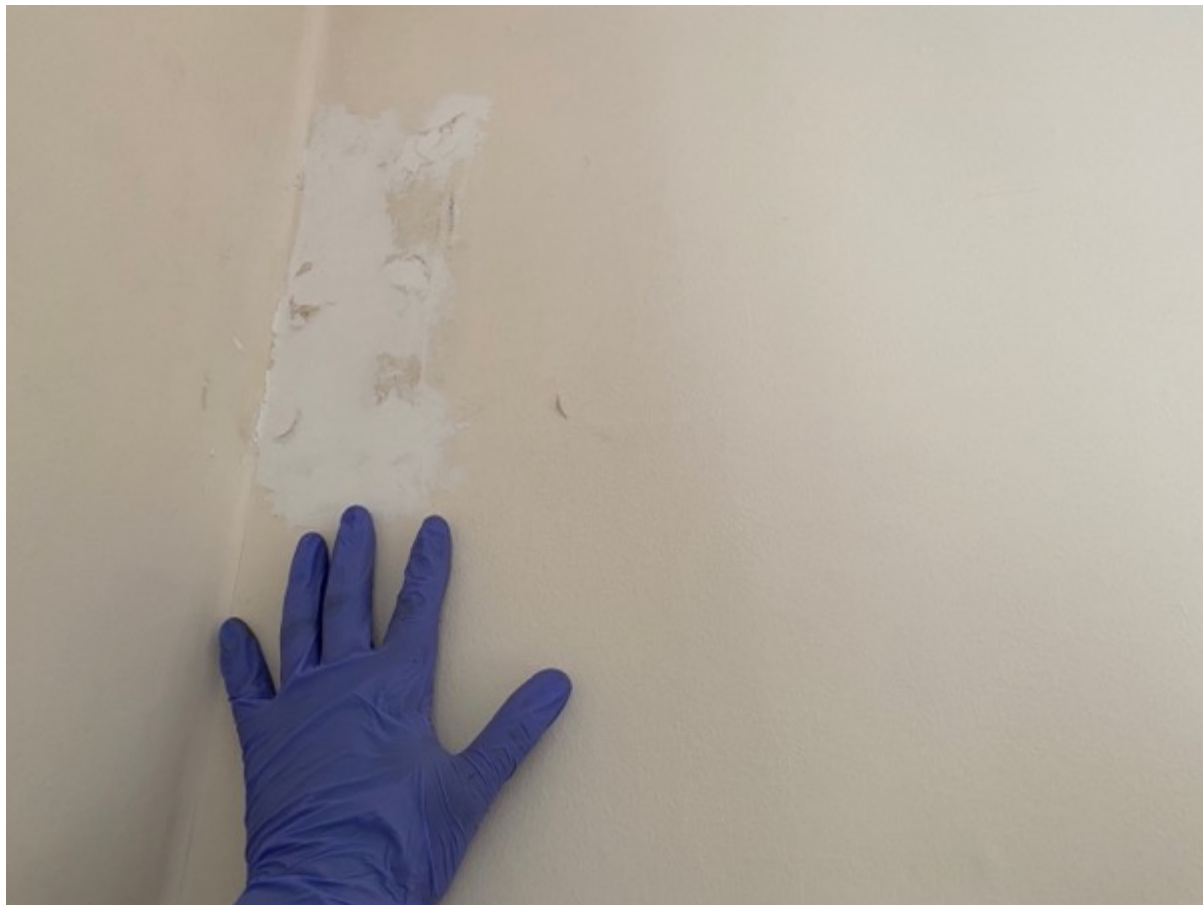
The rear chimney breast in the kitchen has been removed and it appears to be supported by a gallows bracket which is likely plaster boarded and skimmed over, I would advise making enquiries as to whether the necessary Building Regulations consents were in place in this regard and also the necessary Party Wall permissions and consents in regard to the property that this chimney breast adjoins.
