Building Survey Report

Building Survey Report Contents:

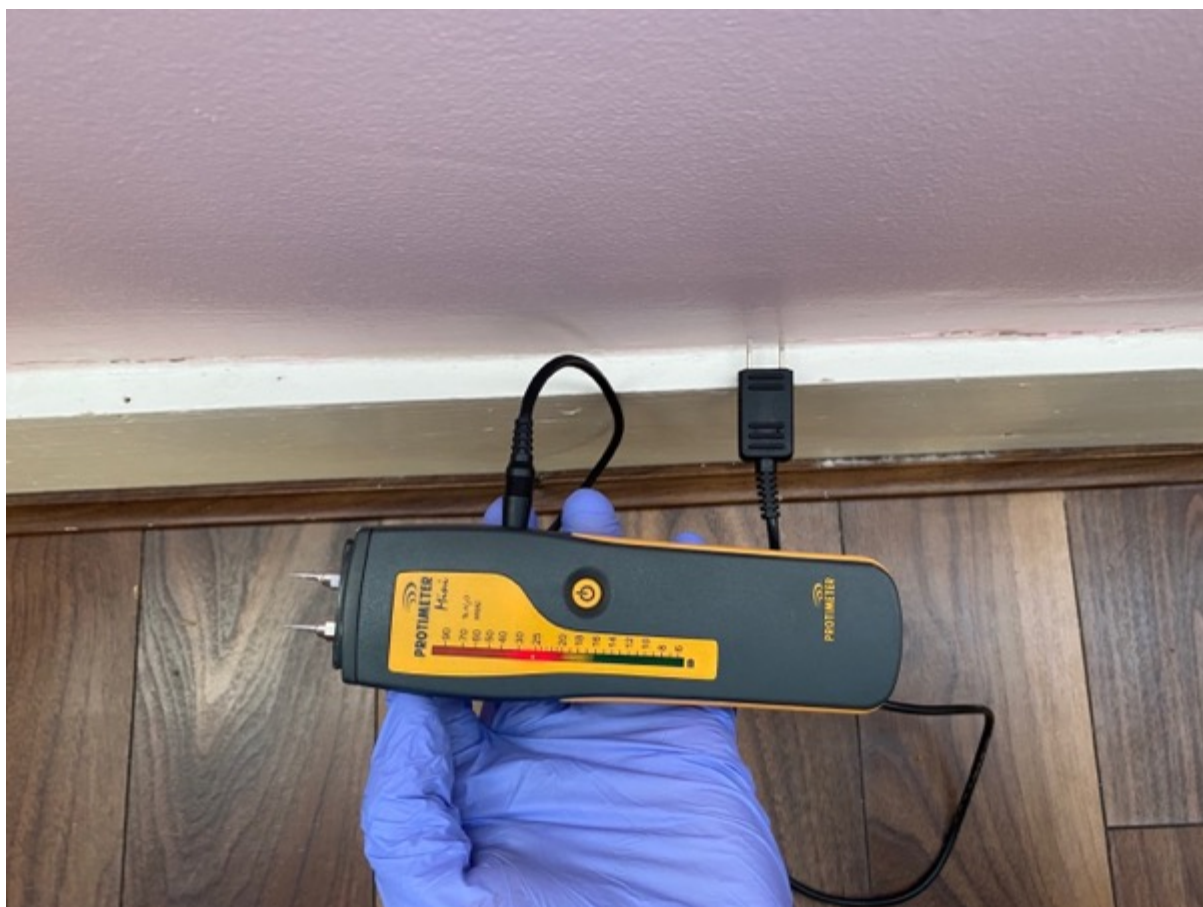
A red reading on the Protimeter confirms that the percentage level of moisture within the wall is at the higher end of the spectrum and in this case, I suspect the damp penetration is a result of the bridging of the damp proof course.

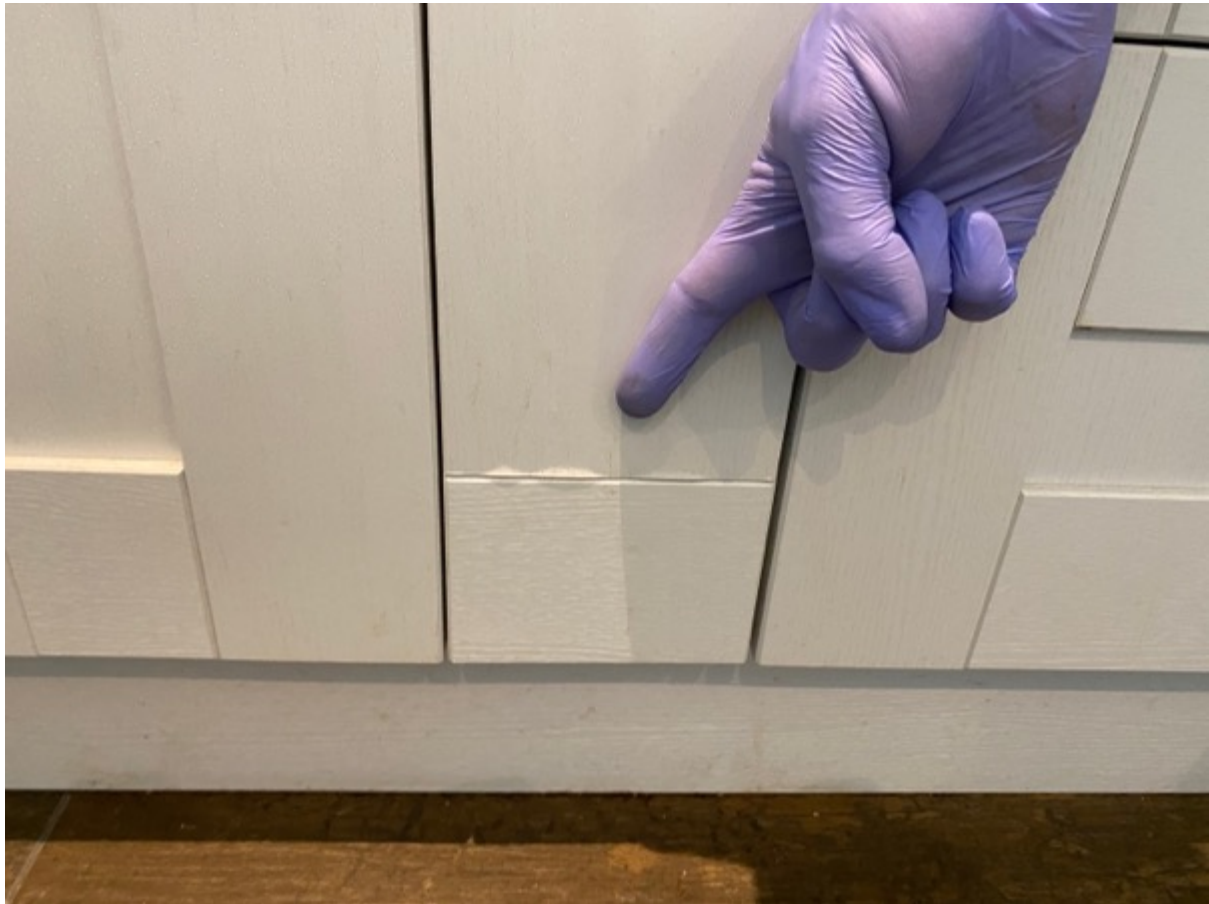
This is likely a manufacturer's error, and you could find that in due course further areas of the kitchen will likewise peel and raise in this manner and therefore you may want to consider that in respect of any Warranties that may exist.

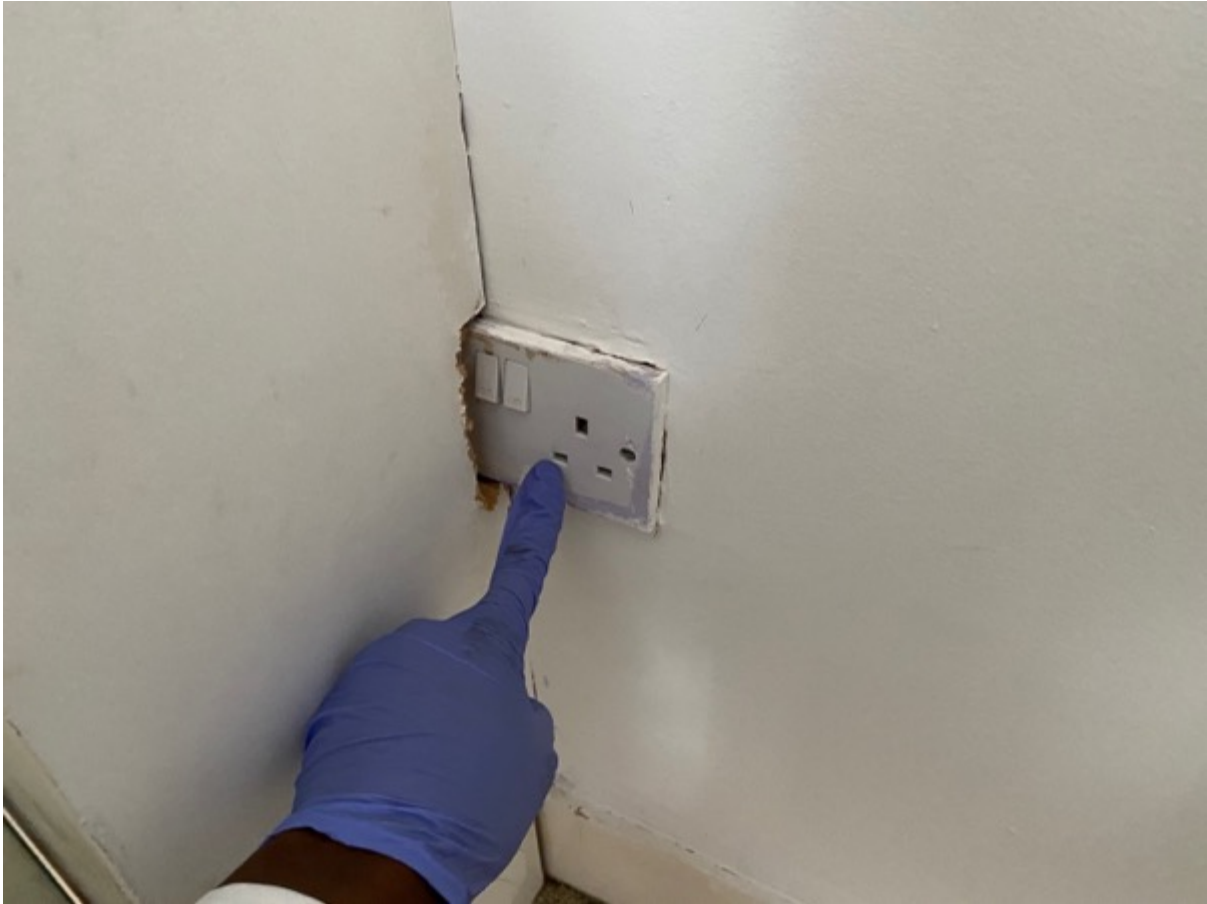
This would not be health and safety compliant and in any event, would mean that there are insufficient sockets within the front bedroom area and therefore to accommodate modern day use you will need to have further electrical sockets installed.

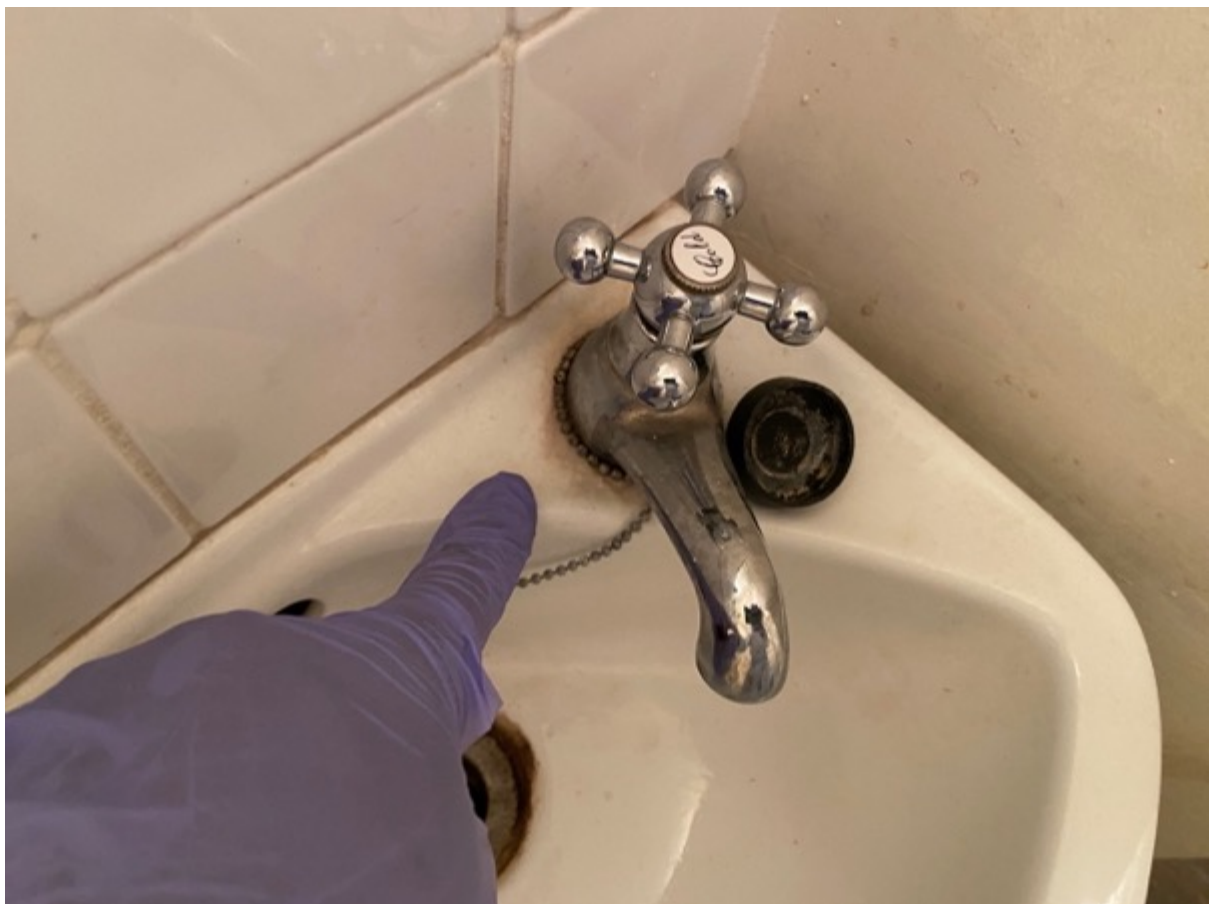
The property benefits from mains fitted water in both the kitchen and bathroom areas. At the time of the inspection the shower was tested and there was no water running as were the taps which likewise had no water running through them.

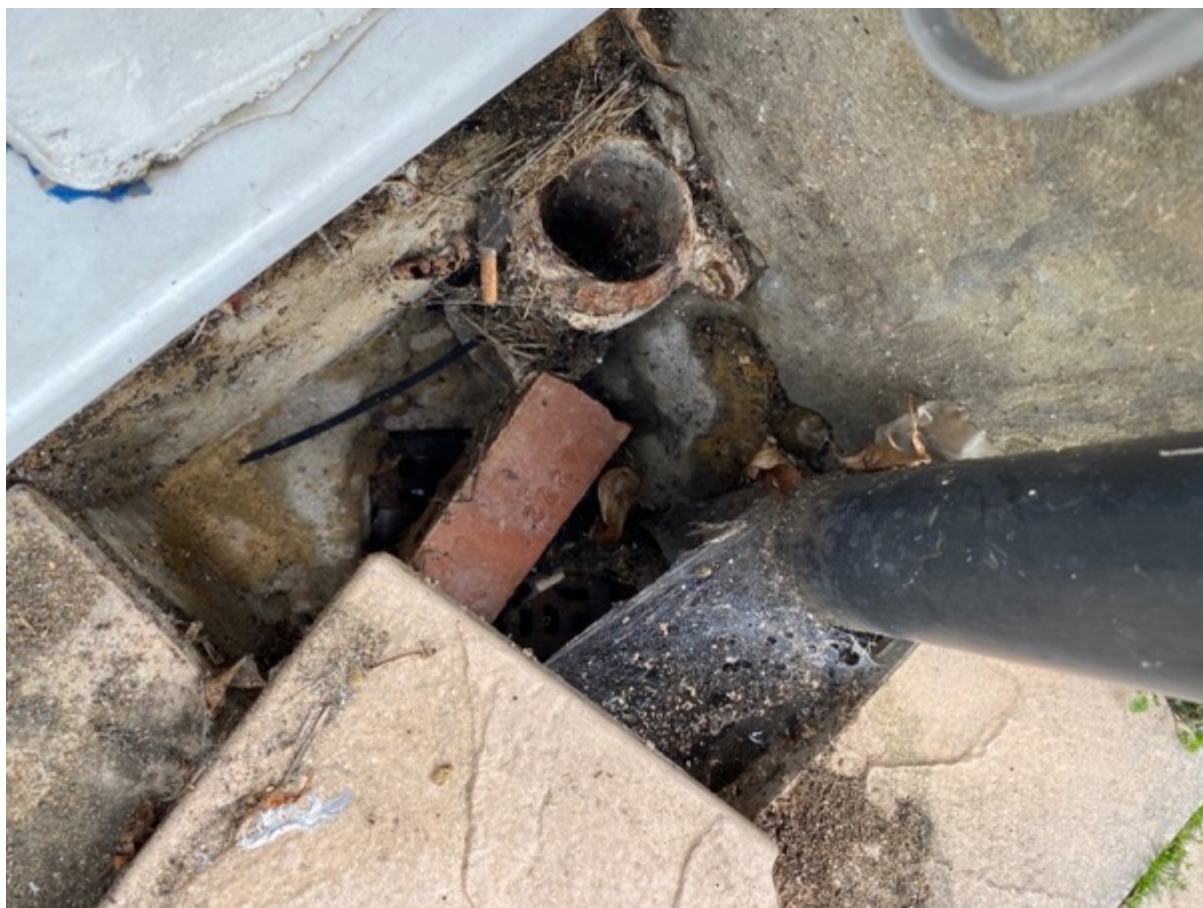
This is a slightly unconventional finish and generally speaking, they should be covered with a grate or drain cover.
