RICS HomeBuyer Report (Level 2 Survey)

Address of Purchase Property

Date of Inspection:

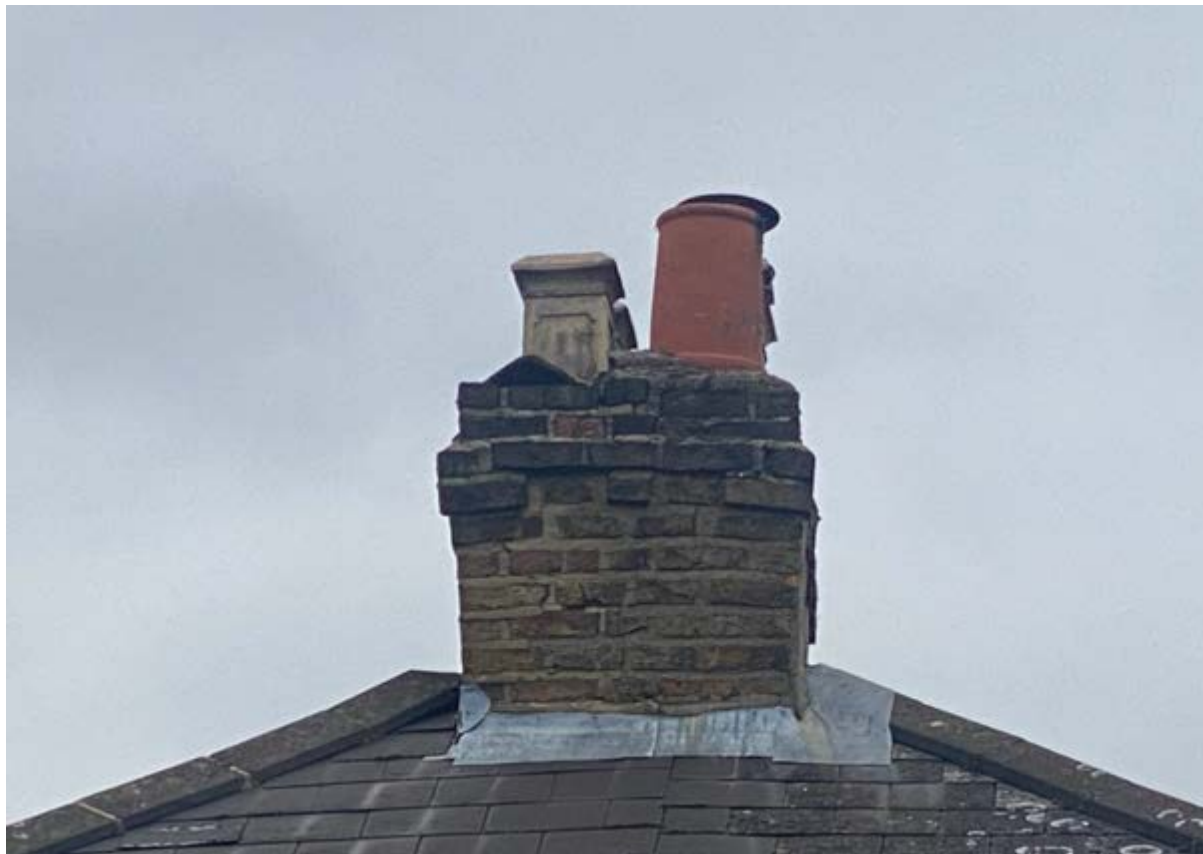
There are also signs of undulation and movement towards the upper section of the stack itself where it adjoins the flaunching.

The chimney stack movement is a relatively normal thing as they tend to get the full brunt of the weather. In this case, while there are historic signs of issue, it doesn't appear to be untoward and would be relatively normal considering the age of the property.

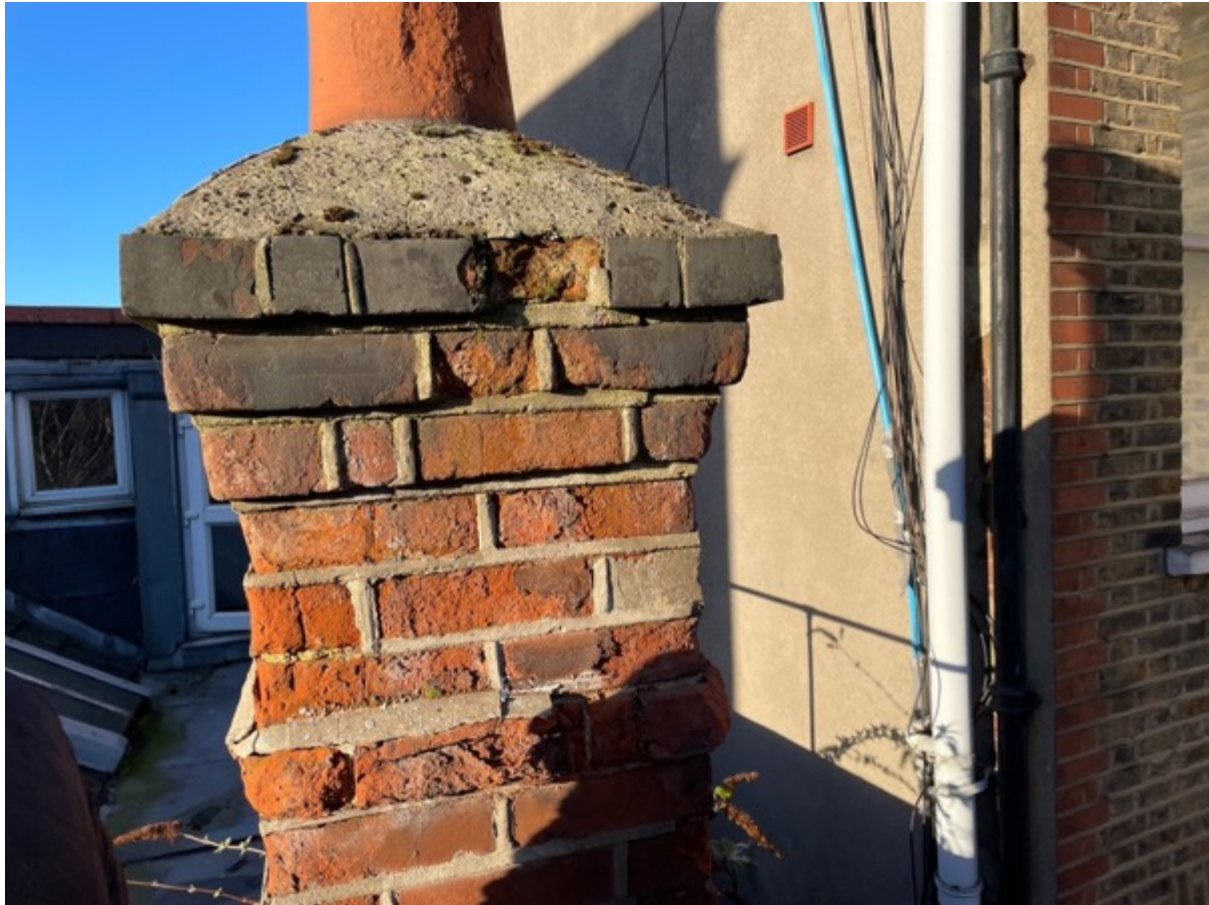
The stack is standing firm and free from a lean. However, the flue at the head of the stack may be of an asbestos type. A roofer can confirm this during further investigation. If it is an asbestos type, it should be removed by an asbestos specialist.

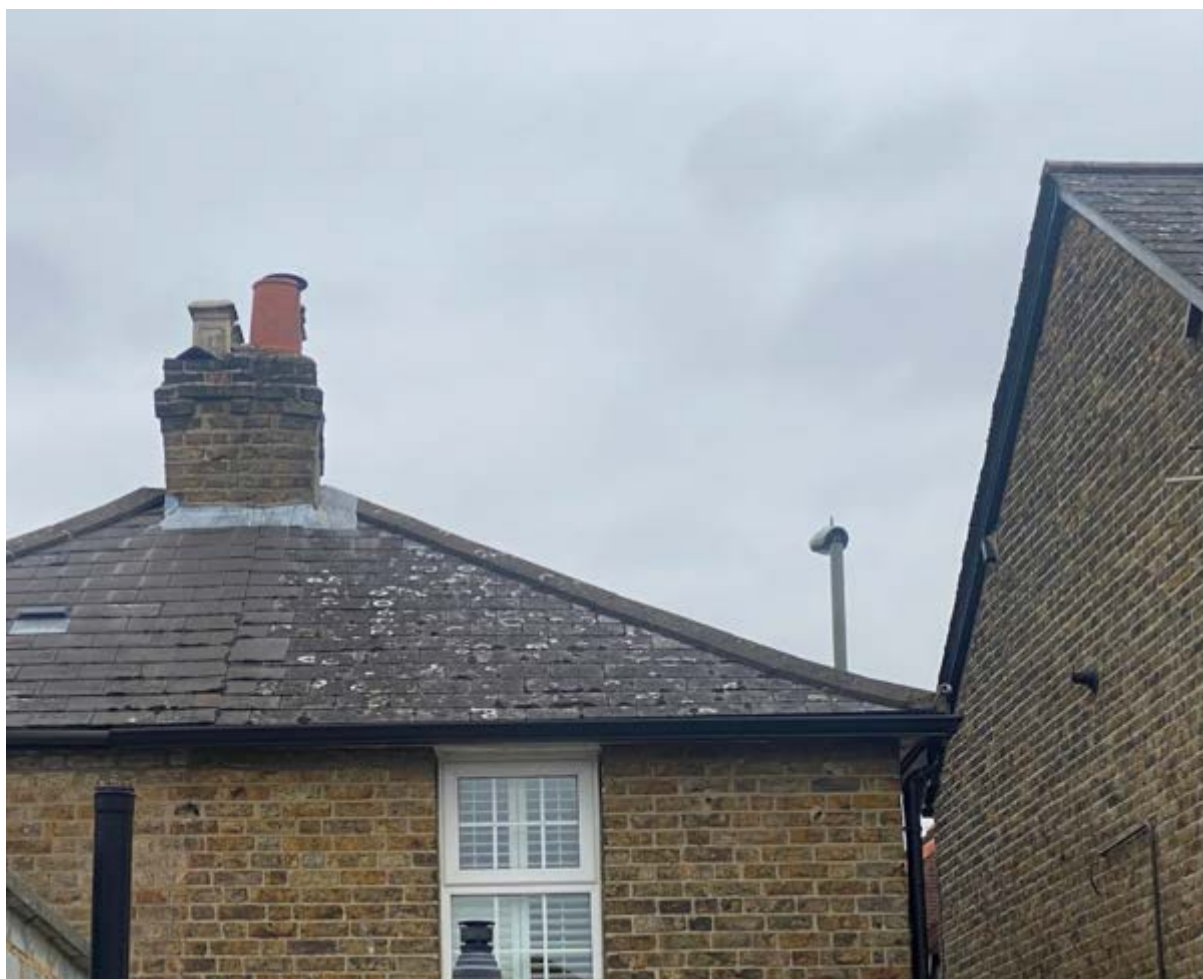
The slate tiles are severely weathered with signs of moss and lichen growth noted throughout. The tiles also appear to be showing signs of delamination throughout, and it is my opinion that the tiles have likely reached the end of their useful life.

I would advise budgeting for replacement of tiles shortly after the sale of the property, as it is likely they are at the end of their useful life and will require action in the immediate future.

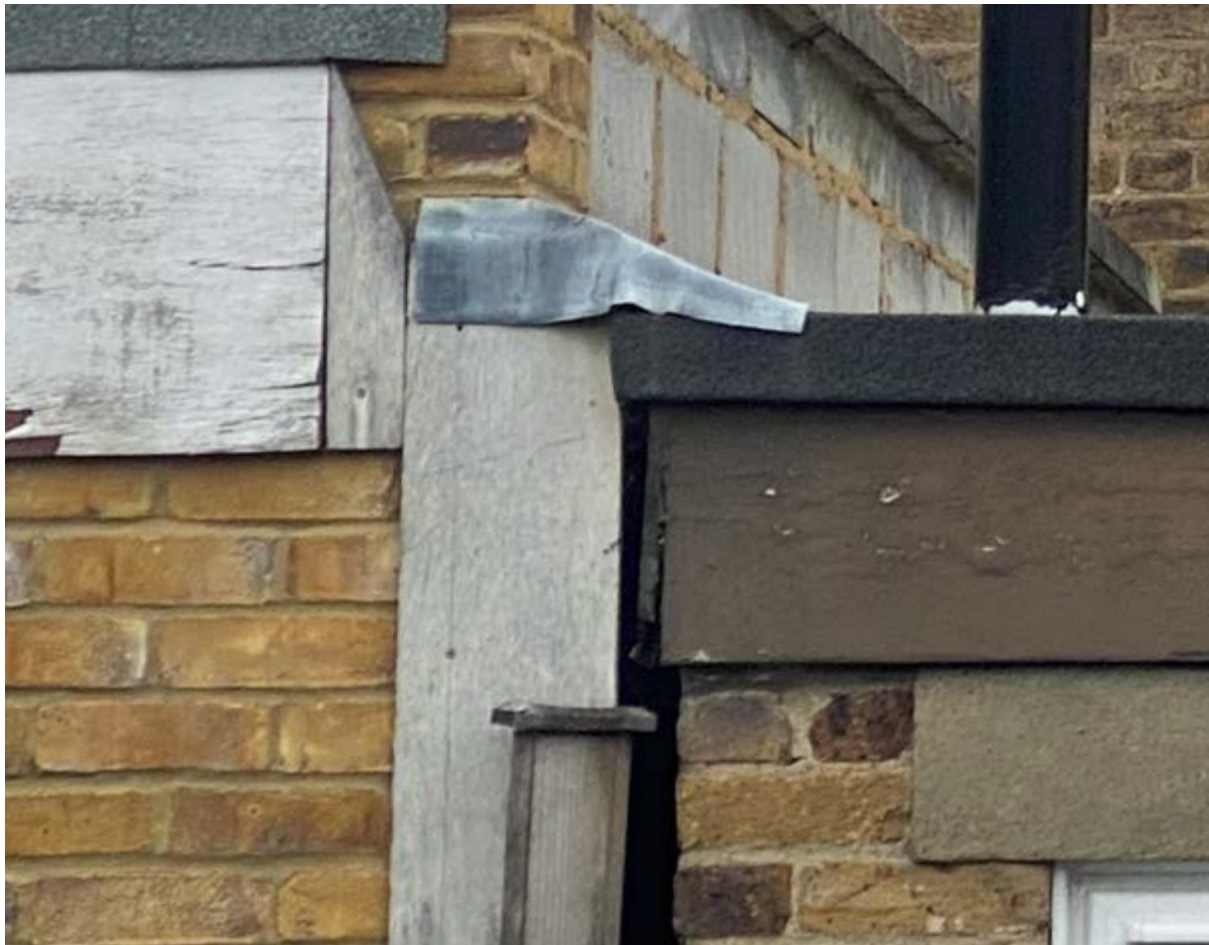
The roof to the rear extension, the fascia board towards the flank of the property itself, where it adjoins the semi-detached property, is showing signs of weather ingress and the fascia boards themselves are also showing signs of blistering and peeling paint throughout.

This will need to be partially cut away and replaced with new timbers, or potentially replaced in the entirety of the fascia board to ensure longevity and a waterproof finish.

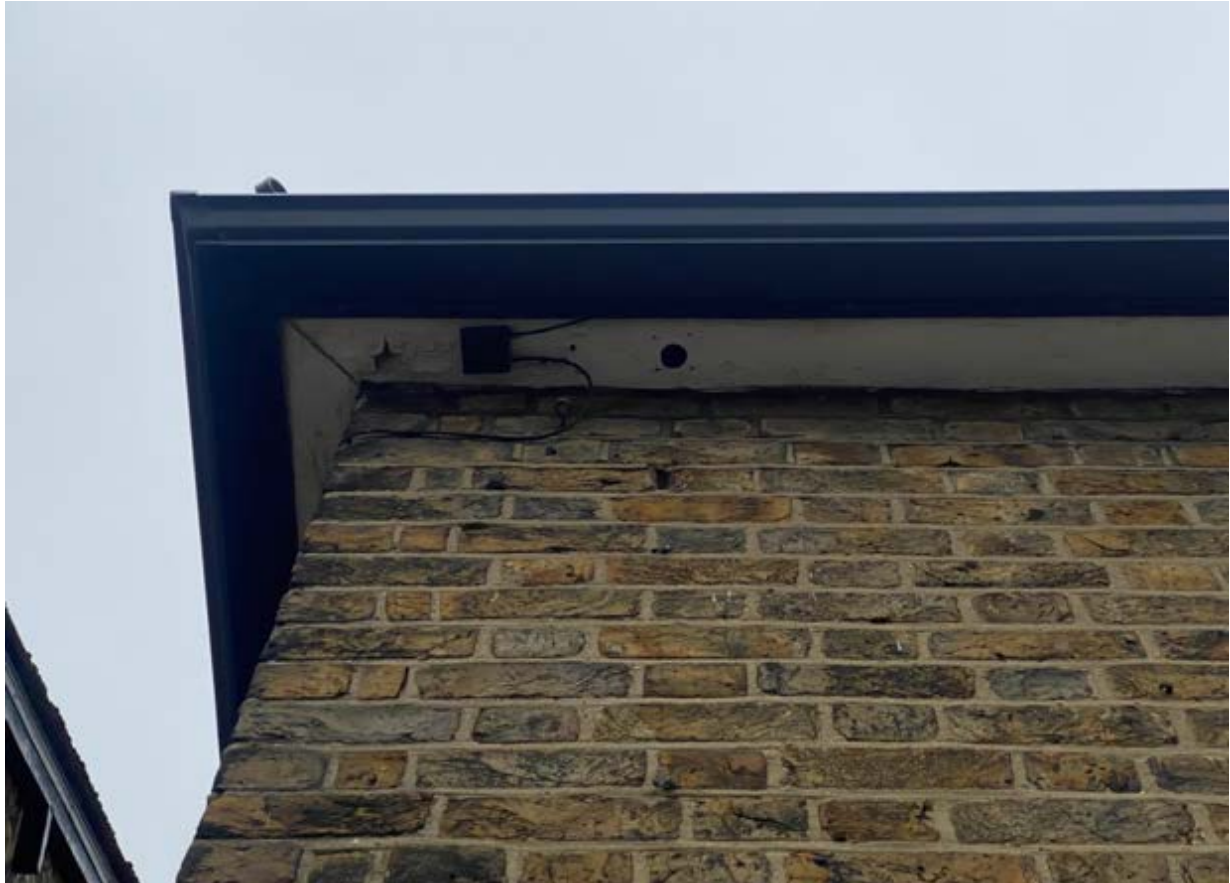
The soffit beneath is a timber type and was showing signs of blistering and peeling paint noted throughout, prominent to the rear left side and front left corner of the property. It is likely that these soffits will need to be treated and painted to ensure their longevity and reduce the chance of water ingress to the property itself.

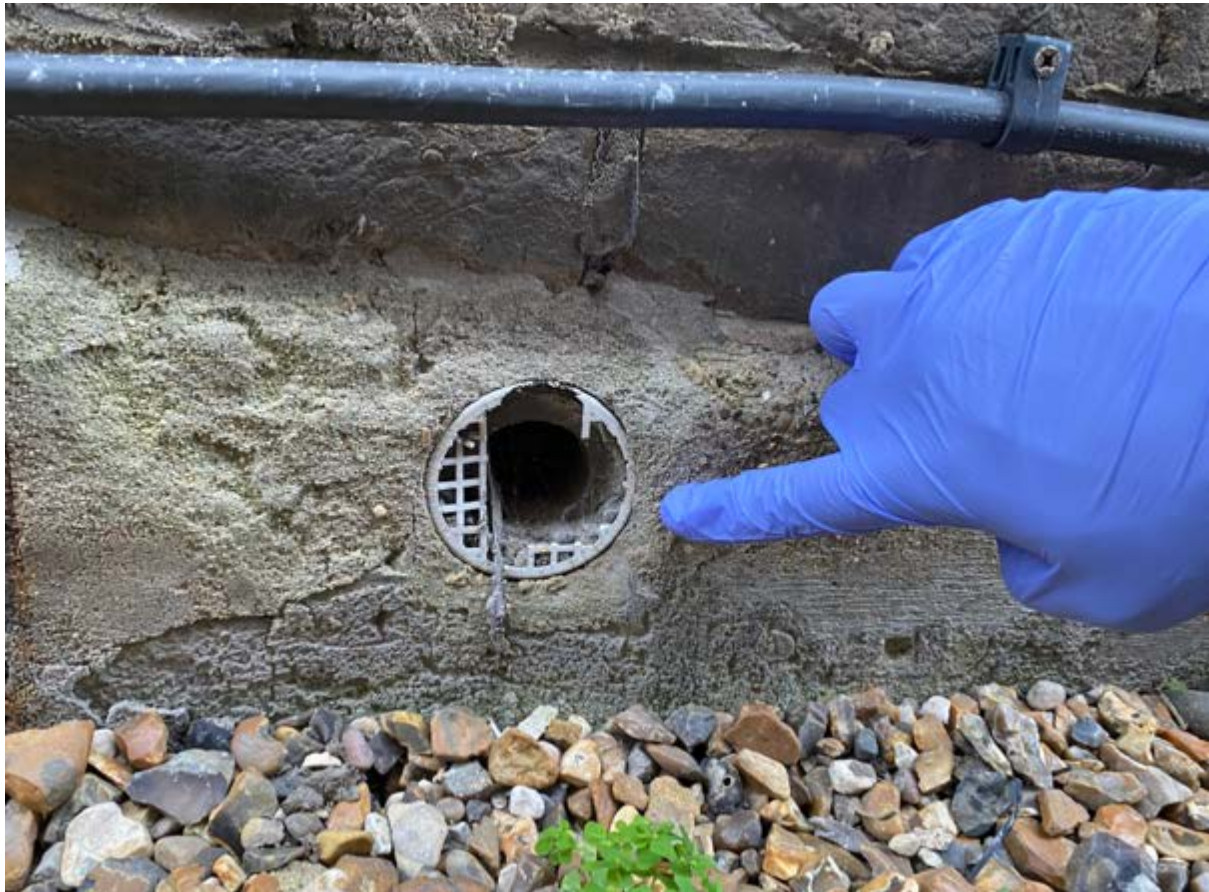
There appears to be a number of retro-fit circular core drilled air vents that have been inserted into the front and flank walls of the property.

You should make enquiries with your solicitor as to what these retro-fit vents were for, and when they were installed.

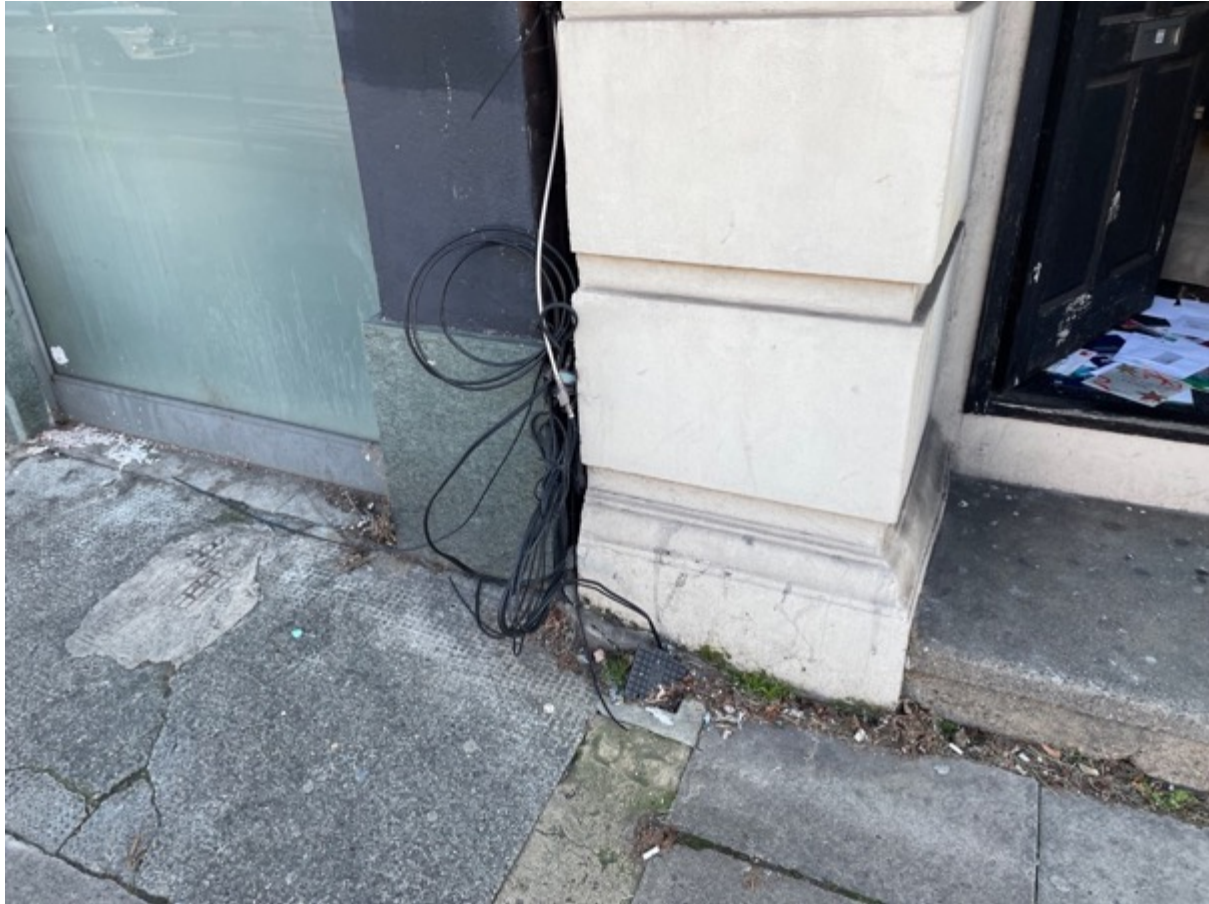
To the flank of the property, there are loose wires from the neighbouring property, which are protruding onto the demised area of the subject property. These should be clipped away neatly.

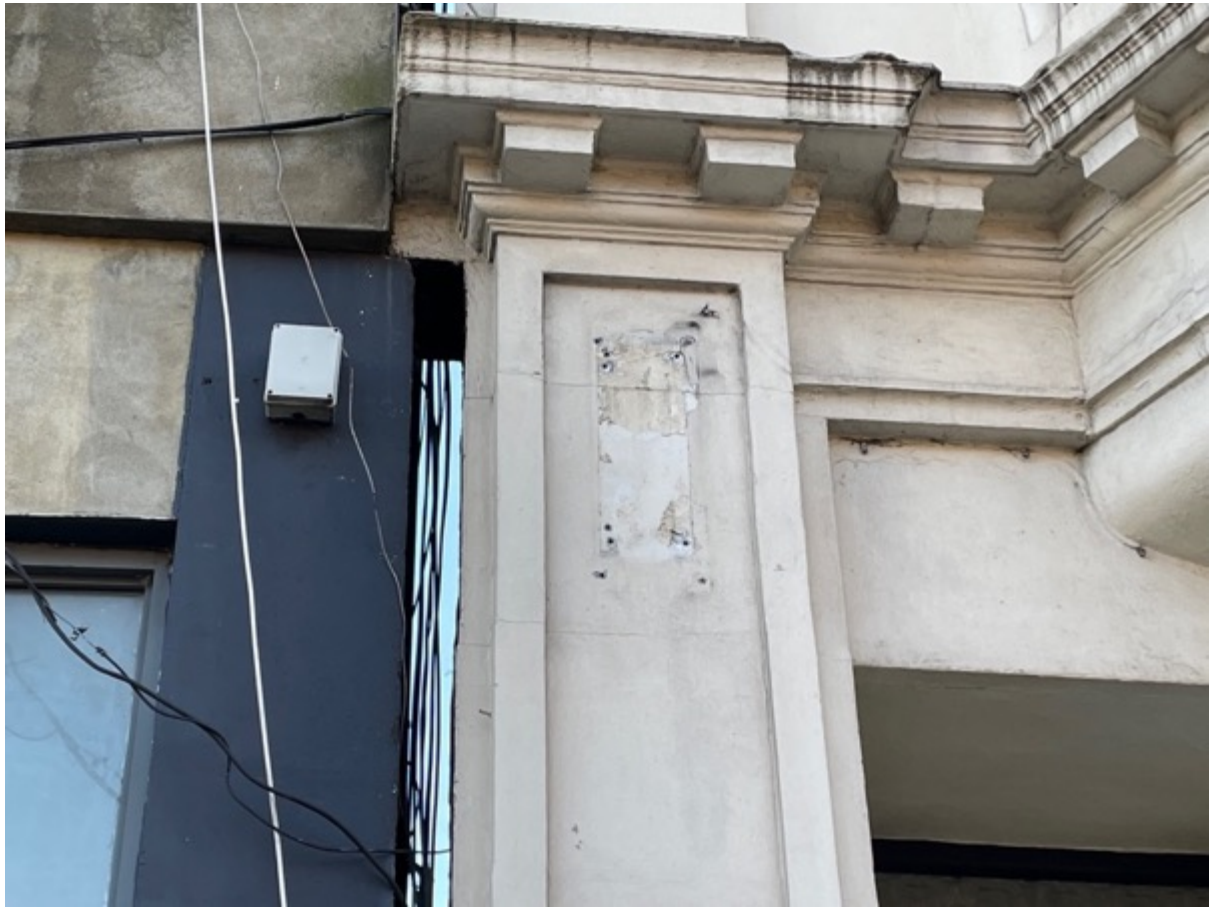
There are historic fixture holes noted on the wall surface. These areas should be filled with render and painted over.

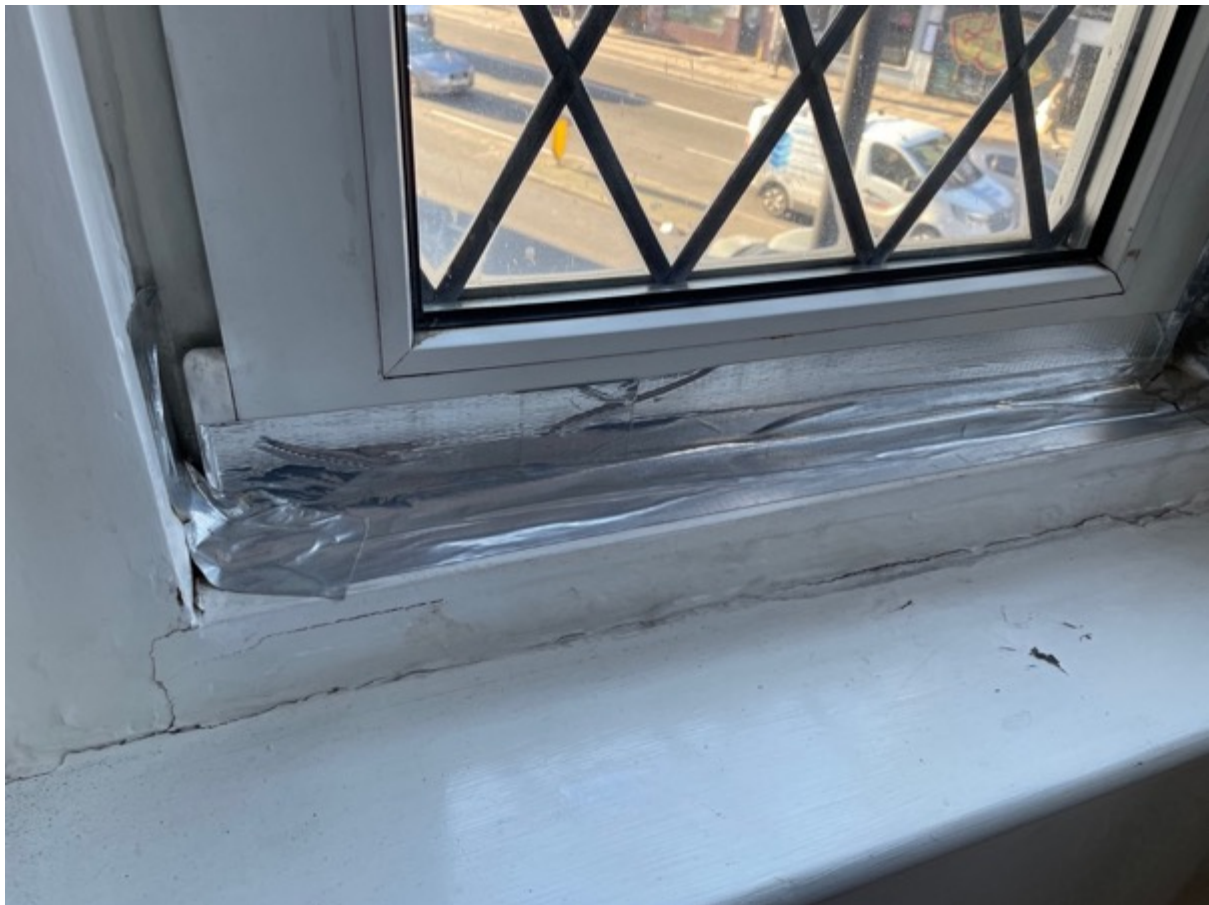
Intermittently, glazing has blown. Handles are defective and non-operational. Duct tape has been utilised to seal junctions, which is unconventional.

These windows will need to be overhauled and replaced.

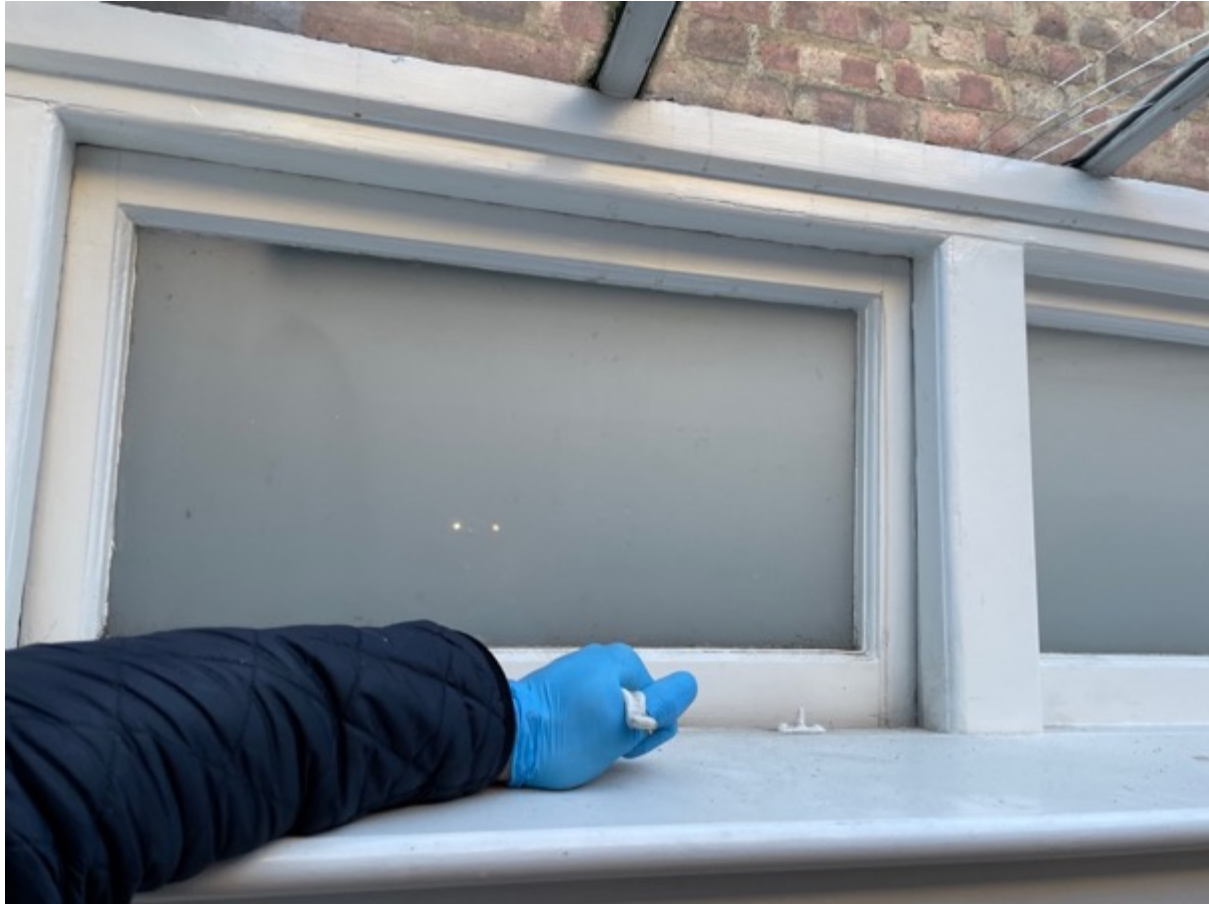
Within the reception area, there are timber-framed casement windows with single-glazing.

At the time of the inspection, a number of these windows were opened, could not be pulled shut, and were defective. These windows should be replaced.

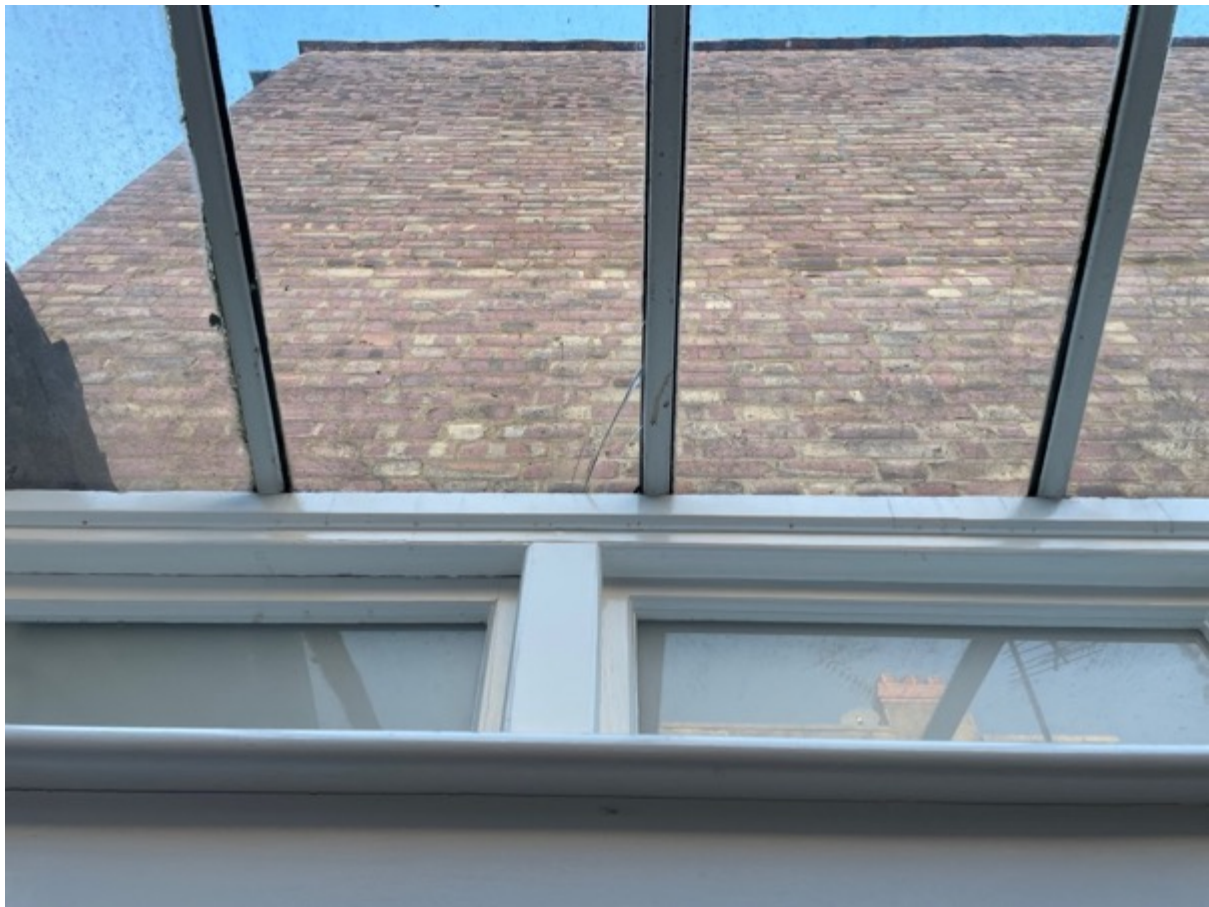
The glazed roof of the reception area has cracked. Unfortunately, there is no easy way to address this, and the defective glazing will need to be replaced.

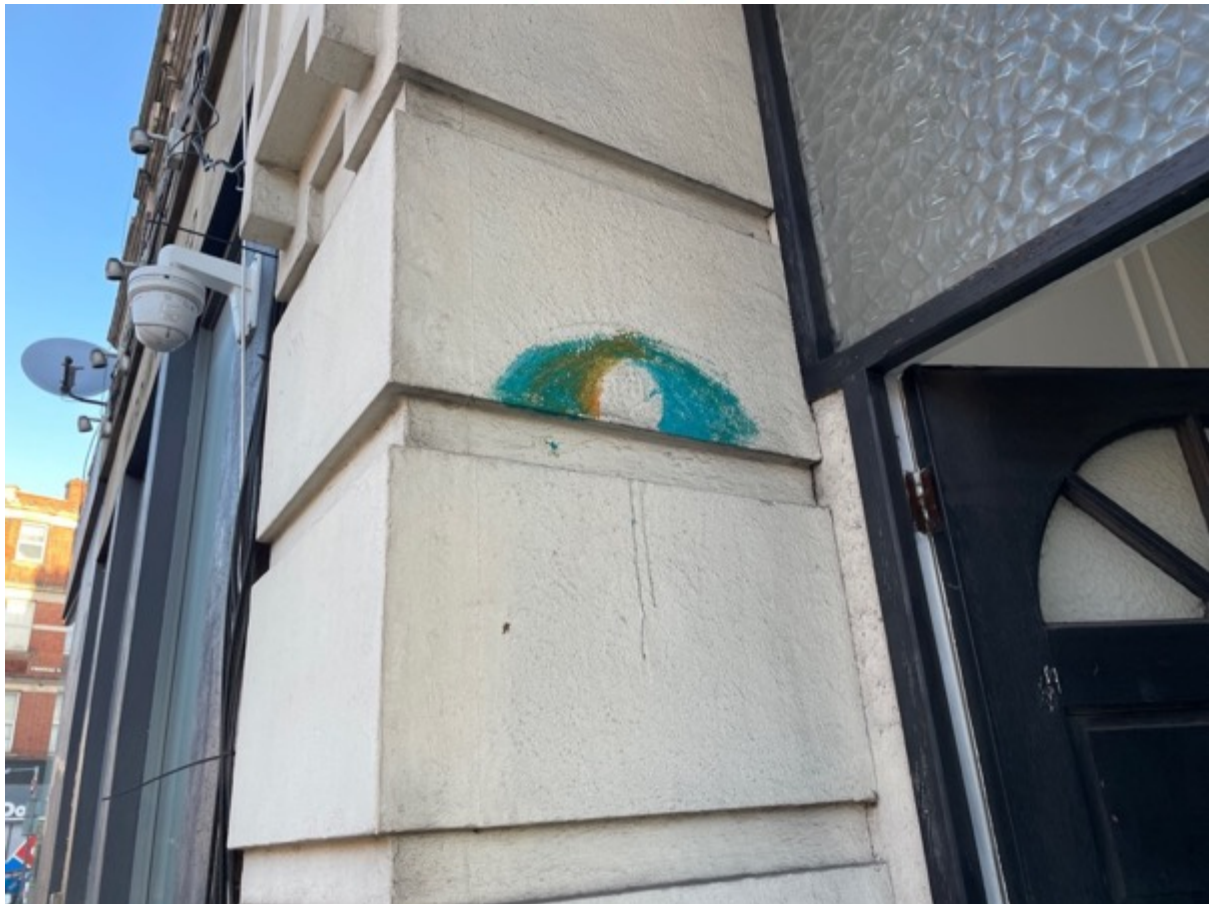
The front porch area has been maintained to a fair standard. However, there is an area of colouring noted to the left side of the opening. This should be cleaned away and repainted.

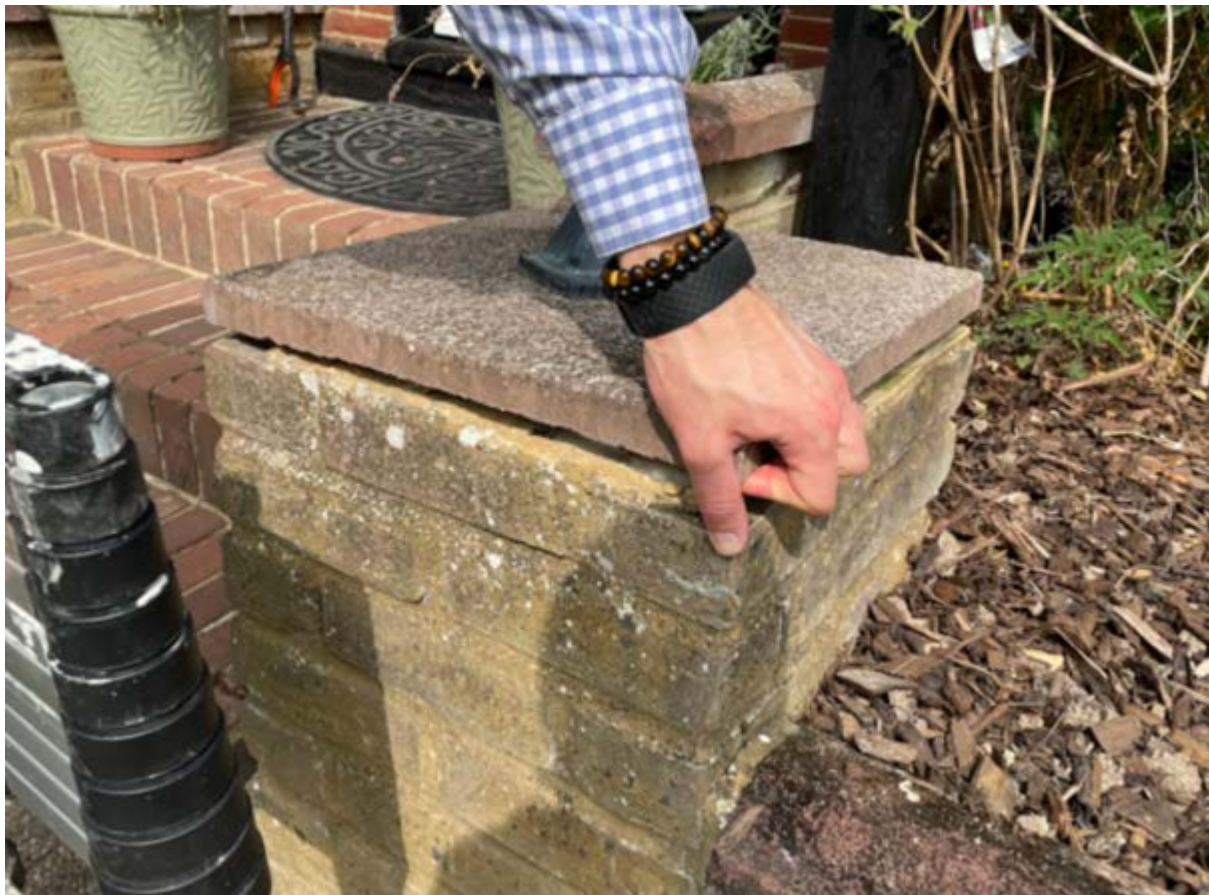
There is a brickwork London stock single skin construction wall, this is significantly weathered. While the wall does have four respective buttresses, which given its length will provide sufficient support. It is showing signs of significant weather ingress throughout, lichen and moss growth throughout, and will likely require some maintenance and repair immediately.

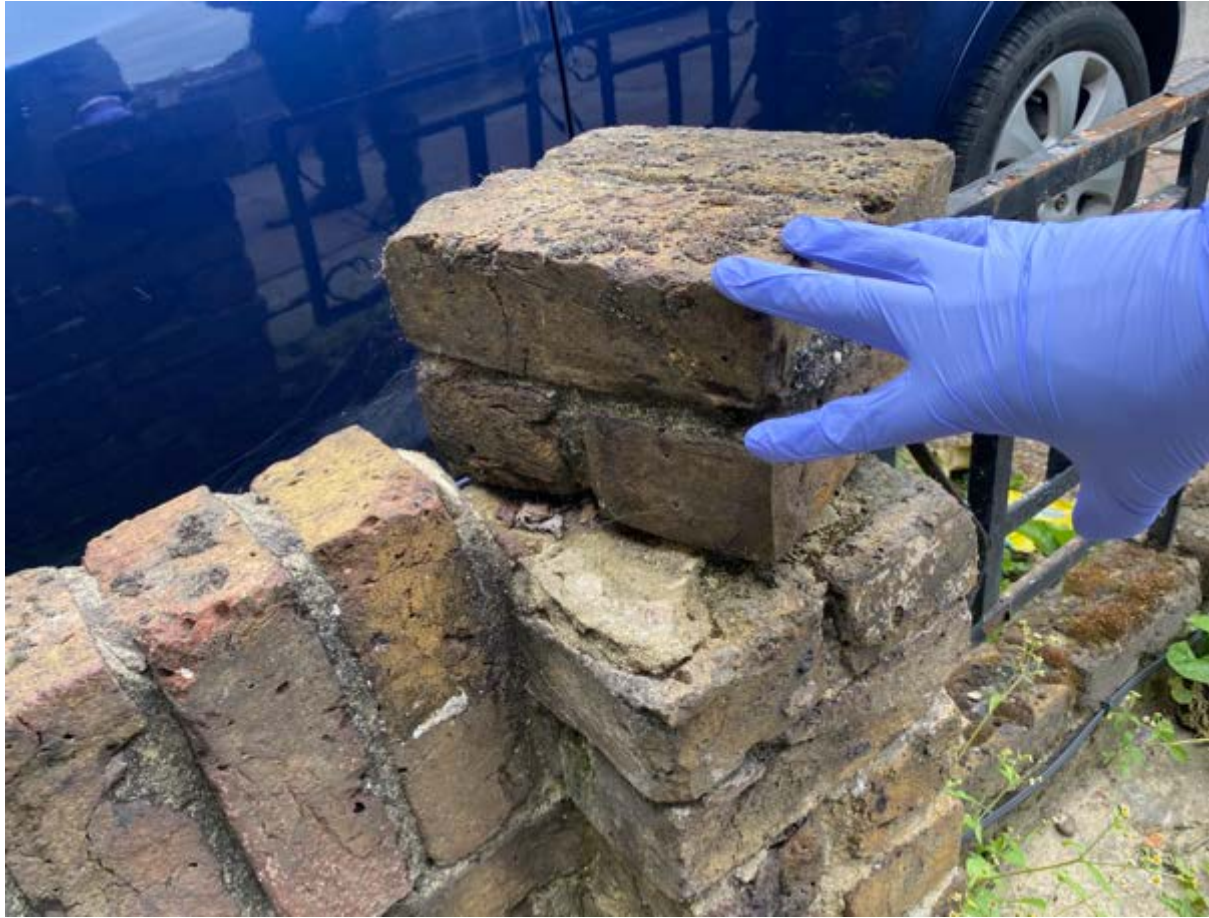
The central pier/buttress, the upper section of the brickwork is loose when tested and is not held in place firmly. This is a danger and will need to be bedded in with suitable cement.

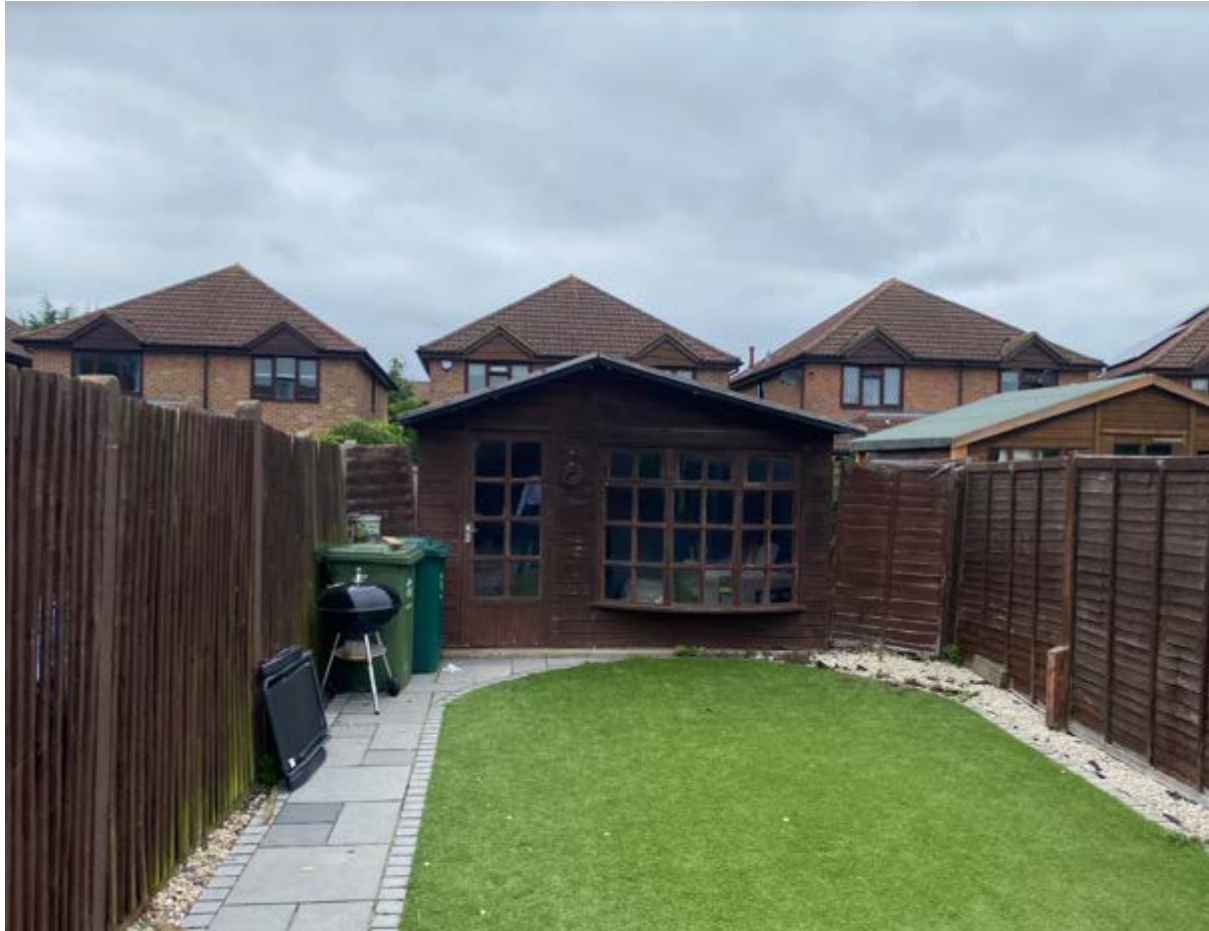
The fence beyond that point has fallen over and has reached the end of its useful life. This will need to be replaced in due course, and would therefore advise budgeting for the costs of an experienced contractor or fencer to visit and correctly install any fence.

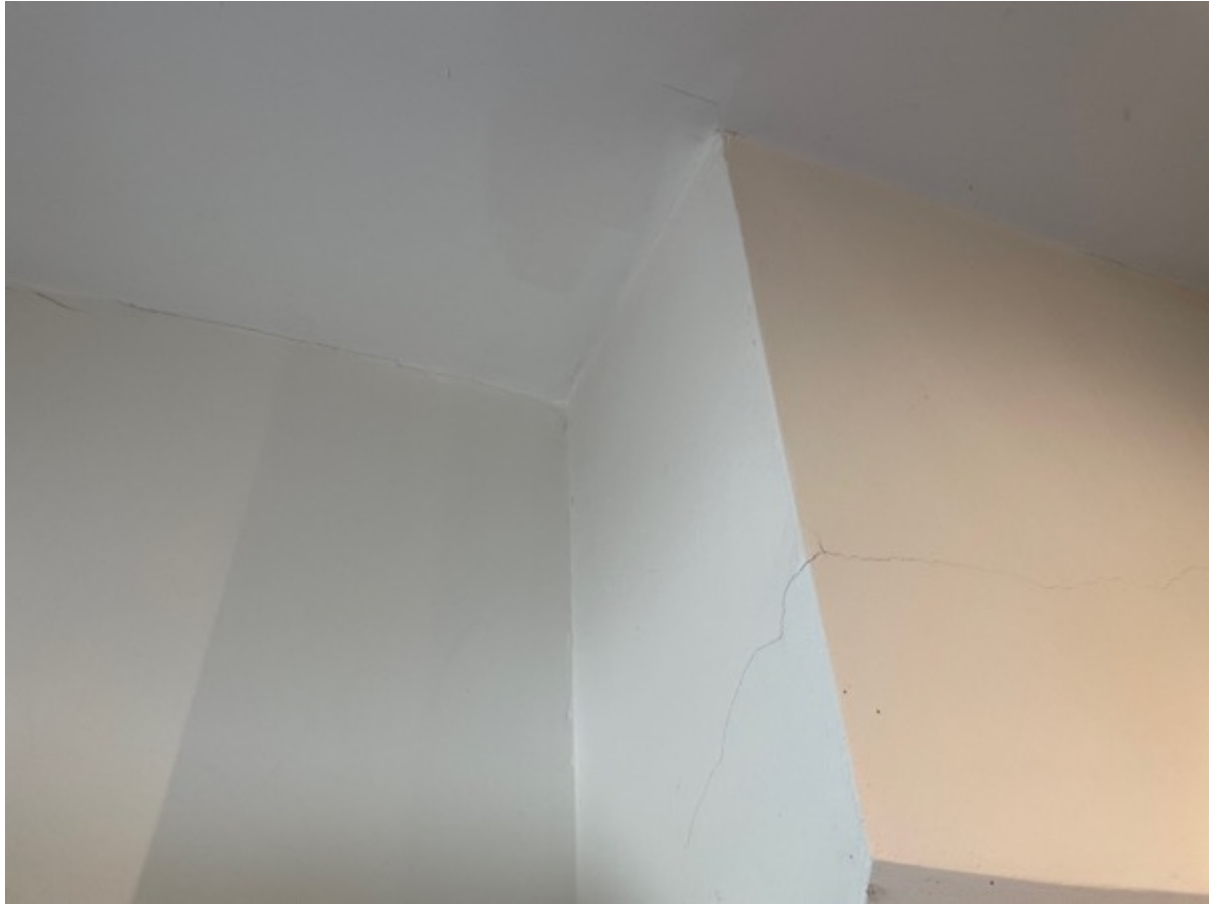
The ceilings throughout the property are of a plasterboard type, skimmed and painted. Generally, throughout the property, there are splits and cracks in the ceiling surfaces.

This is relatively conventional for a property of this age and can be addressed by cutting these areas out to a wider width, filling them with plaster, skimming and painting over them.

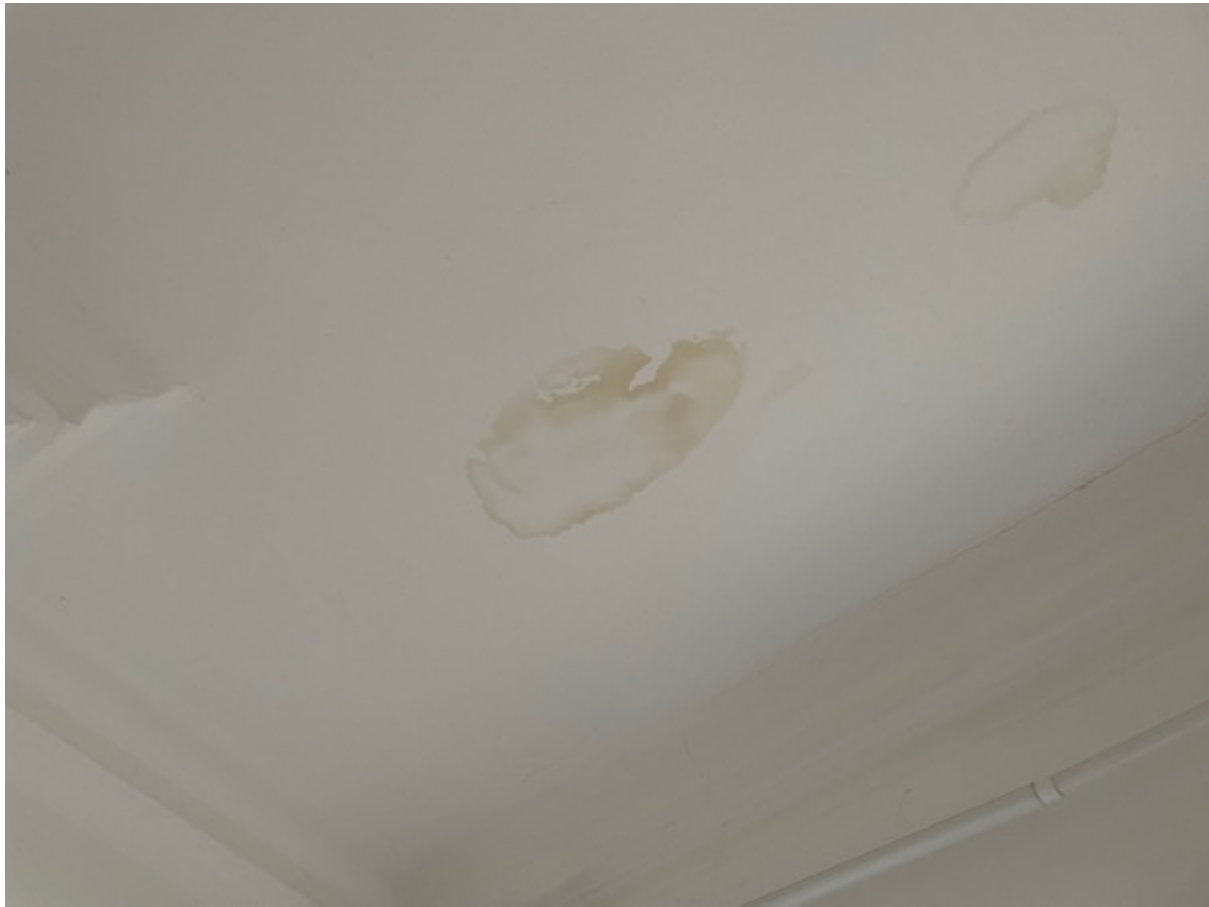
There are also general areas of staining, flaking and blistering on the ceiling surfaces. This is to be expected, given the current condition of the external roof coverings, causing saturation to the plaster, through moisture and water ingress.

Once the external roof coverings have been overhauled and replaced, this would address the issue internally. It should be noted that during the wetter months, this is likely to worsen until the external roof covers have been overhauled and replaced.

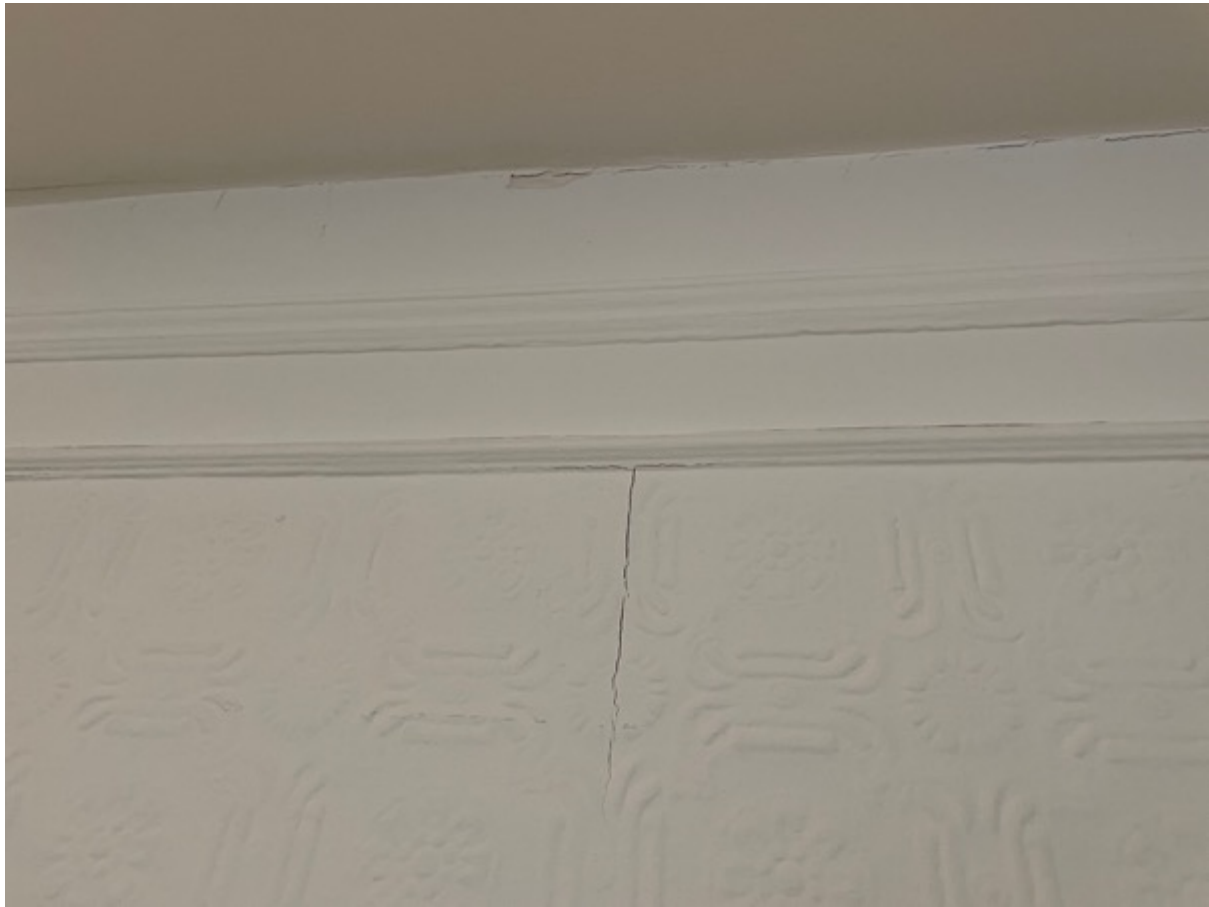
Generally, throughout the property, there are splits and cracks noted to the wall surfaces, more prominent at the junction where walls meet adjoining walls.

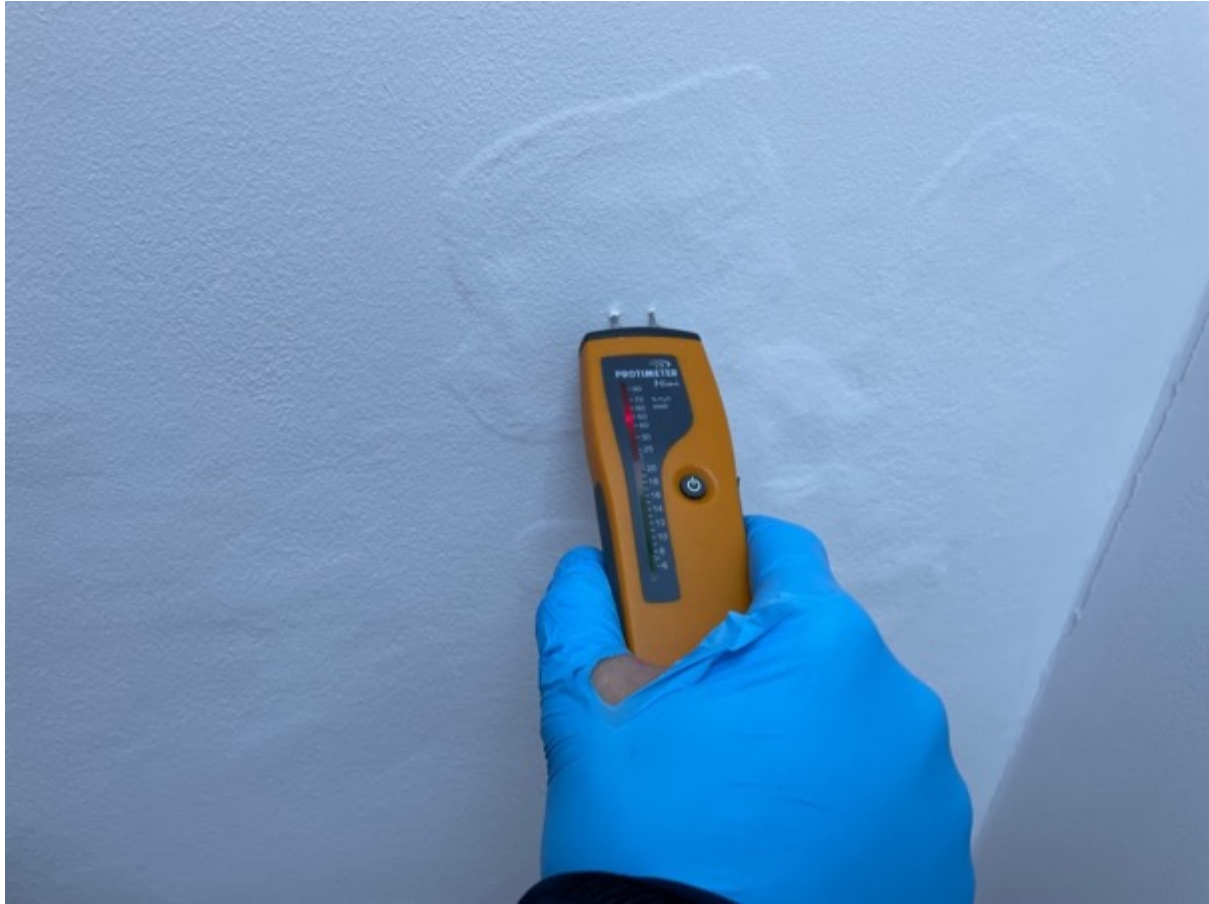
In various areas within the property, there was various blistering and flaking to the plaster finish, predominantly due to the aforementioned failed roof coverings.

When these areas were probed with the Protimeter, I was able to obtain a red reading, which confirmed the presence of moisture.
