RICS HomeBuyer Report (Level 2 Survey)

Address of Purchase Property

Date of Inspection:

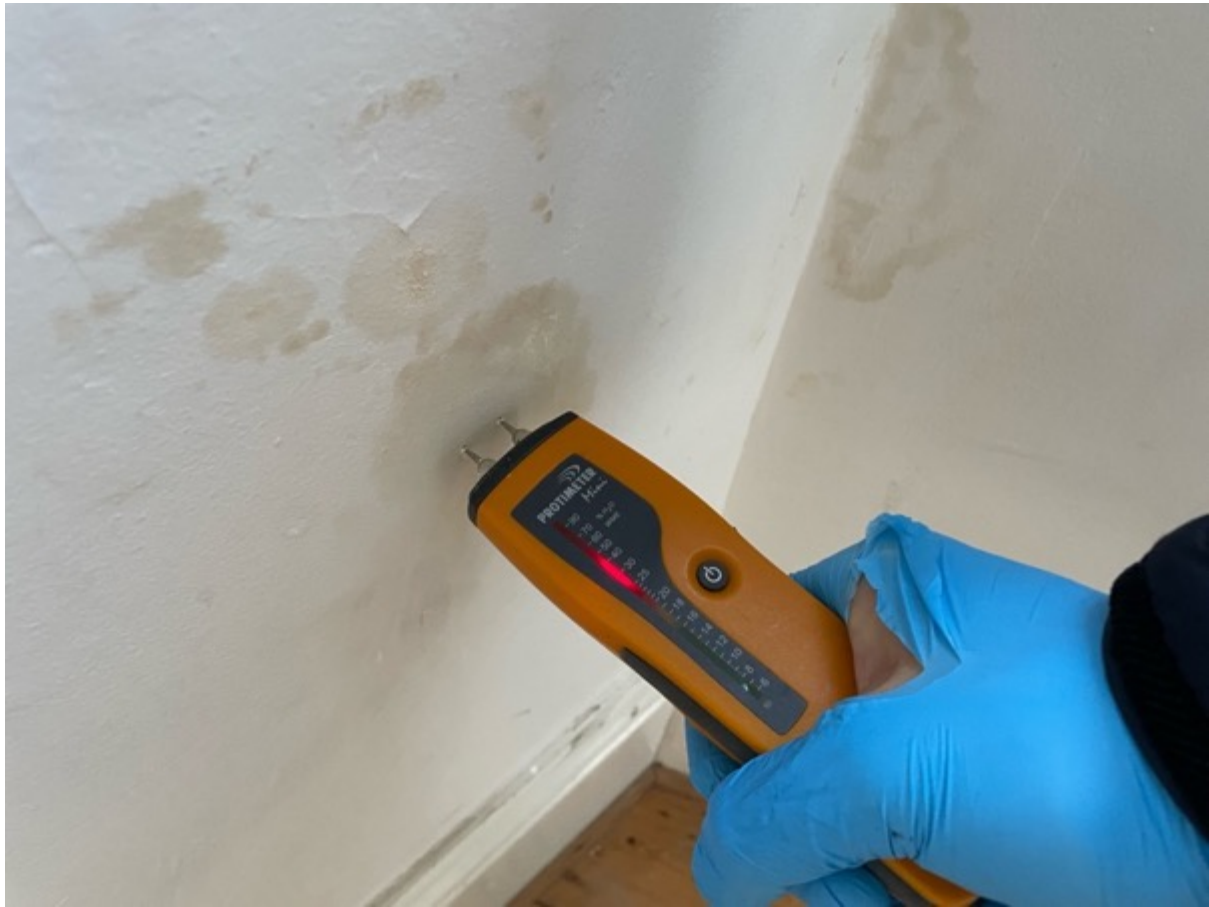
A further area of staining was noted within the left front room to the bay area. When probed with the Protimeter, I also obtained a red reading which confirms the presence of moisture.

From my observation of the external parts, this was most likely due to the failed external sill and rendering, all of which will need to be addressed.

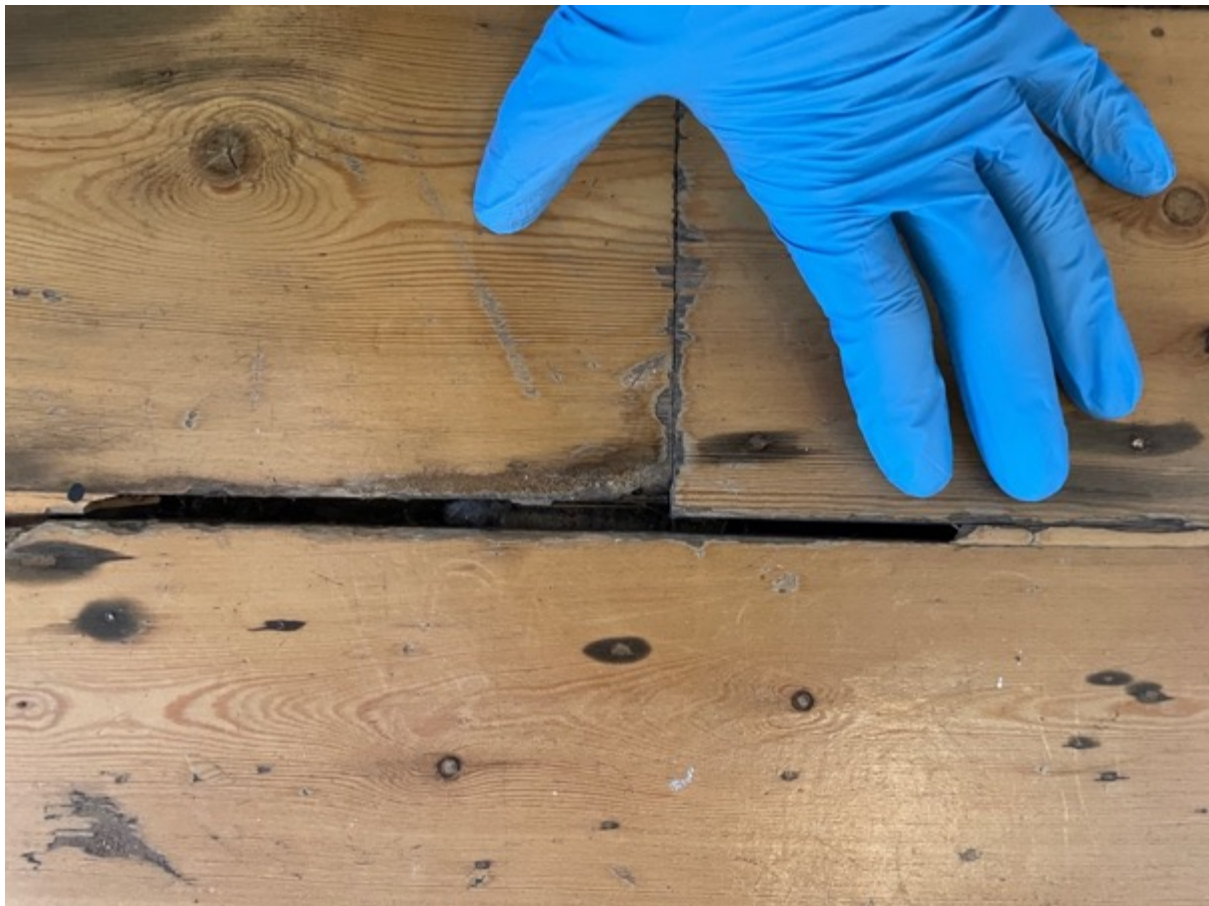
There are various gaps in between the floorboards, which will need to be sealed to avoid heat loss, dust build-up and pest infestation.

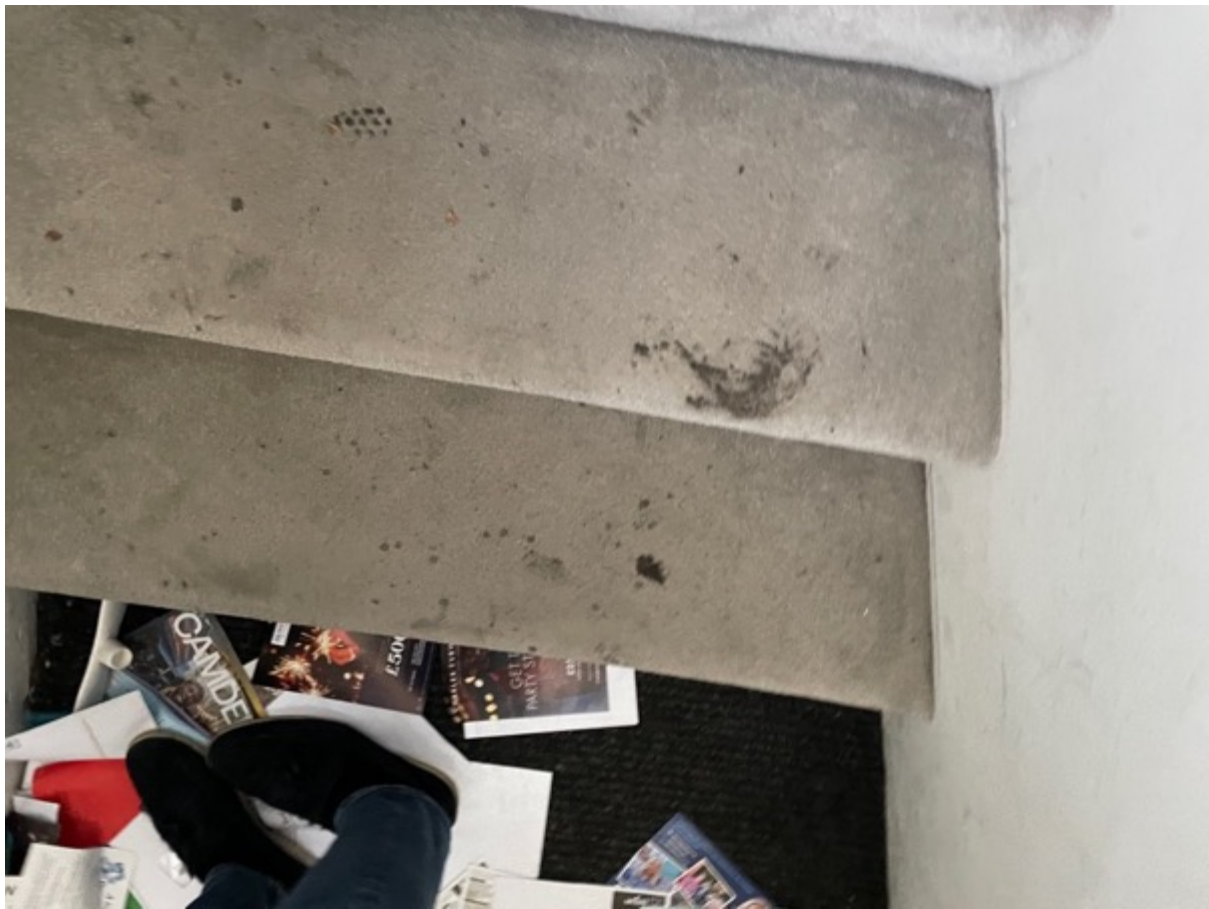
There is also carpet to the entrance staircase, which is stained intermittently and has reached the end of its useful life and requires replacing.

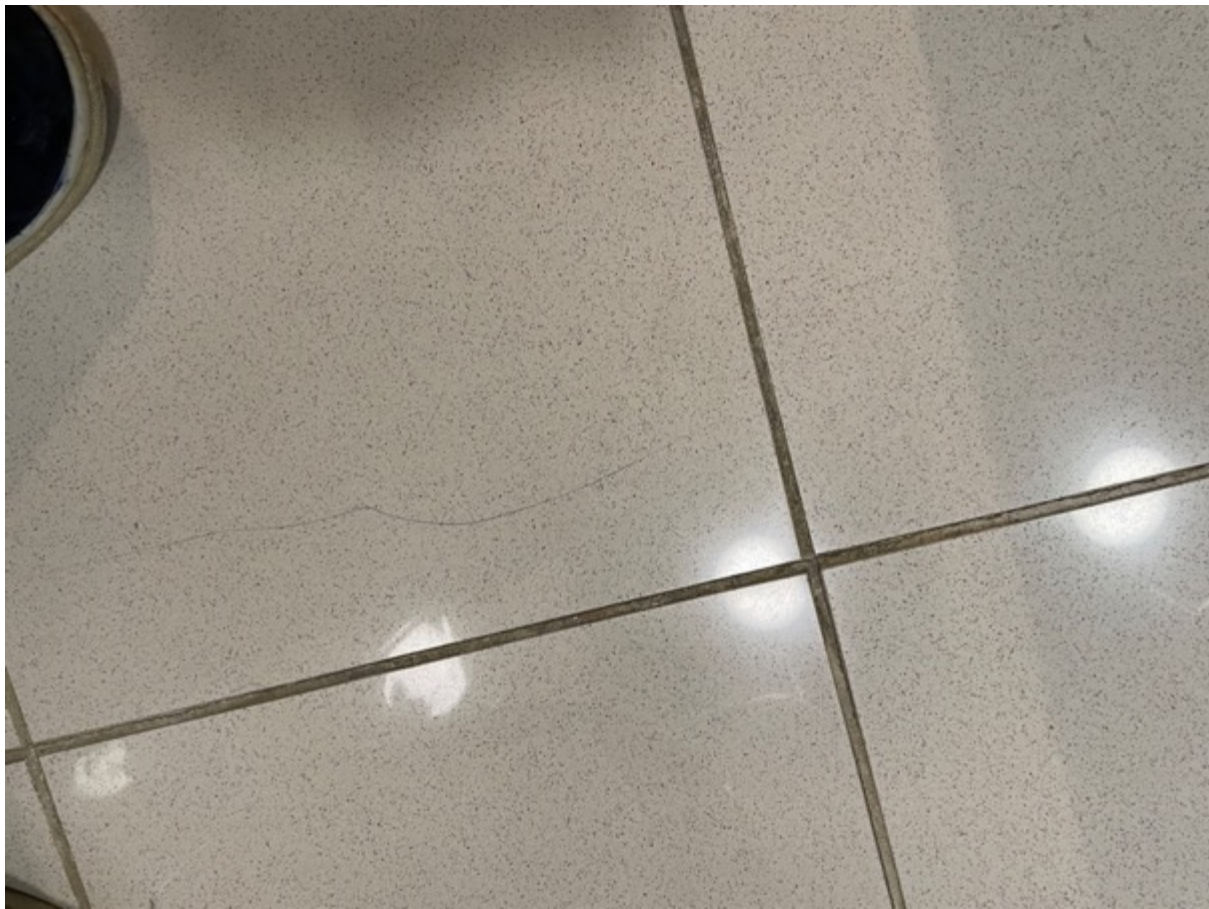
The ceramic tiles within the bathroom have cracked. Furthermore, the grouting has popped away intermittently.

Unfortunately, regarding the cracked tiles, there is no easy way to address this, and the defective tiles will need to be replaced due to the popped-away grouting.

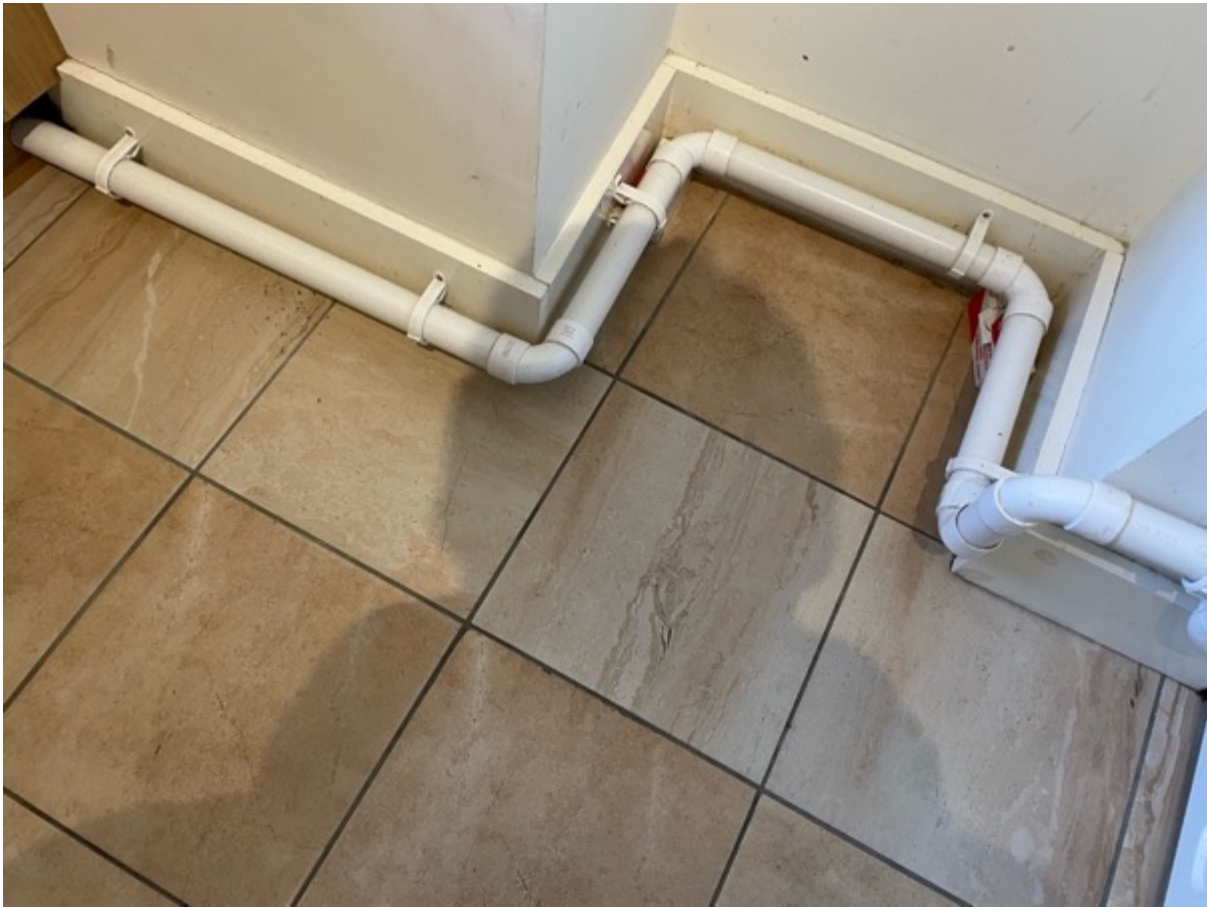
Within the kitchen, there is a mismatch of tiling, which is unsightly. Unfortunately, a like-for-like replacement will likely be hard to find.

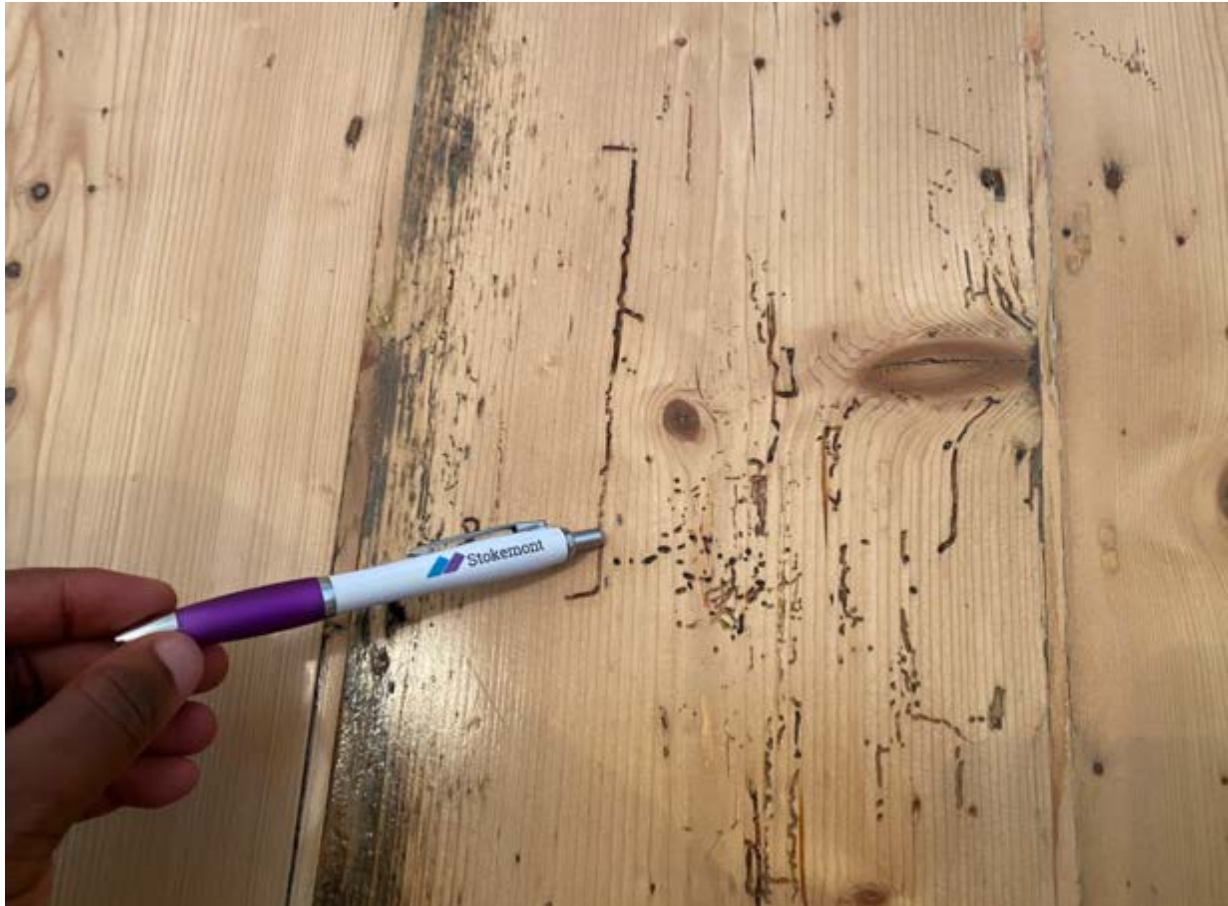
On all timber floors, predominantly on the first floor level, there are signs of historic infestations, whereby it appears to have been some form of woodworm, or woodboring beetle, or weevil problem.

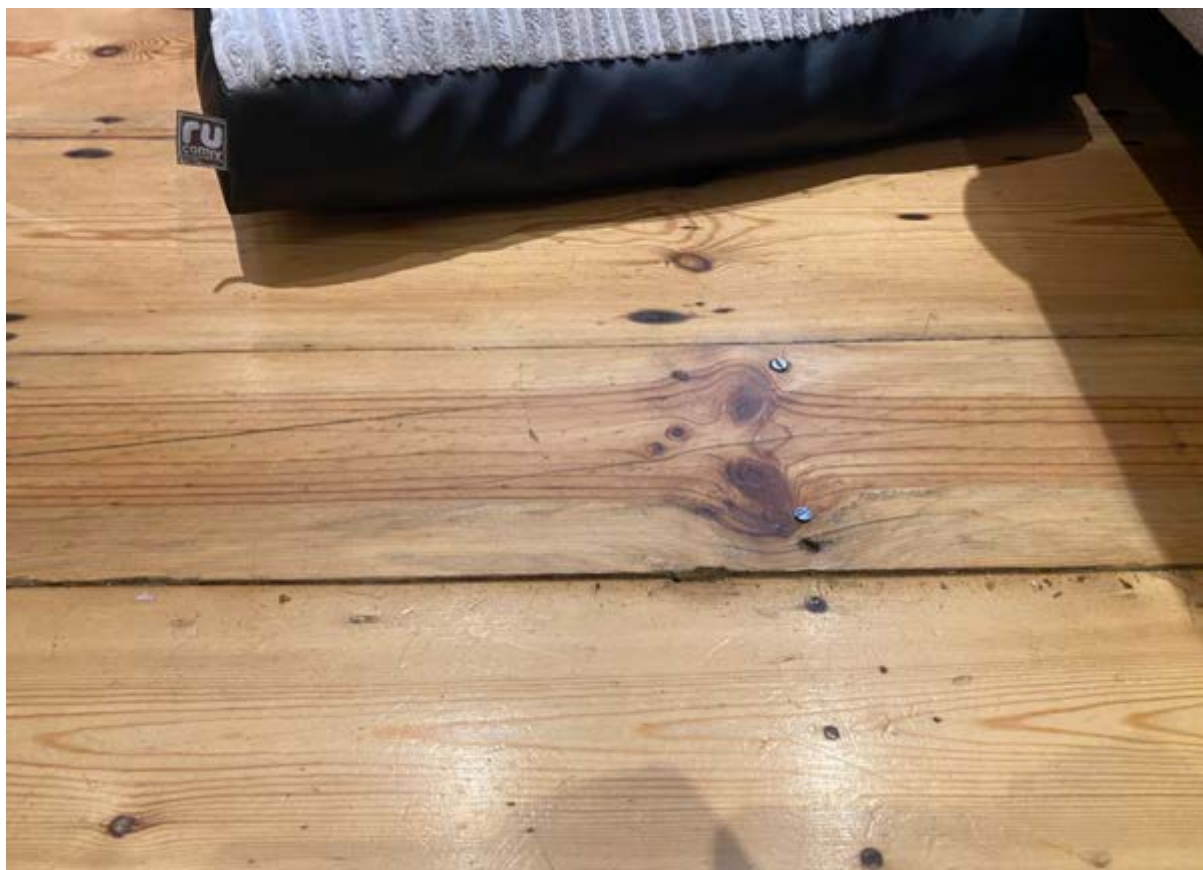
To the ground floor, the central wooden board, approximately 2.5m from the junction of the entrance, has been screwed down, and the screws themselves were sitting proud from the ground.

These are a safety hazard and you could easily catch your toe on these, and I would advise, that if you do proceed with the purchase, that these are recessed into the board itself and infilled to ensure a smooth and neat finish.

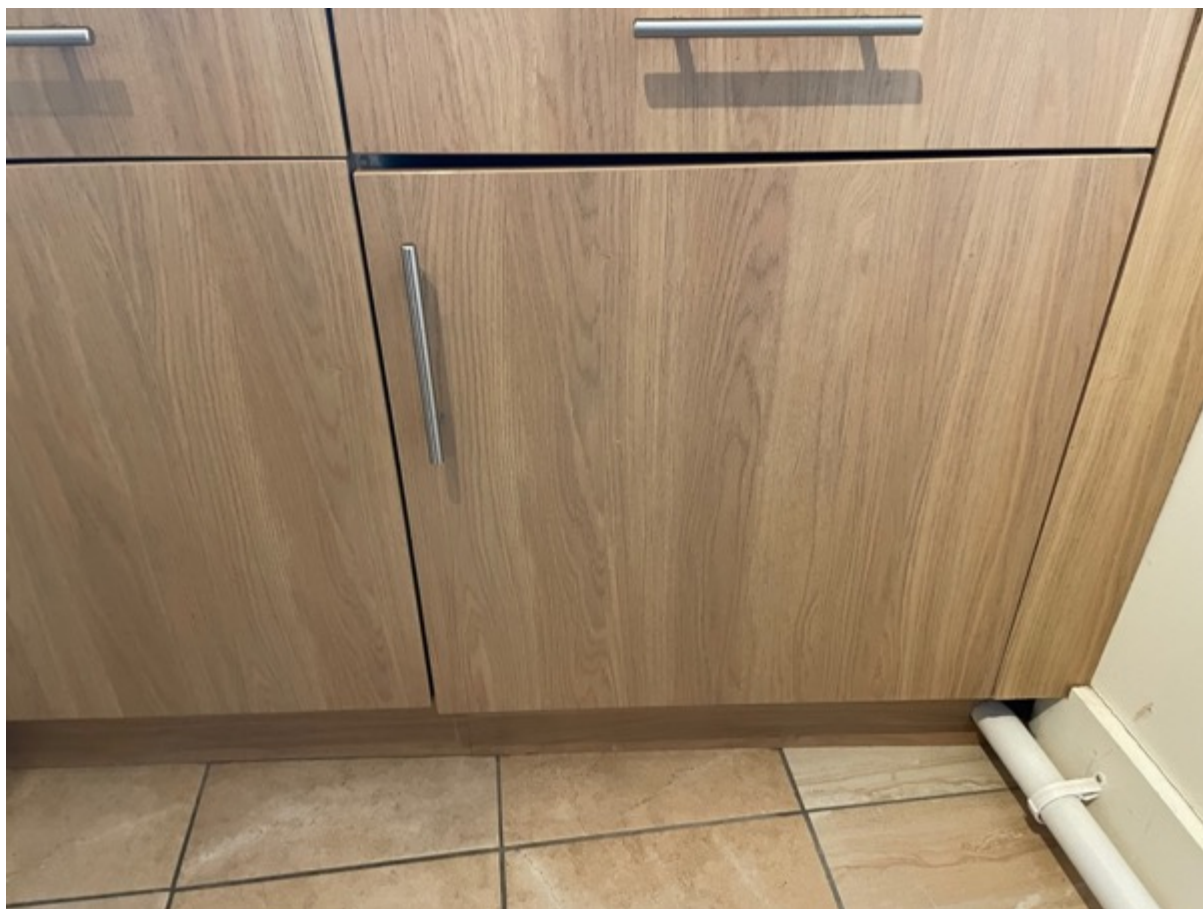
A number of the fitted cabinet doors had dropped from their fixings. To address this, the hinges would need to be adjusted.

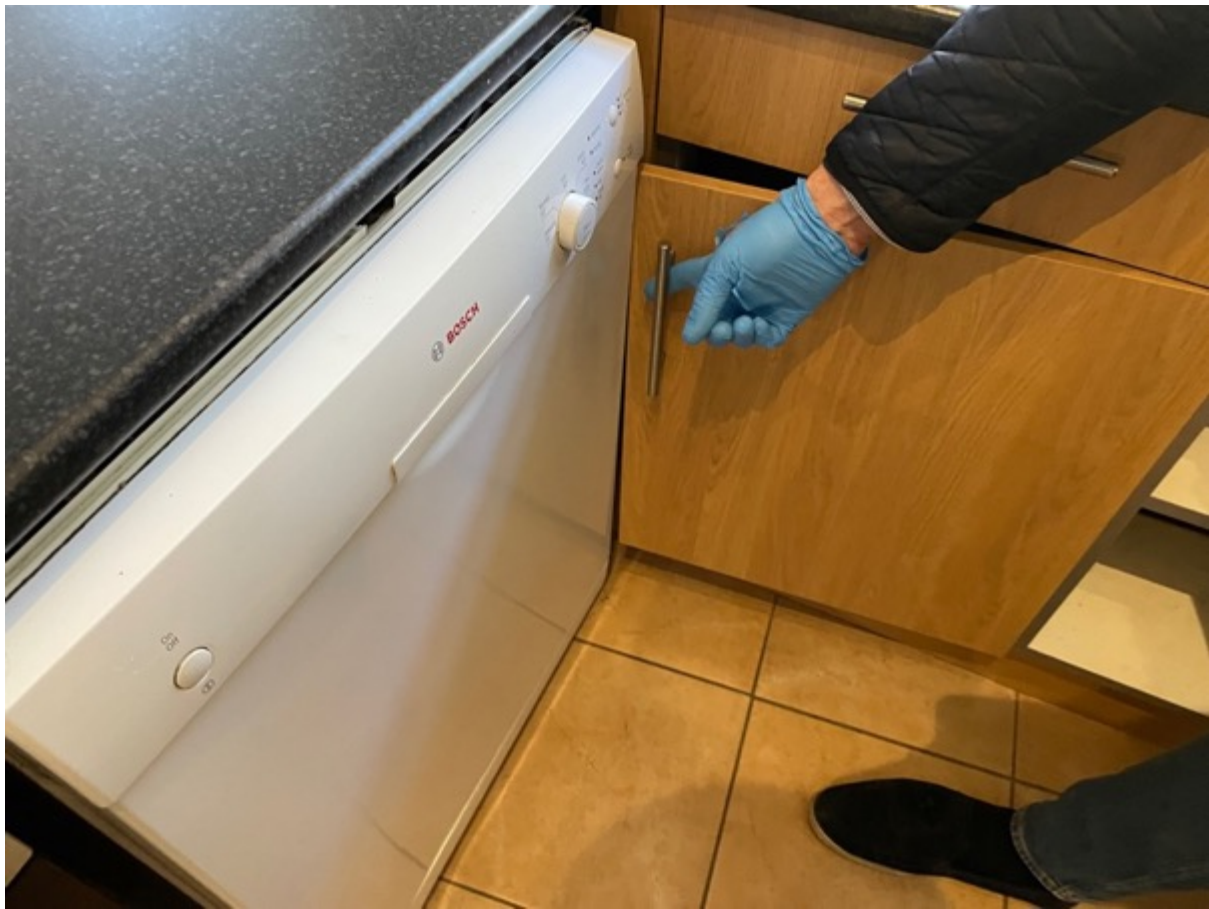
The cabinet door to the underside of the sink binds against the dishwasher. To address this, you can either install a smaller door and larger plinth or relocate the dishwasher.

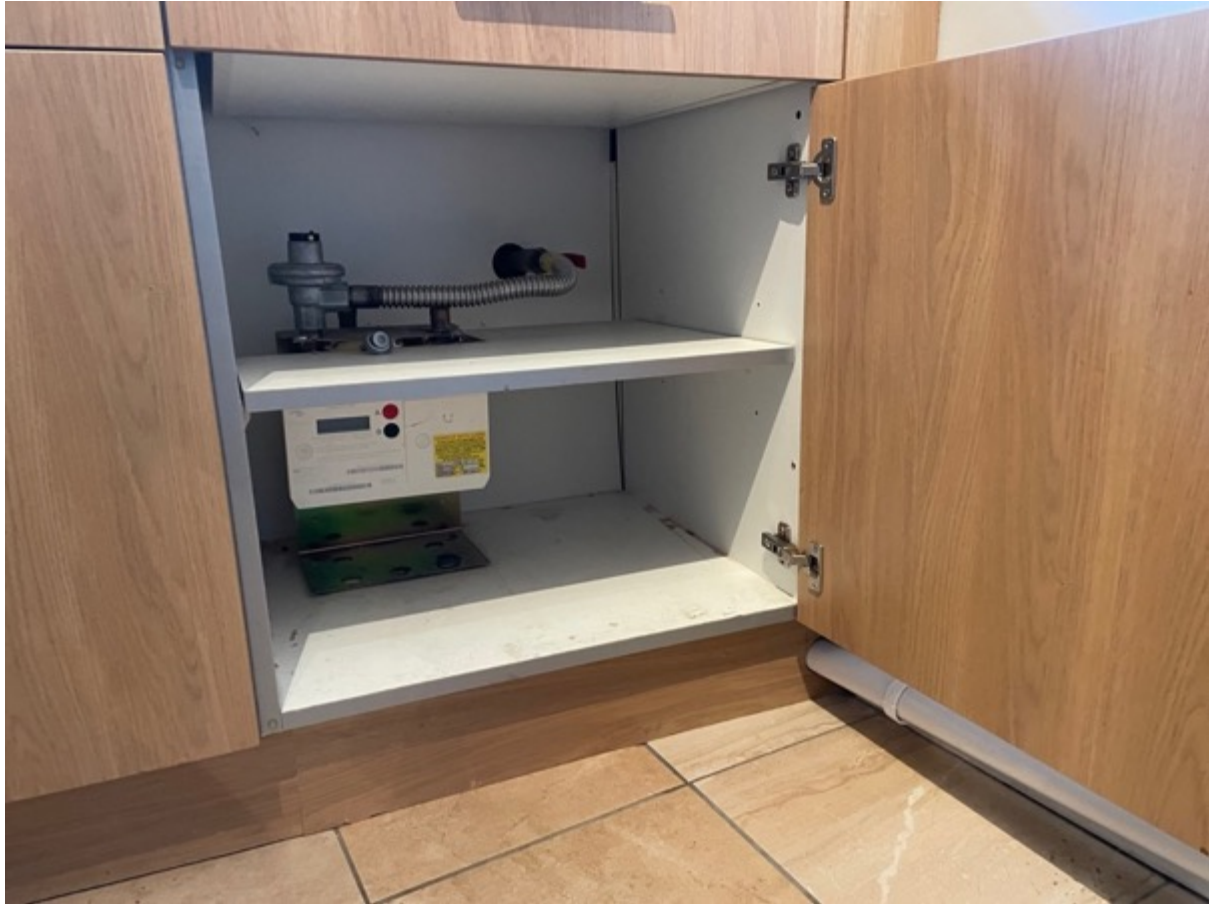
I was able to locate a gas meter to the underside of the sink. This is an unconventional location for a gas meter.

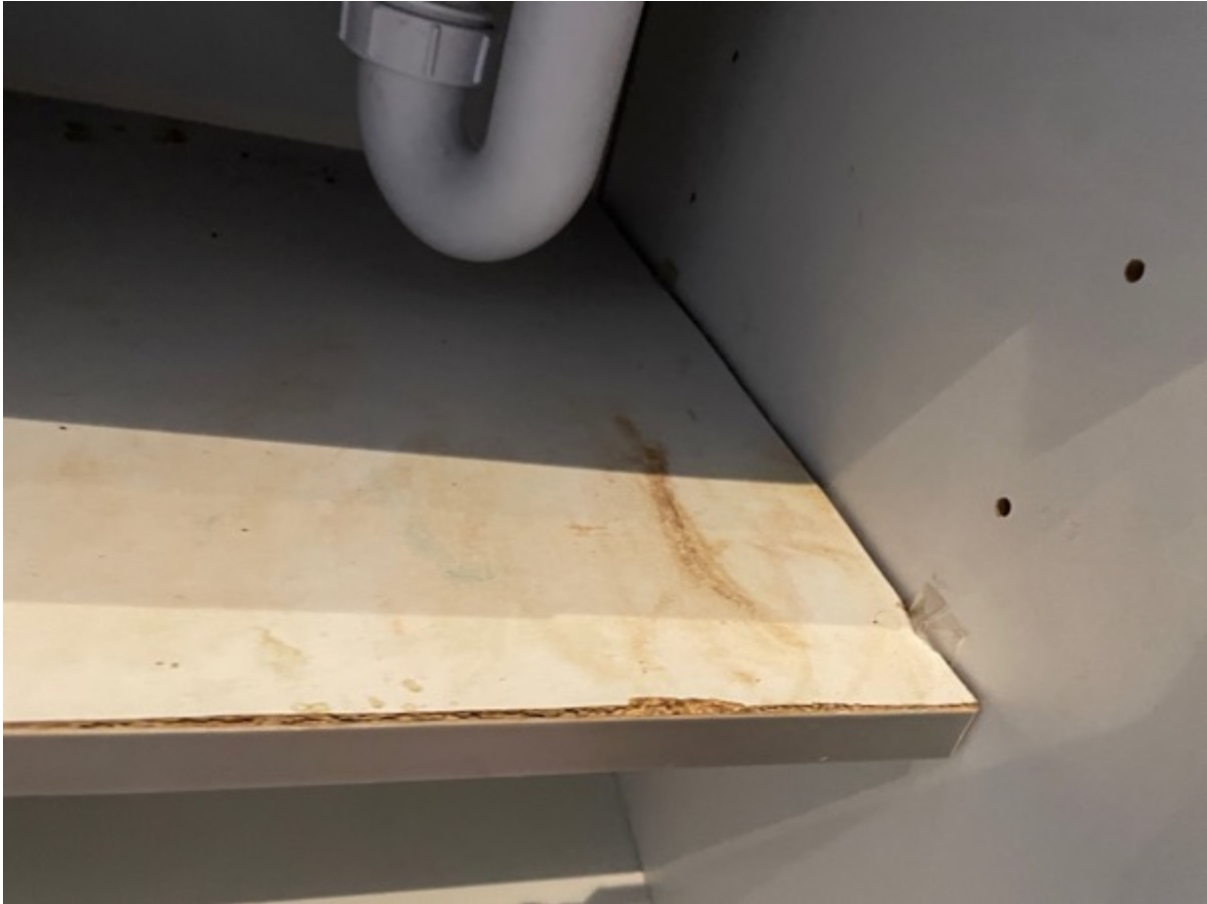
The shelf to the underside of the sink has failed and will need to be replaced, as the laminate covering has pulled away, indicating water ingress from a potential leak from the sink above.

As previously confirmed, a plumber should visit to investigate further.

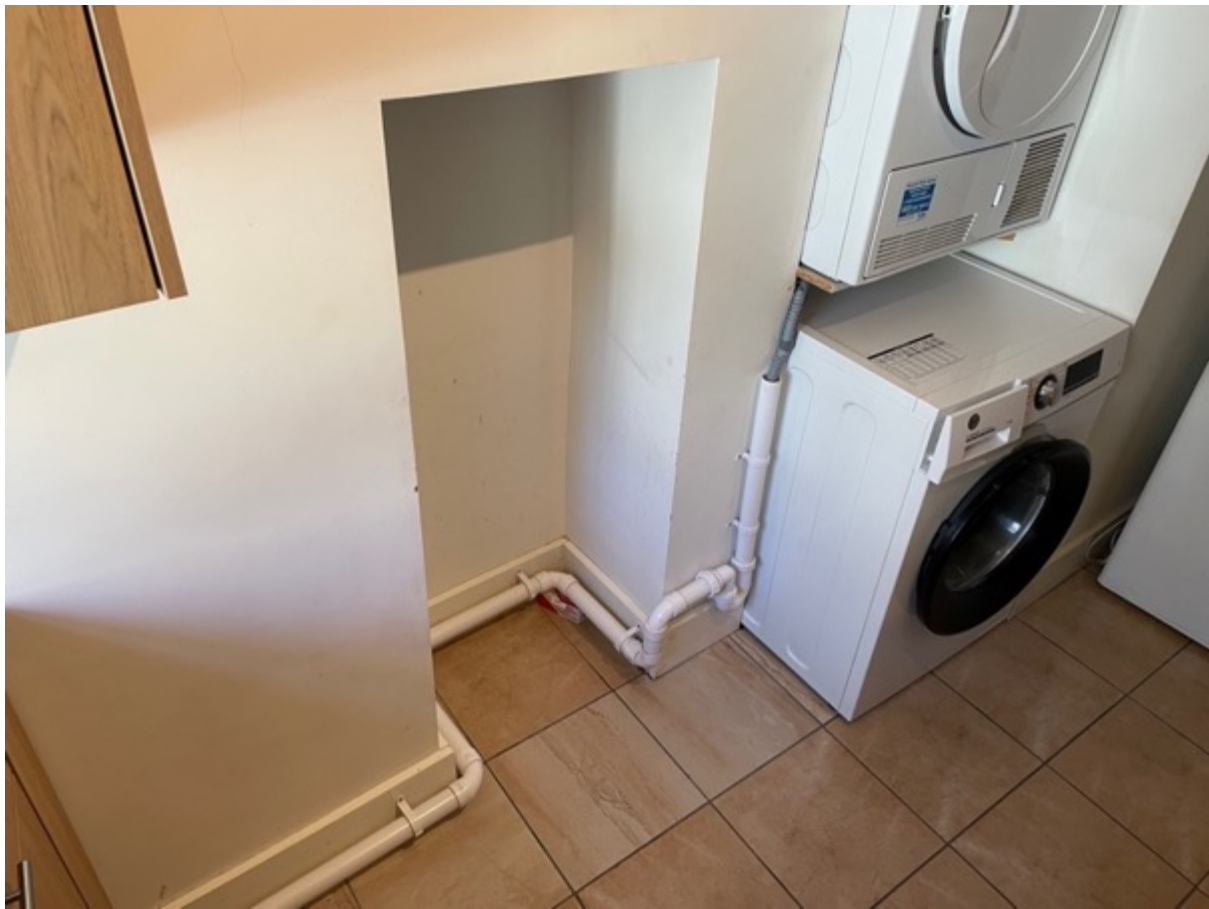
The washing machine waste feed pipework has been mounted to the wall. This is unconventional. You may want to consider having this reconfigured.

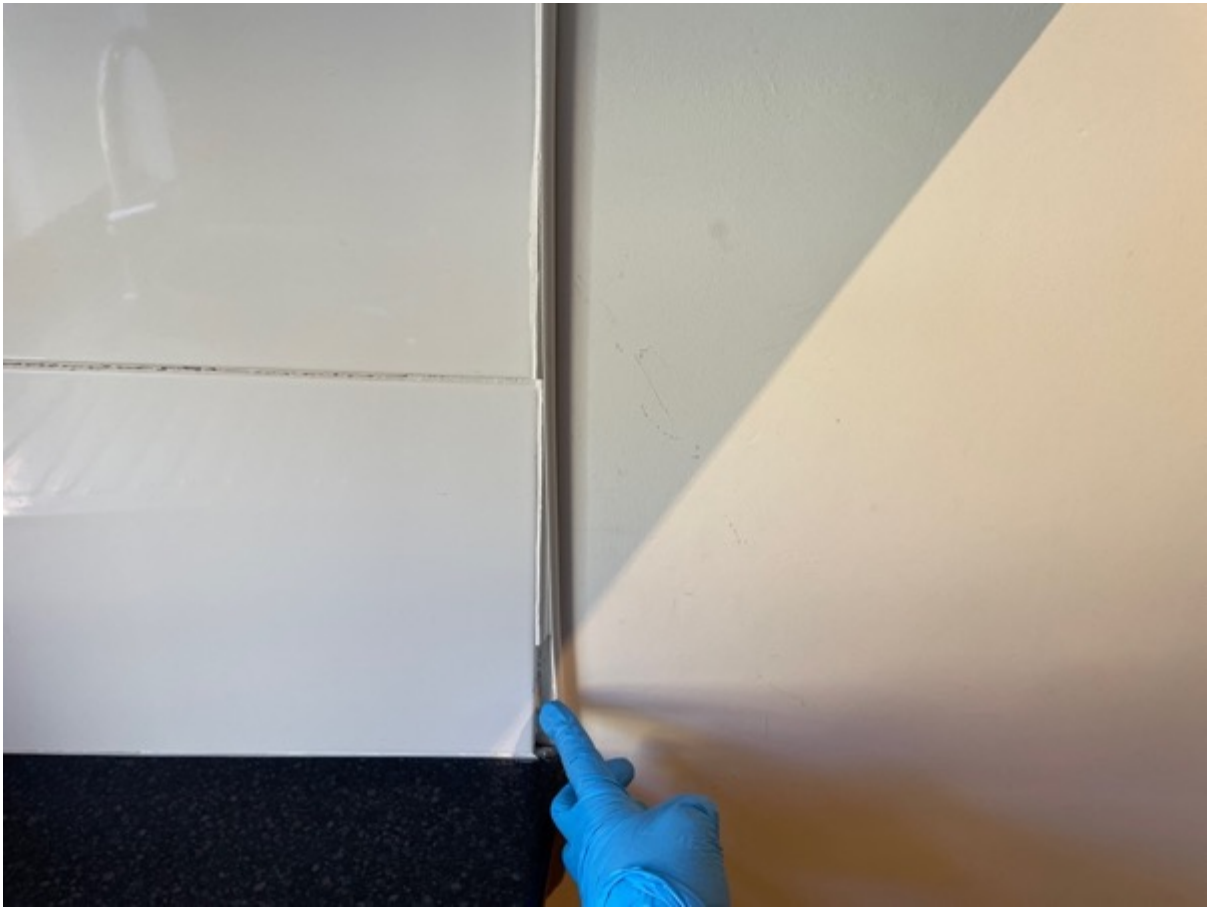
The trim to the tiled splashback has pulled away. This will need to be made good.

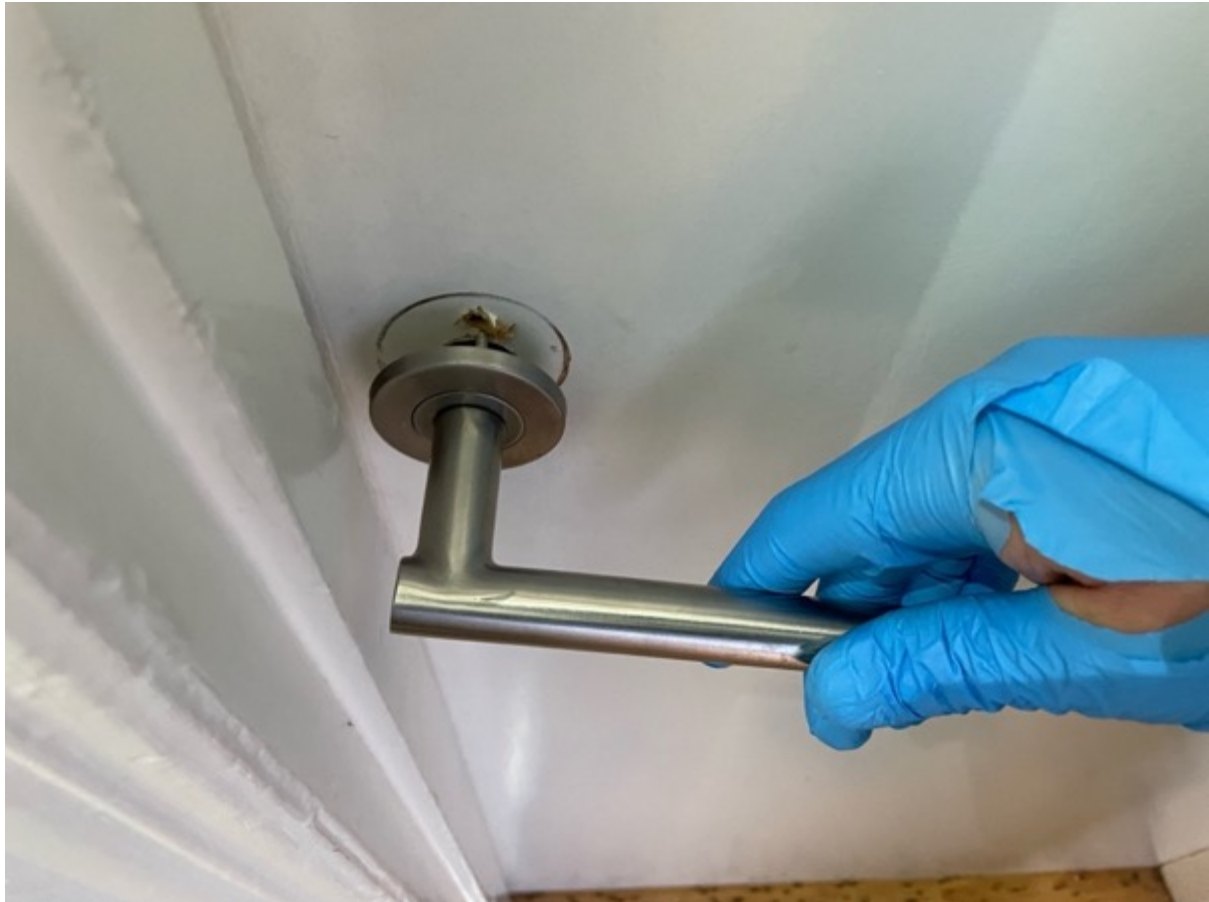
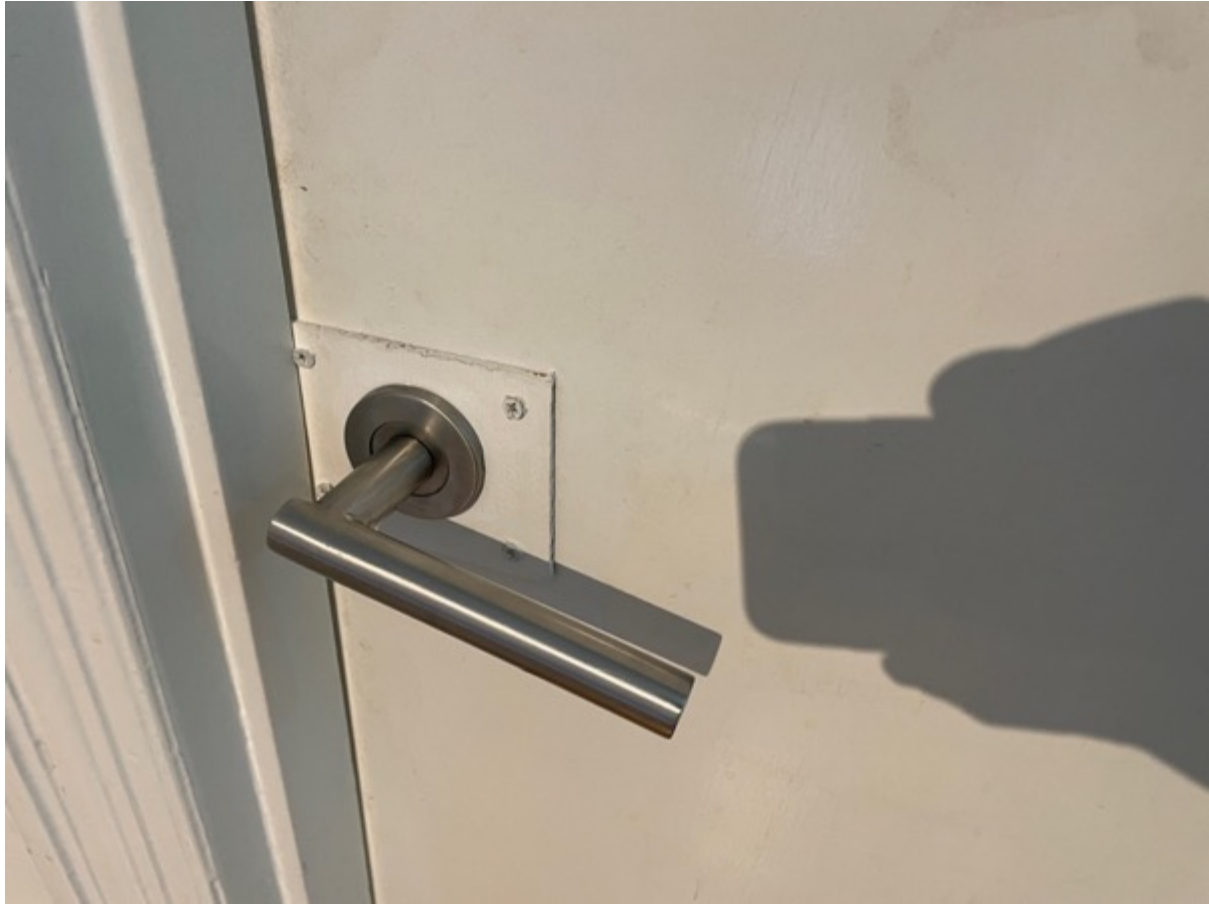
All internal doors are of timber type. The majority of the door handles are defective, with the bathroom door being made good to a DIY standard.

This will need to be addressed.

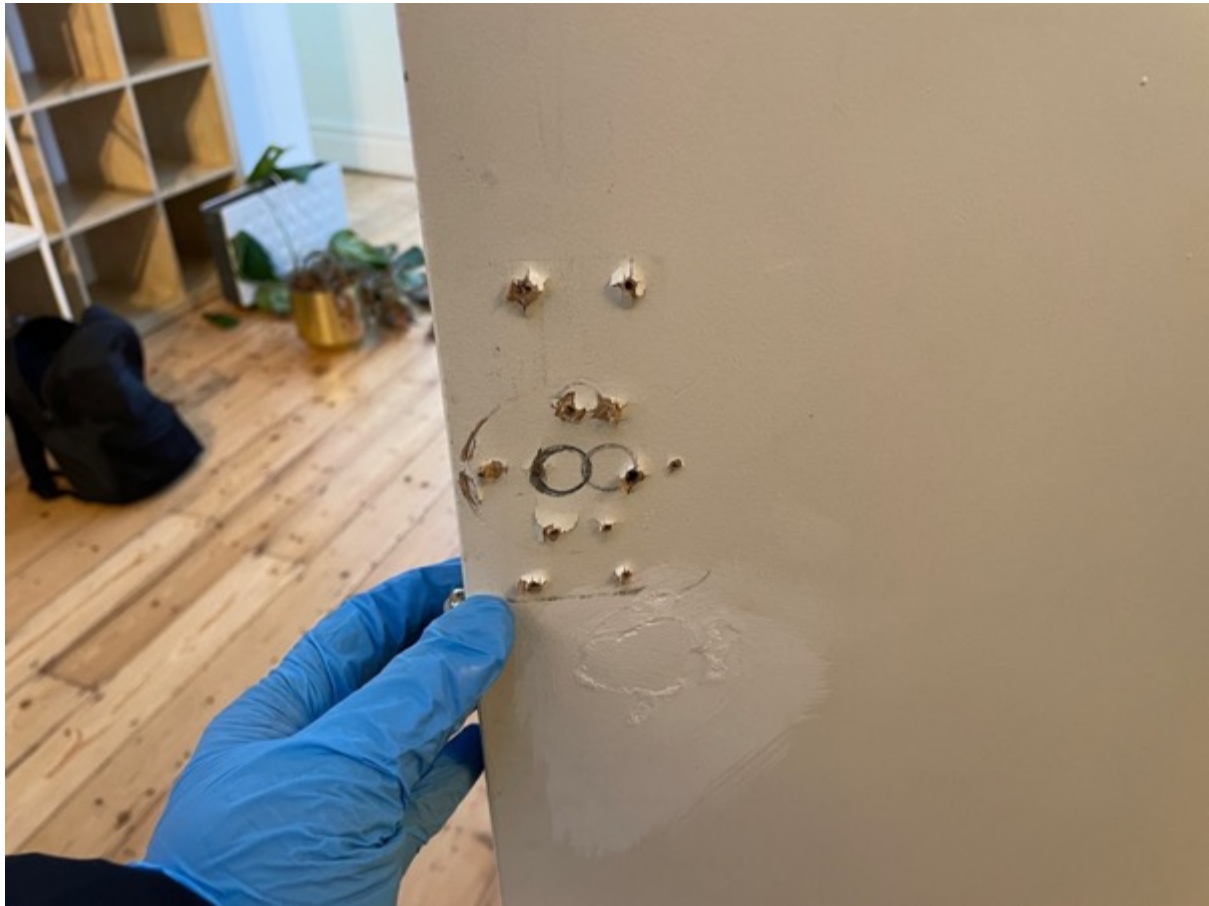
The services cupboard is missing a door handle, and this will need to be replaced.

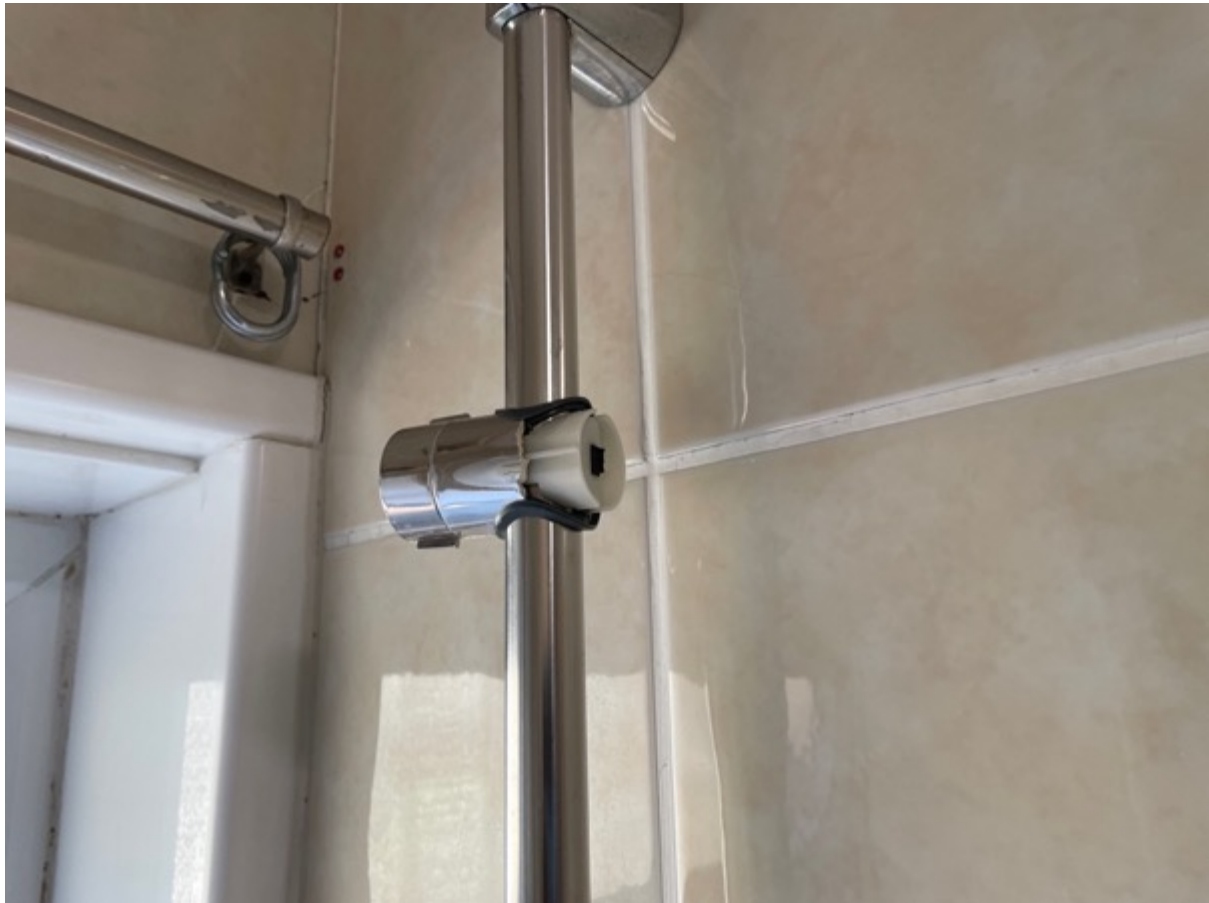
The bathroom appliances are dated and should be replaced. Furthermore, a number of the fixtures have been damaged and will require replacement.

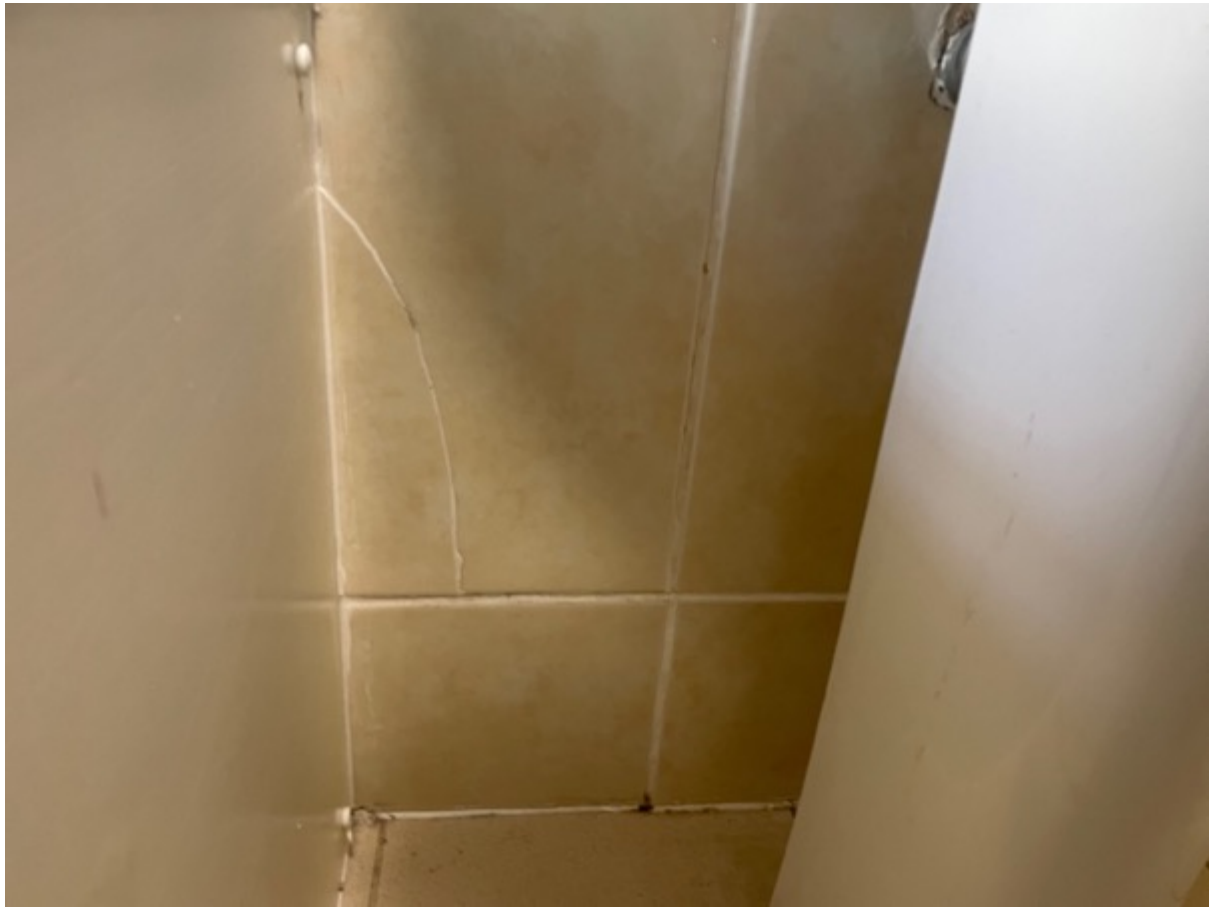
Some tiles to the perimeter of the bathroom have cracked. Unfortunately, there is no easy way to address this, and the tiles will need to be replaced.

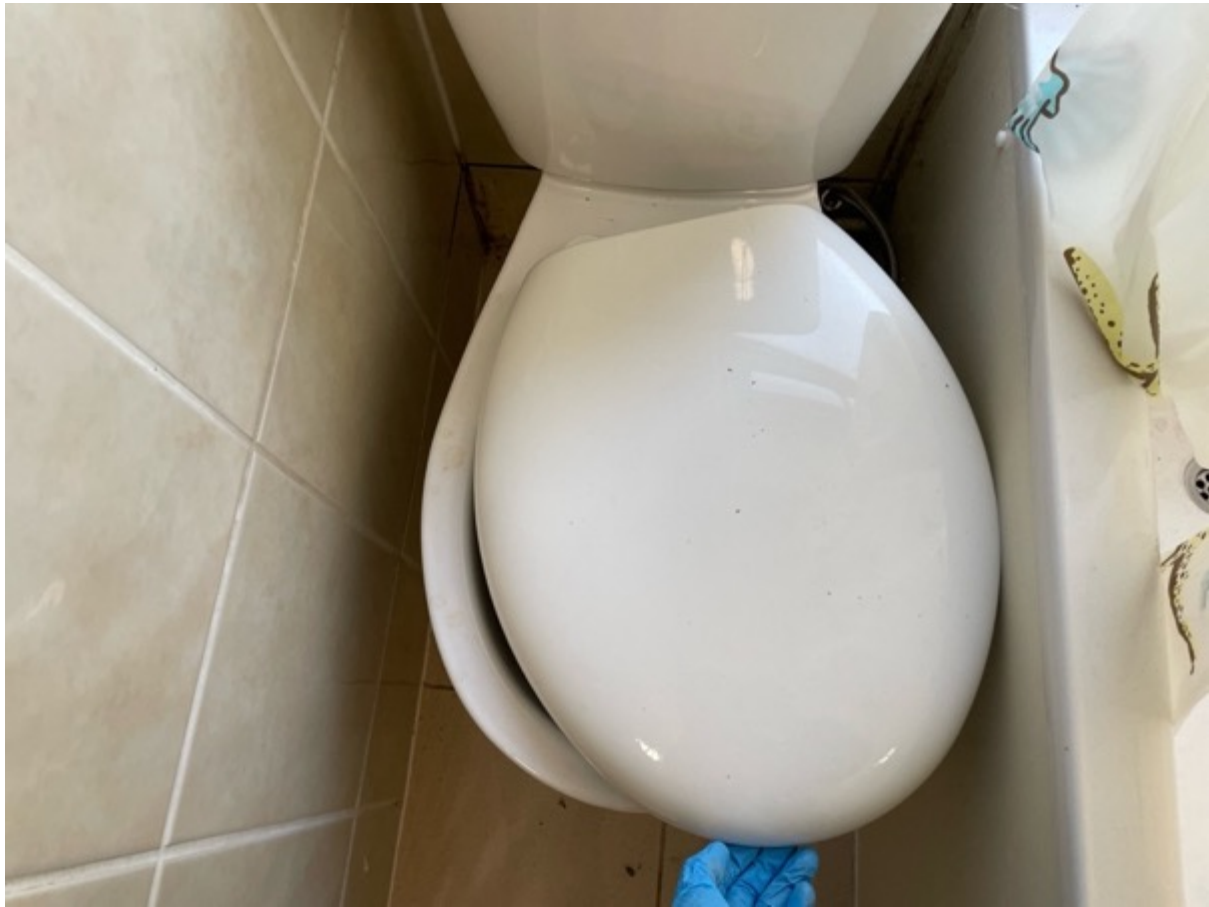
The toilet seat has come loose from its fixture and will need to be firmly fixed back in place.

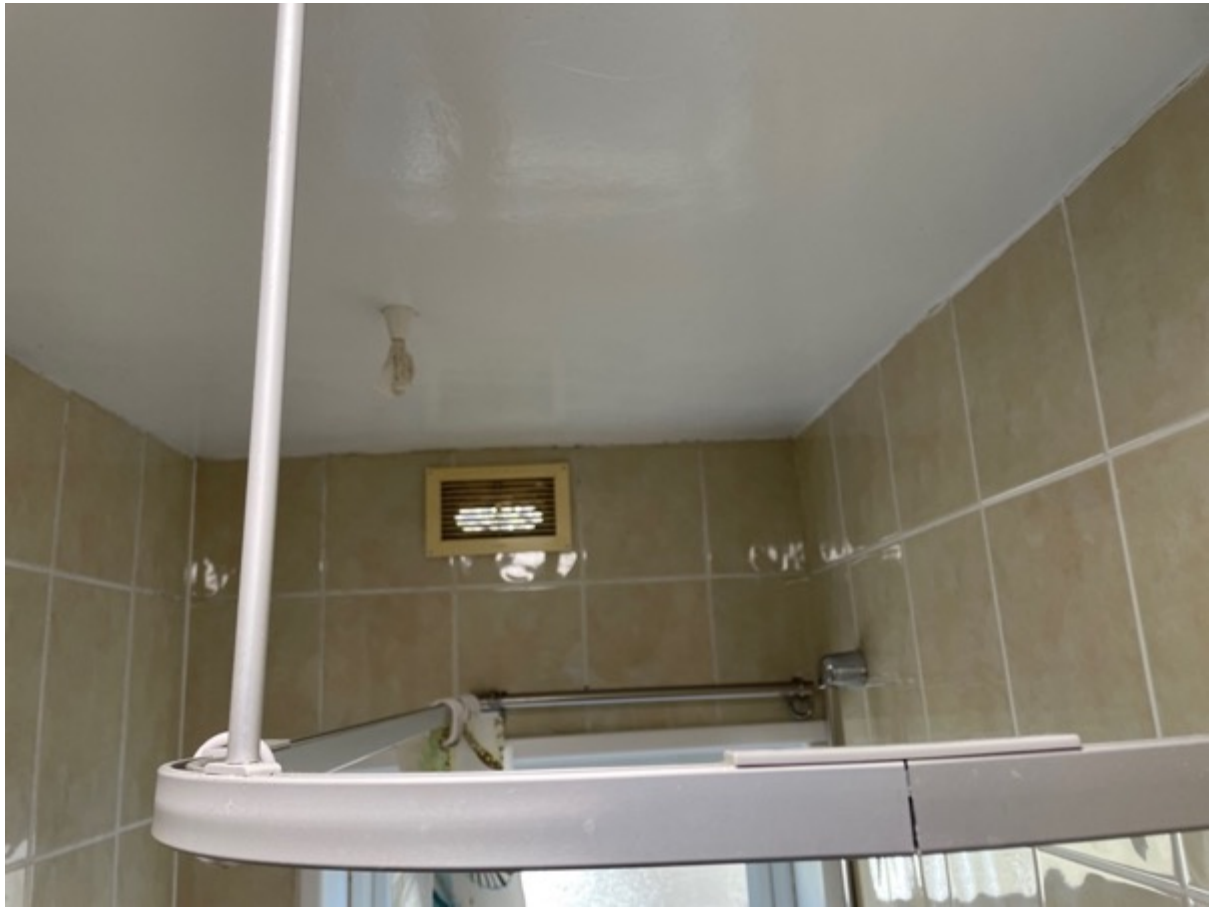
The current air vent within the bathroom is more or less just a hole in the wall. This will need to be addressed.
