RICS HomeBuyer Report (Level 2 Survey)

Address of Purchase Property

Date of Inspection:

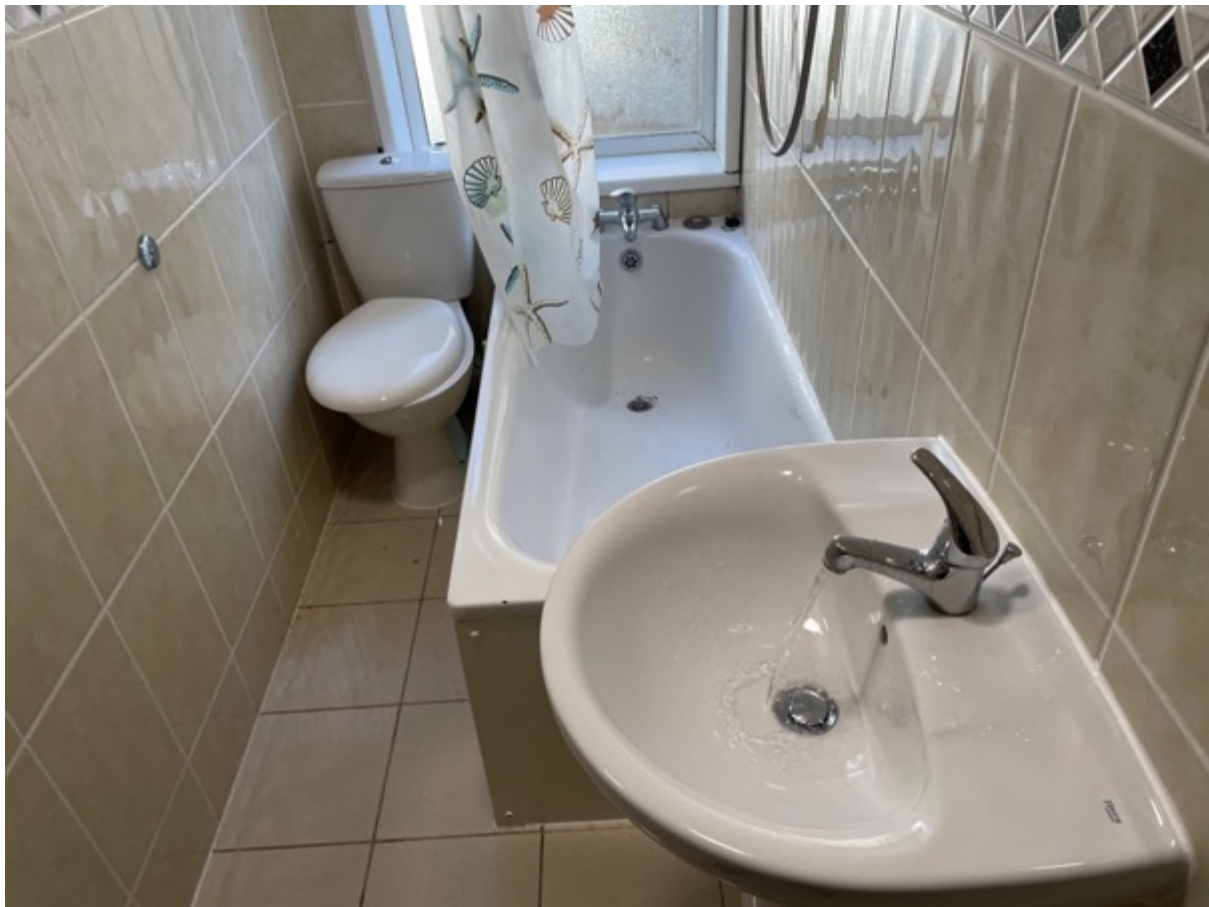
Furthermore, the distance between the toilet and the bathtub is relatively narrow. This should be taken into consideration, should you proceed with the purchase, as I suspect the majority of individuals would not be able to comfortably utilise the toilet facility.

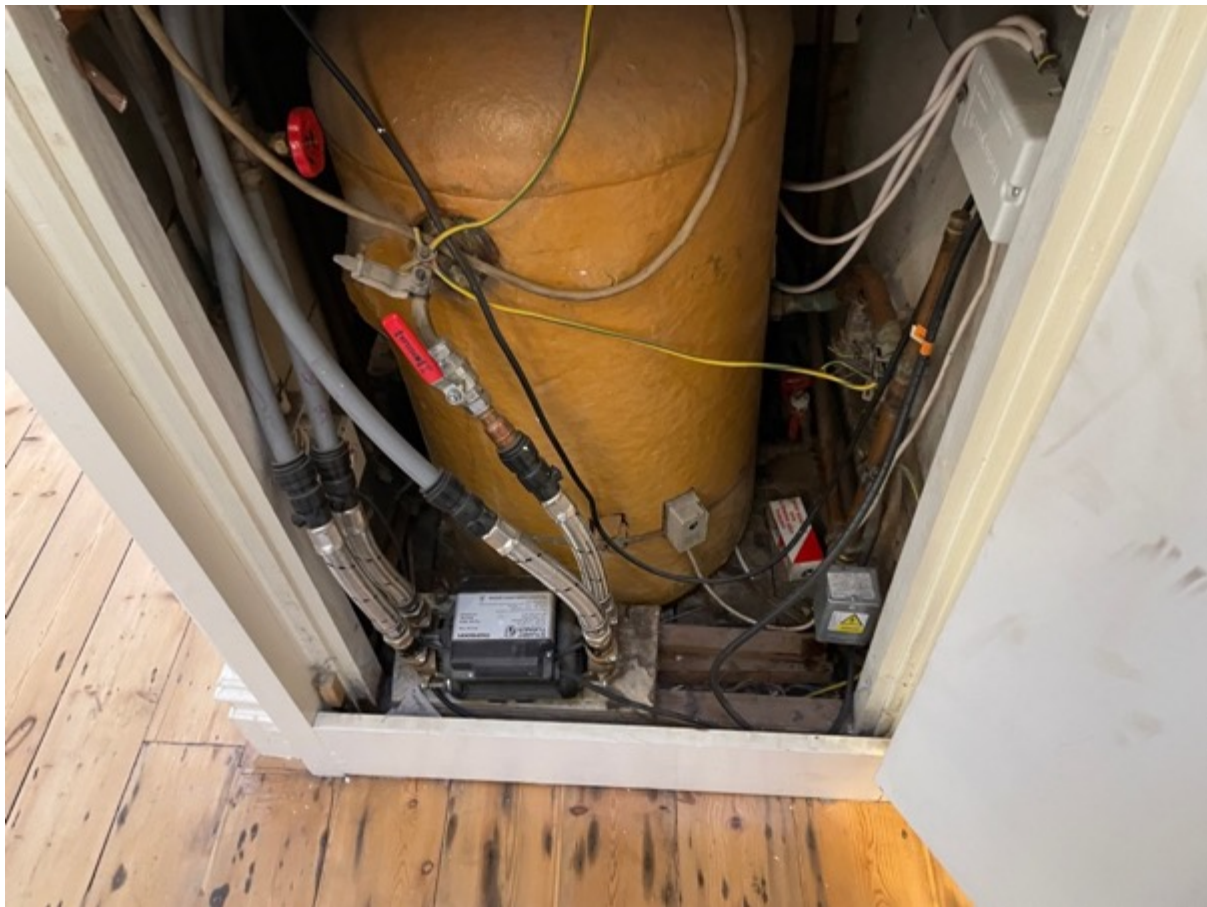
I also noticed a strong smell from the service cupboard, which could potentially be due to a dead rodent. Further investigations from a pest specialist would be required.
