RICS Full Building Survey Report

(Level 3 Survey)

Full Property Address:

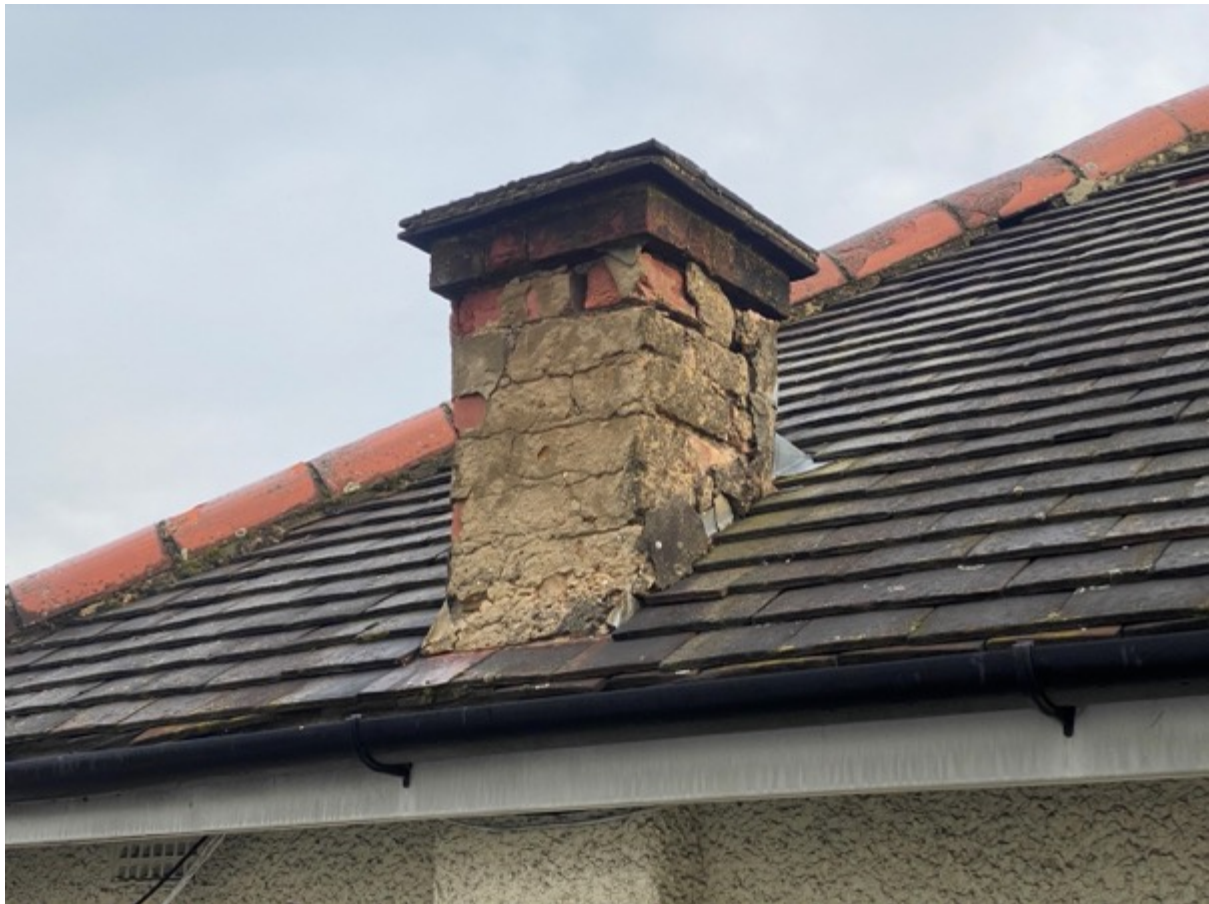
D1 Chimney Stacks:

The chimney stack is of brickwork London stock solid construction. There are a total of eight pots on the stack shared with the adjoining property.

It is worth noting that there is a television aerial attached to the chimney stack itself. This can be an issue in windier weather and during the time of the inspection the street itself was relatively windy so in very strong days of wind this could be a potential hazard and could peel away or be blown off the chimney stack.

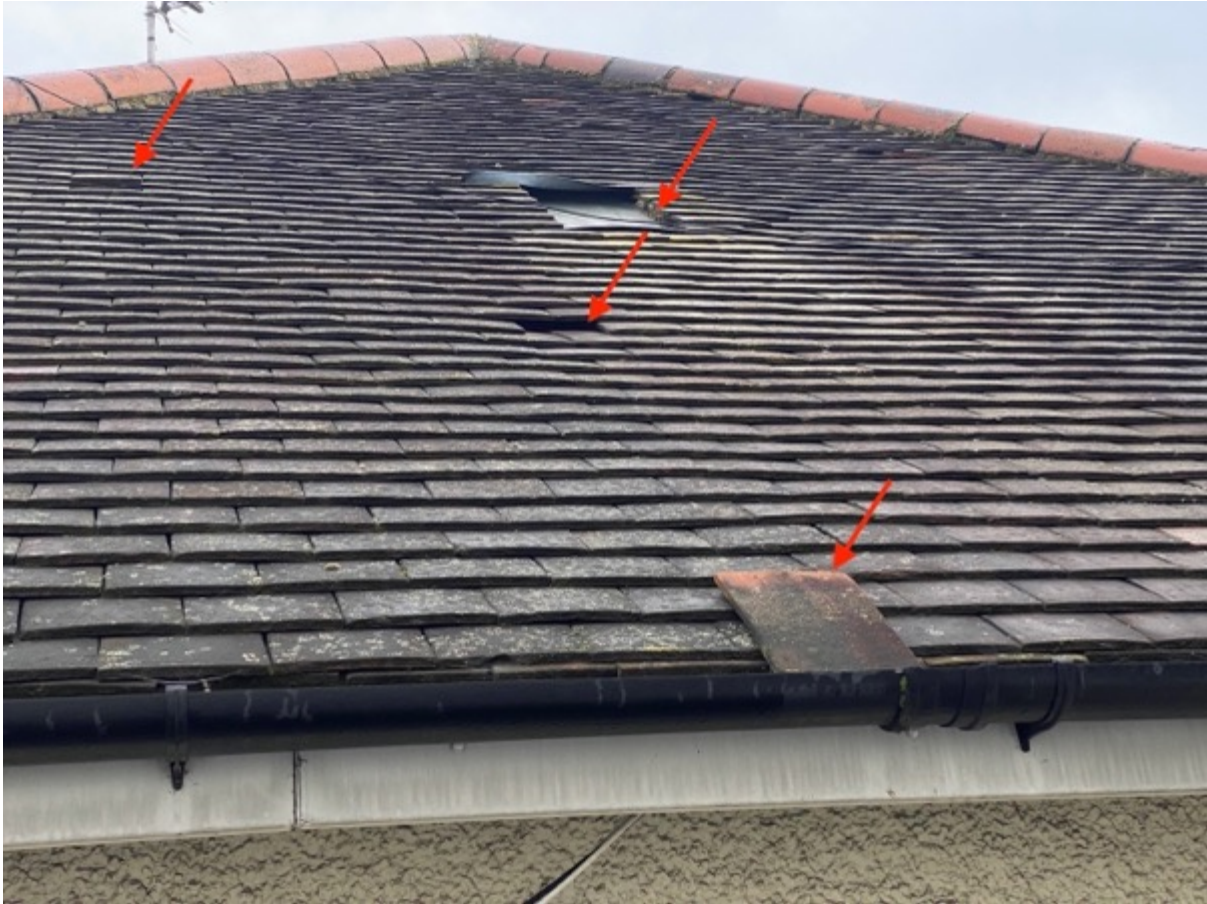
The coverings themselves have lichen and moss growth noted throughout, however, overall, there did not appear to be any signs of lifting or disrepair of tiles.

To the rear of the property the roof is fully covered with a loft dormer. The dormer itself appears to be clad and painted timber, however, it is worth noting this could be a uPVC cladding.

The upper level of the dormer appears to have a mineral felt covering. The covering itself, where visible from the rear garden, does appear to be showing signs of fading which is usually indicative of failing of the roof covering.

I was unable to inspect the upper level of the roof itself as there is no safe way to gain a vantage point on it and therefore, I would advise that, prior to proceeding with the property, it may be advisable for you to have a roofer look at the dormer roof itself to ascertain the condition and the longevity of the roof covering.

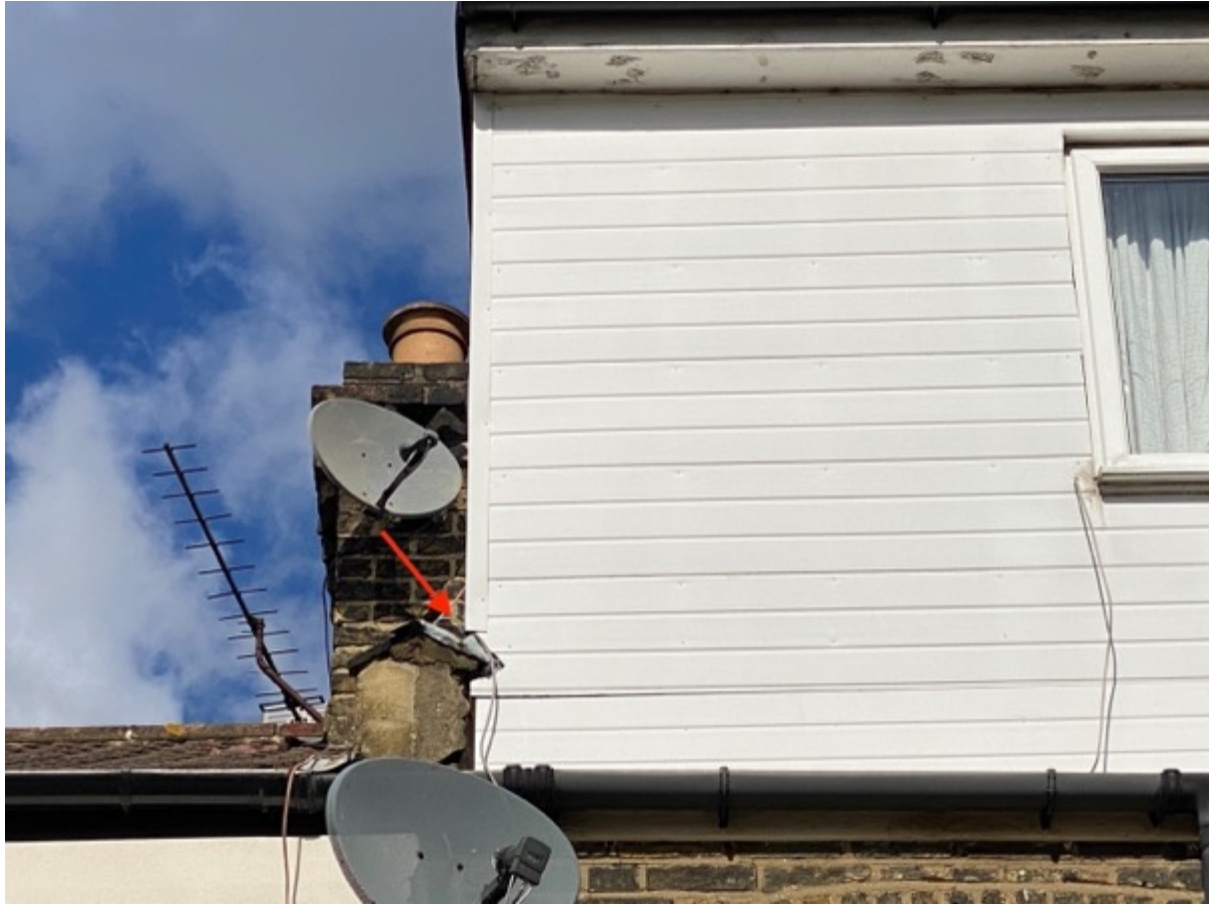
Generally speaking, this is a poor installation, and the conventional way would have been to remove the ridge tile and have a lead flashing dressed onto the party parapet wall itself with some form of considered final finish.

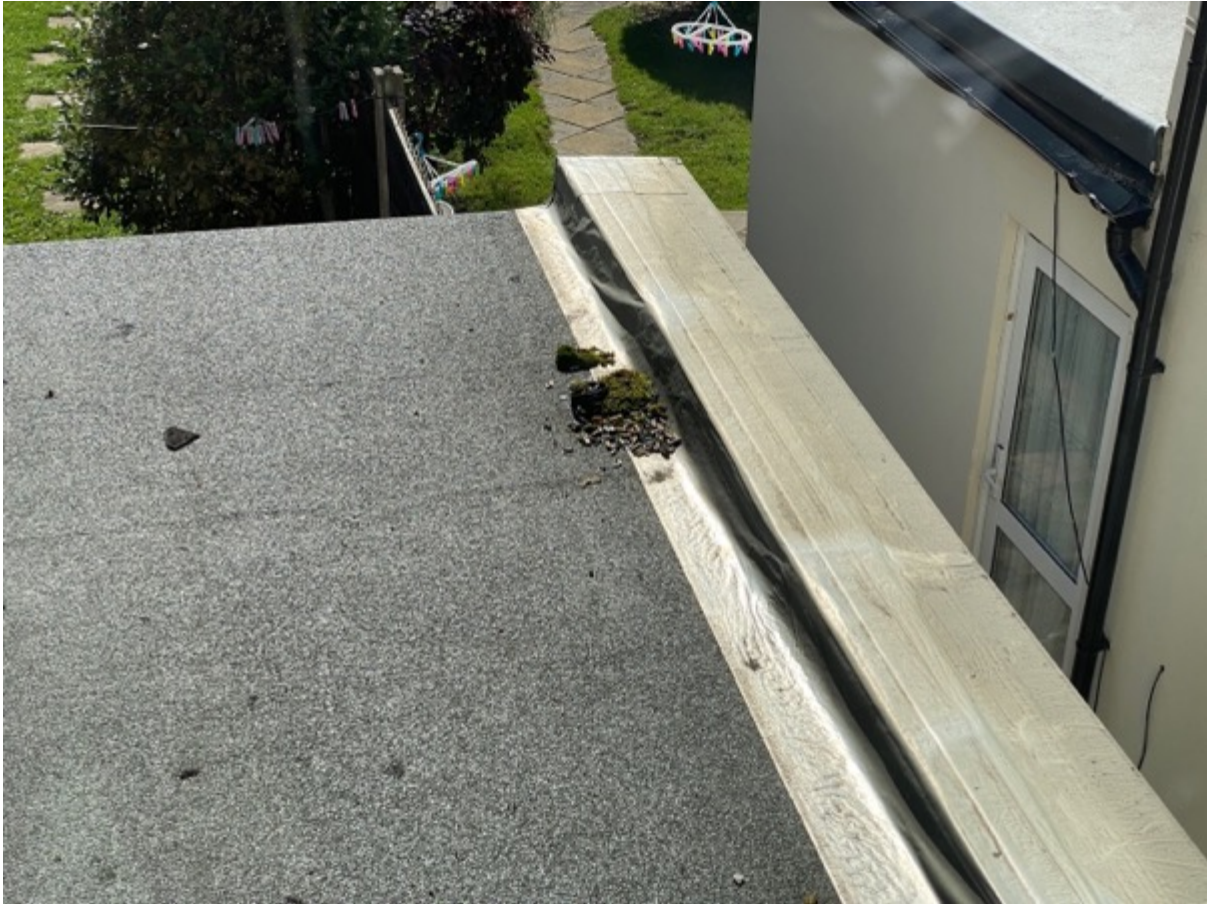
Flashband, generally speaking, has a very short lifespan and ideally this would have been done with a lead flashing which increases the longevity of the abutment itself.

Towards the rear of the roof covering there is an area of damp staining noted at one of the junctions of the mineral felt.

This is an indication that the Flashband could be failing, and water could be starting to pool.

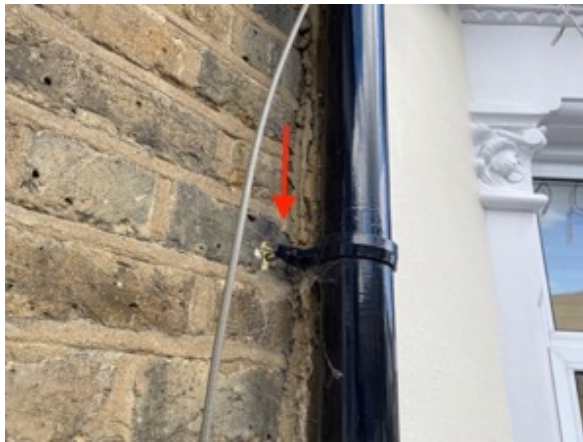
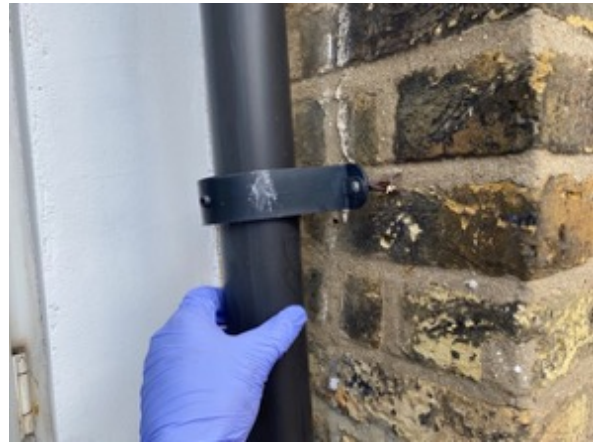
The upper clip screws have pulled loose from the wall itself and this will need to be re-secured to ensure that it is firmly screwed against the wall itself so that in the wetter months there is not an overspill of the gutters or that the gutters do not miss the hopper head and discharge water onto the wall itself.

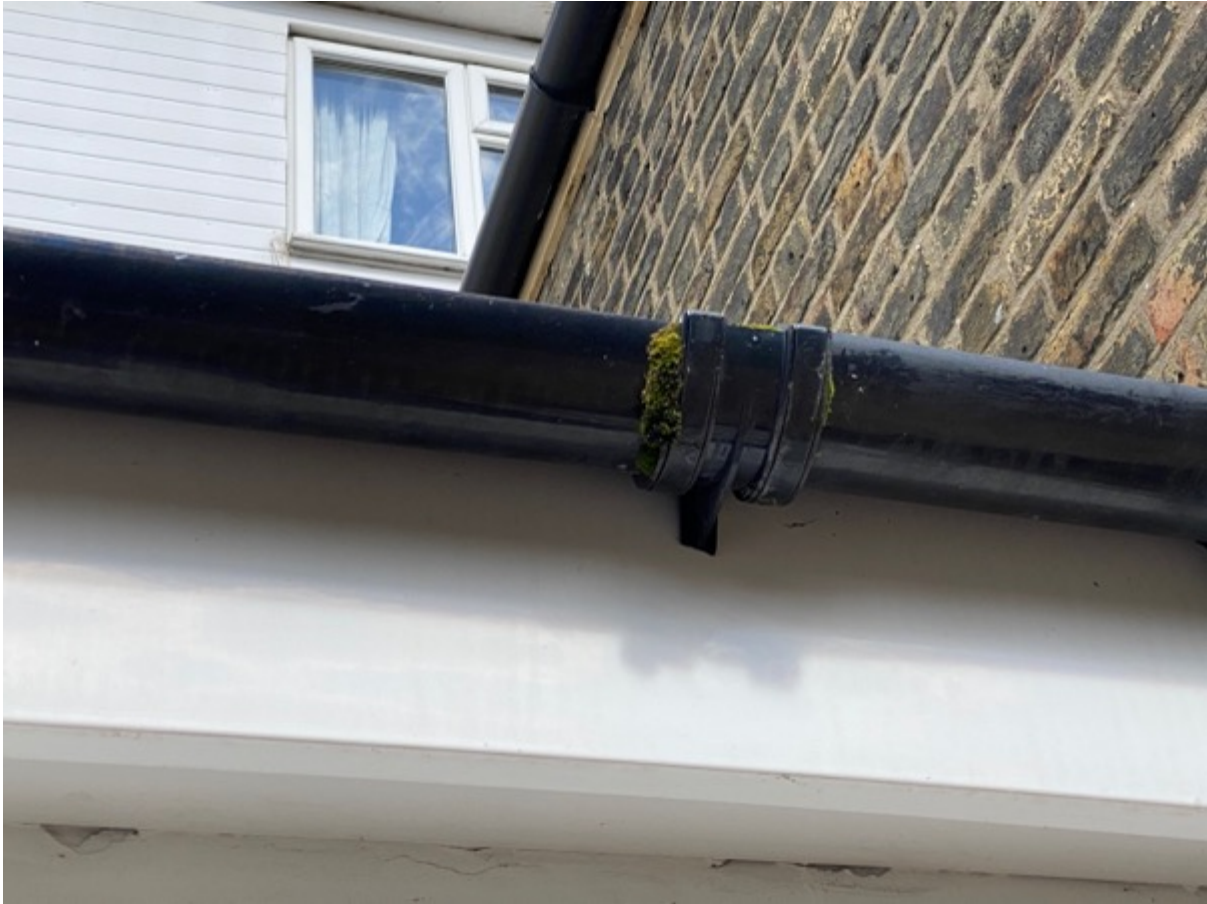
The gutters towards the rear of the ground floor extension are showing signs of moss growth and are unlevel throughout and I suspect in periods of heavy rain this could likely be spilling onto the fascia and rear extension itself.

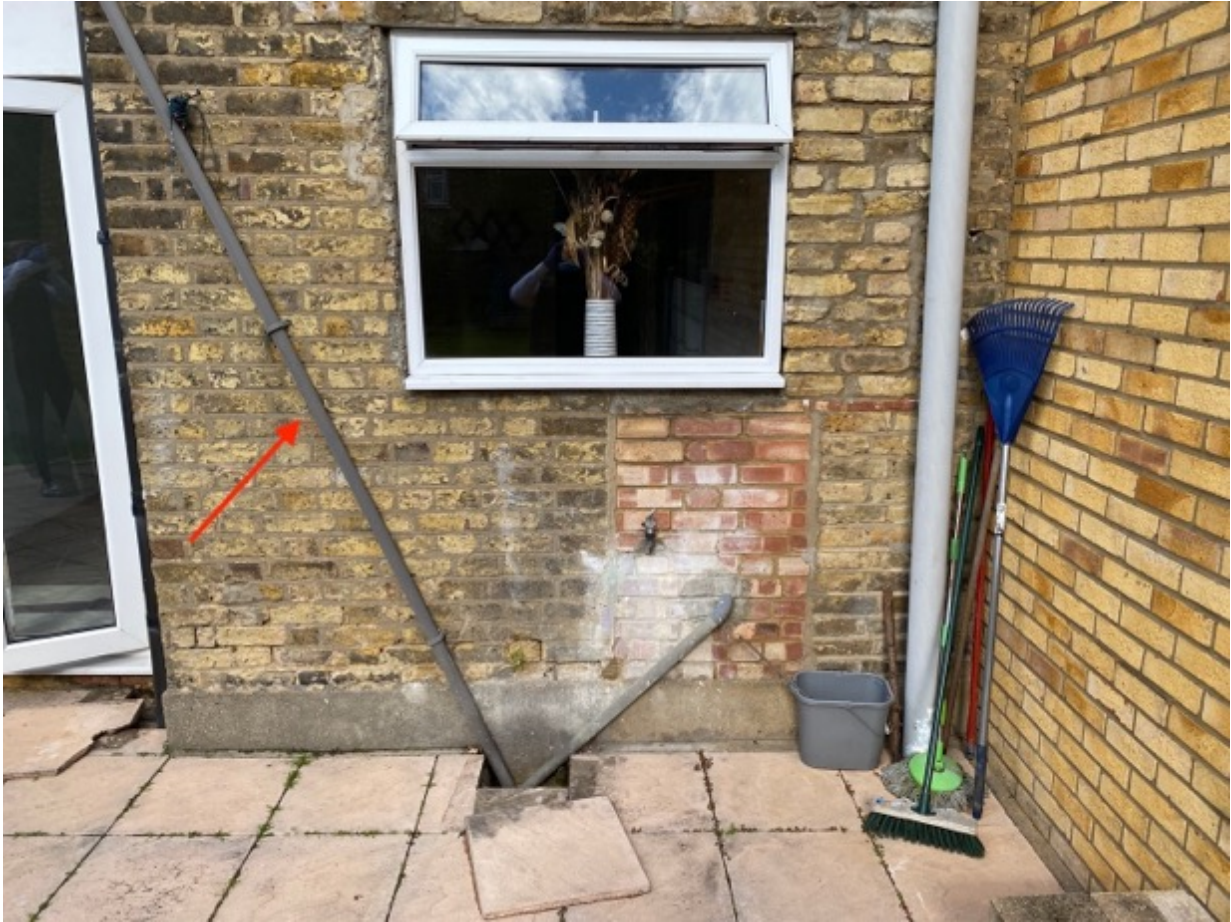
The rear wall of the rear addition has a large diagonal pipe which runs from the upper level and down towards the centre of the rear drainage gulley.

This is an unconventional installation, and I would advise it is modernised to ensure that there is a more properly considered solution.

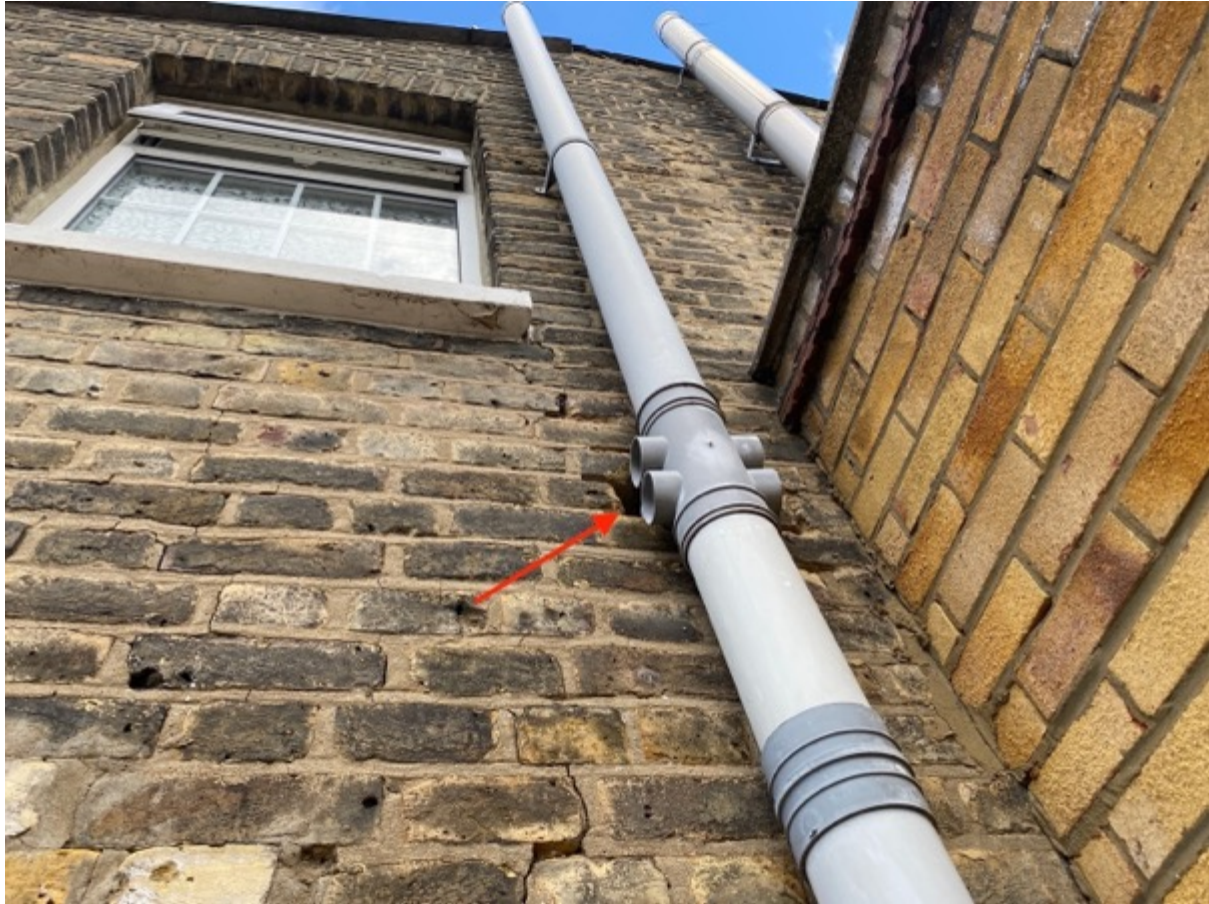
This is both a weather and pest ingress issue and I would therefore advise, prior to proceeding with the property, that this area is suitably filled.

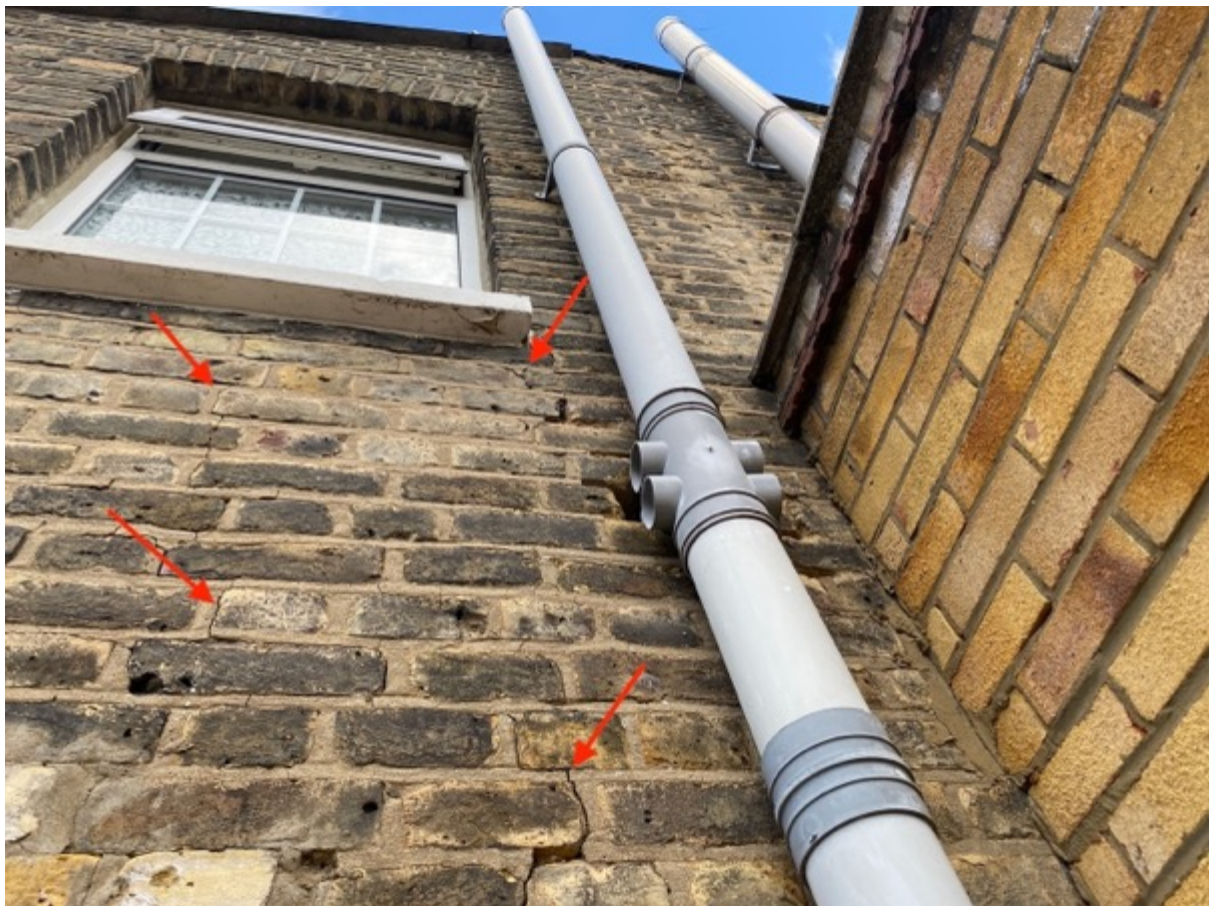
Brickwork to the rear is likewise London stock, towards the rear addition rear wall there are a number of movement cracks to the underside of the first-floor window which run downwards in a diagonal stepped cracking direction towards the flank of the property and the upper right corner of the kitchen window.

These types of cracks are relatively normal and generally speaking the gap between windows at ground and first is a soft spot and is susceptible to movement.

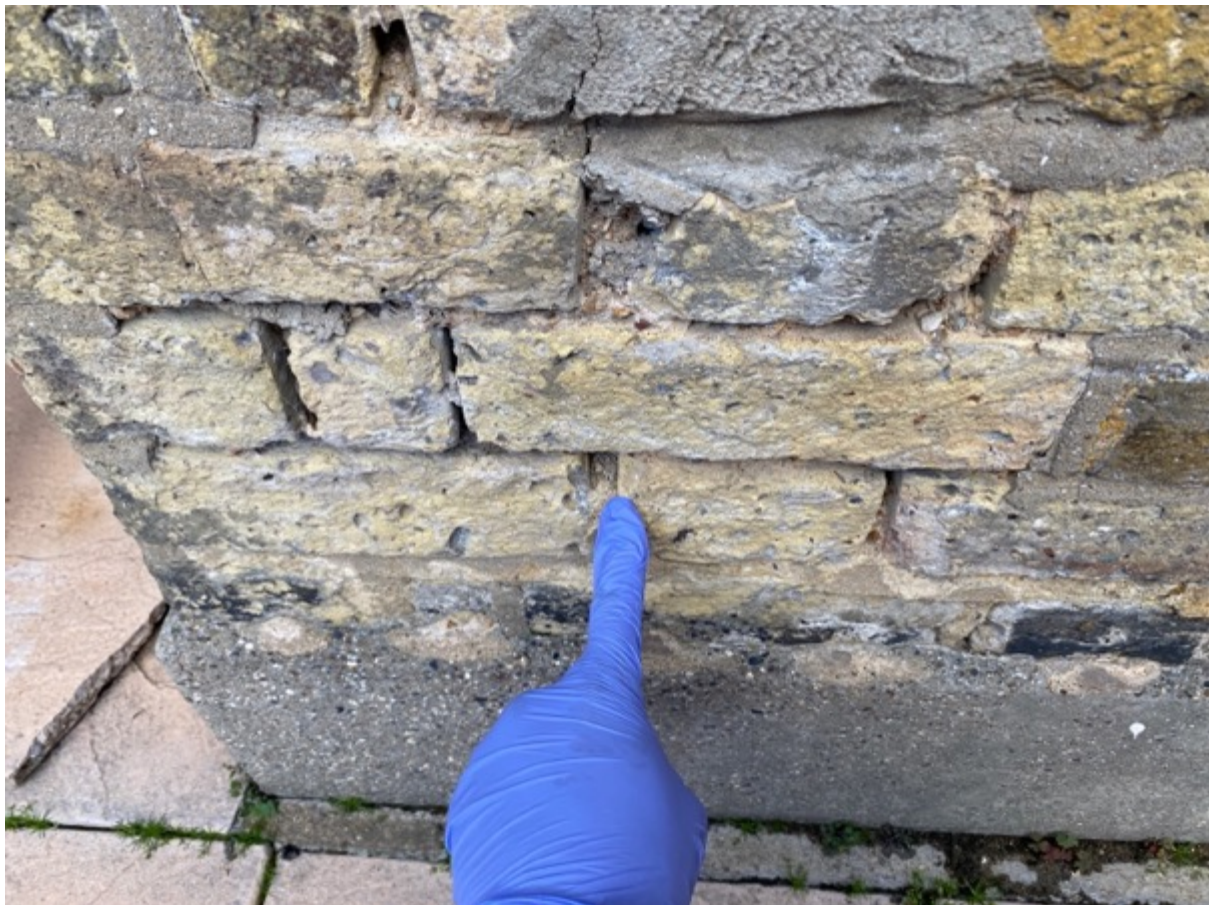
The brickwork to the rear elevation has been re-pointed at some point in the past, however, towards the lower section above the rendered plinth there are areas where the pointing is completely missing and further areas where pointing is popping or chipping away.

Generally speaking, this is usually a sign that the pointing that has been done is insufficient and I suspect in due course defective pointing will need to be raked out and filled to ensure that there is a sound weather break between the external areas of the property and the internal walls themselves.

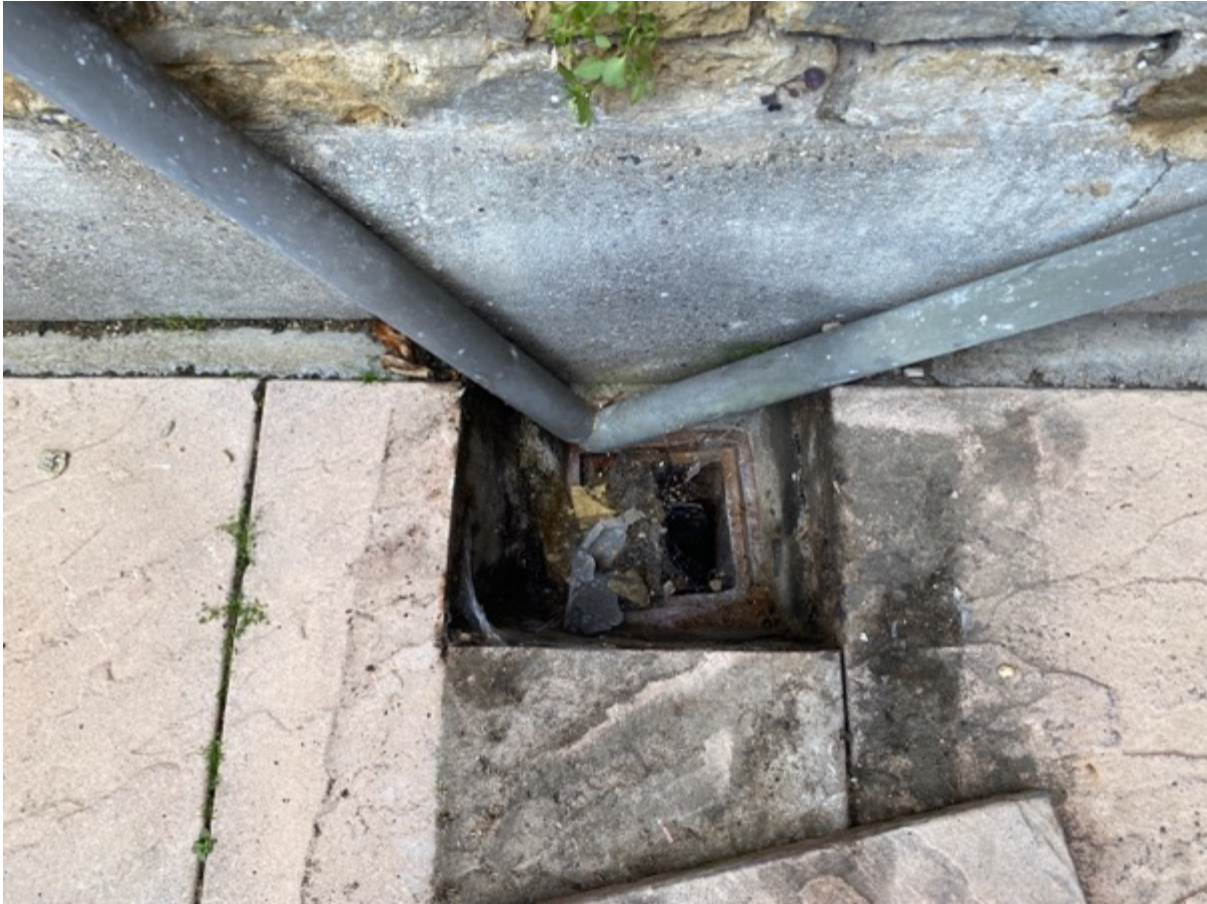
It is also worth noting that during the inspection I noted areas of vegetation and crumbling brick to the head of the drain at the rear.

This whole area will need to be re-pointed as a matter of urgency.

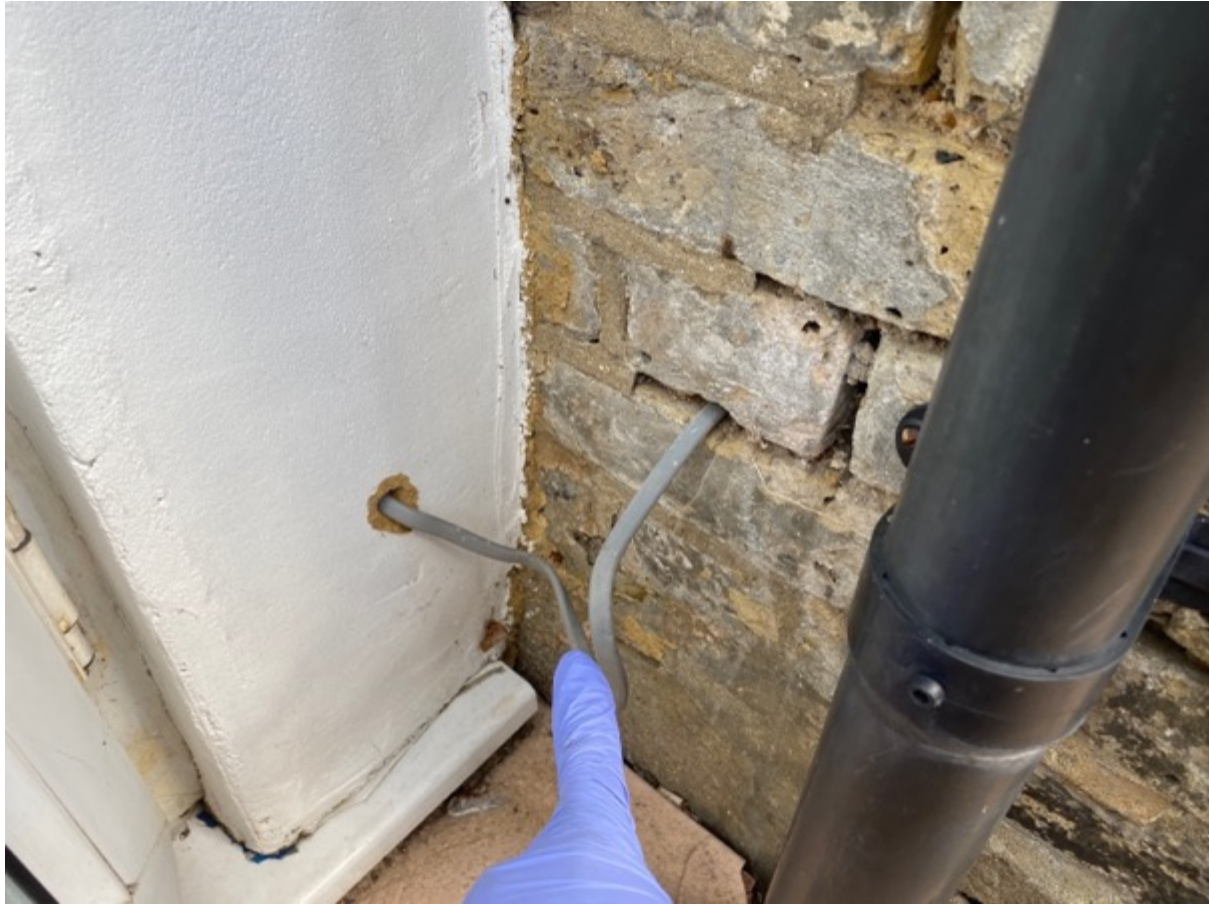
It is also worth noting that on the rear wall of the rear addition there is a drilled pole through the lower right corner whereby a wire is protruding and then running back into the flank wall of the kitchen itself.

This would not be Health and Safety or Building Regulations compliant as the wire can be pulled and moved, and I would advise that this is either boxed in, trunked in or the conventional wires are run through the internal voids of the property.

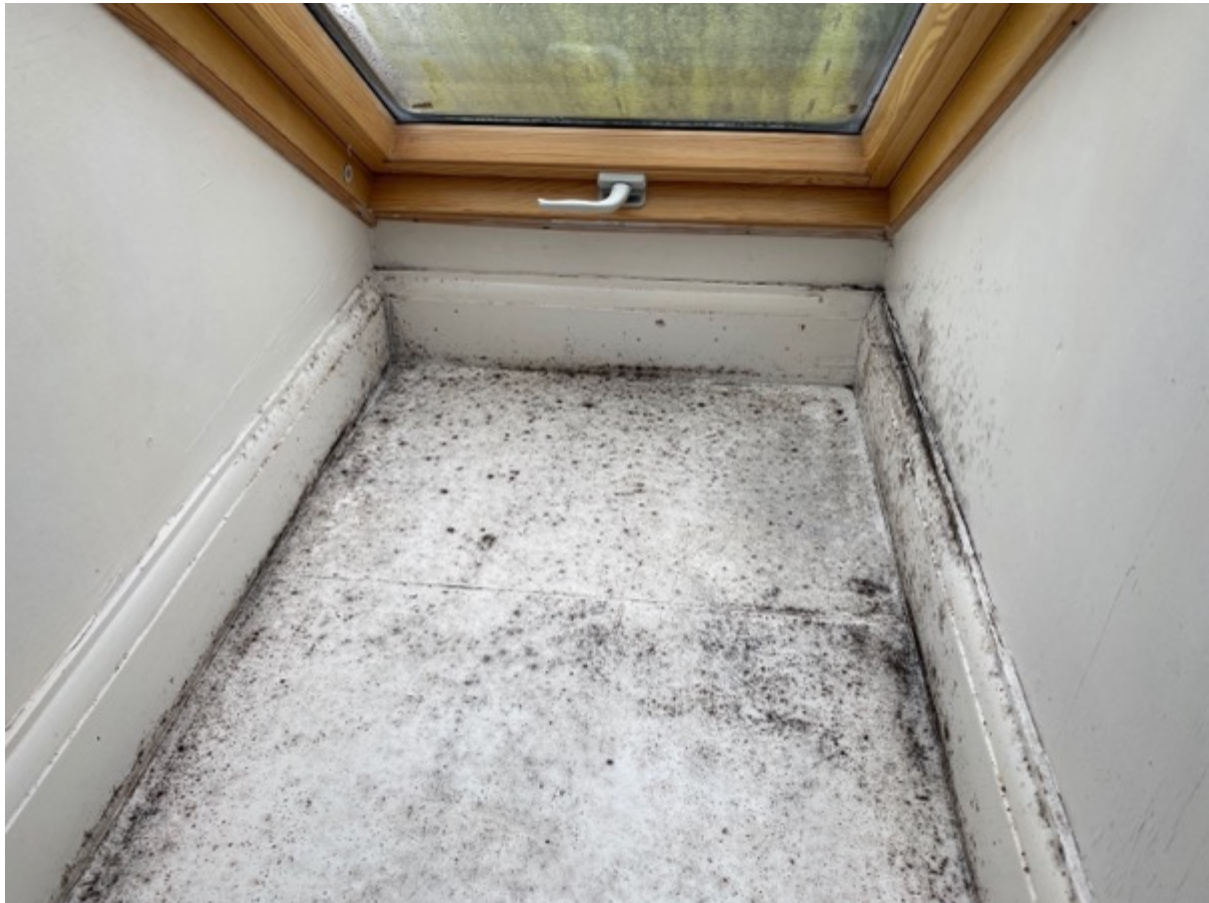
D5 Windows:

Windows are uPVC double-glazed type. To the window in the kitchen, the opening and closing lever catches on the underside of the window frame itself and will likely need to be adjusted. To the remaining windows the seals themselves are towards the end of their lifespan and I suspect will start to fail in the coming future.

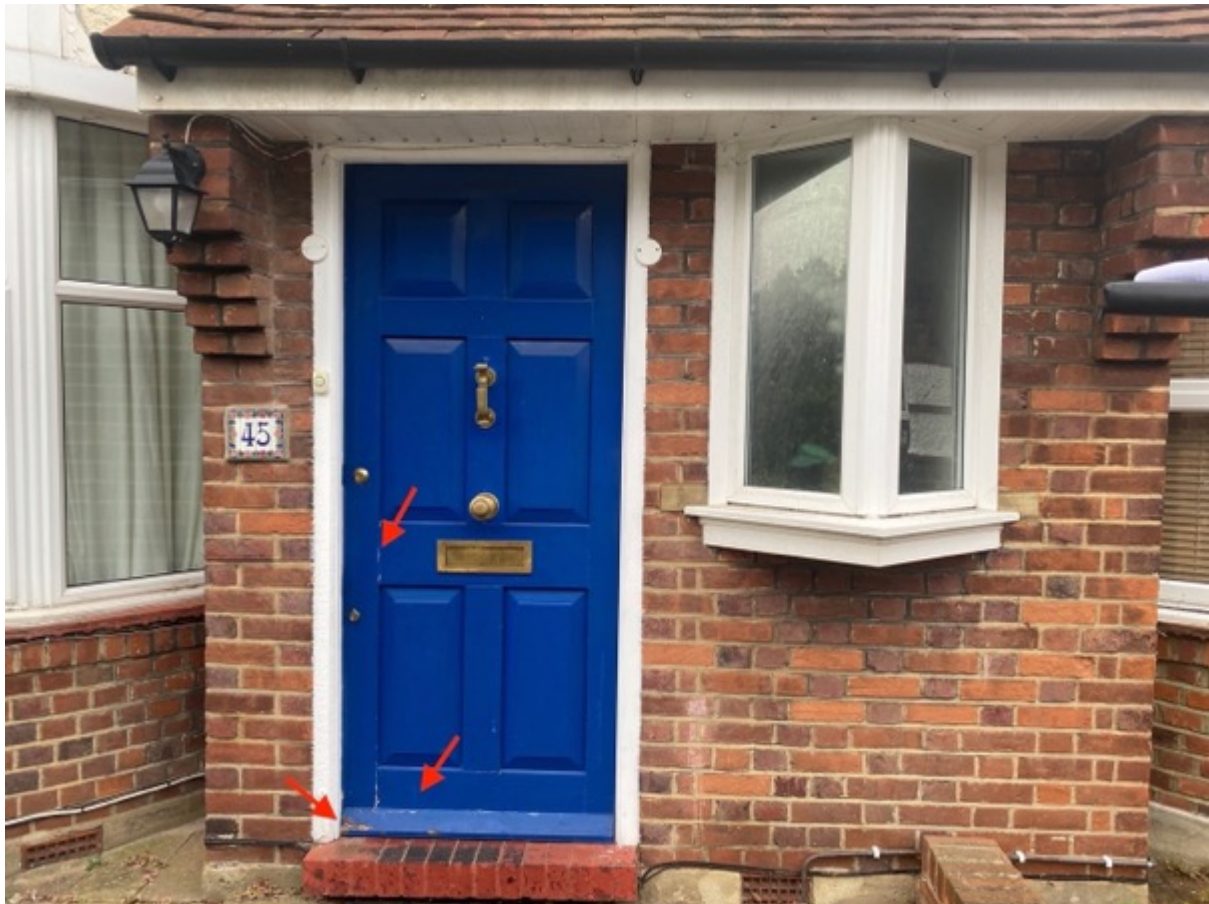
The front door is a uPVC double-glazed type, when the door opens and closes, the latch does not catch which means that the door needs to be manually locked internally via lifting the handle and turning the deadbolt.

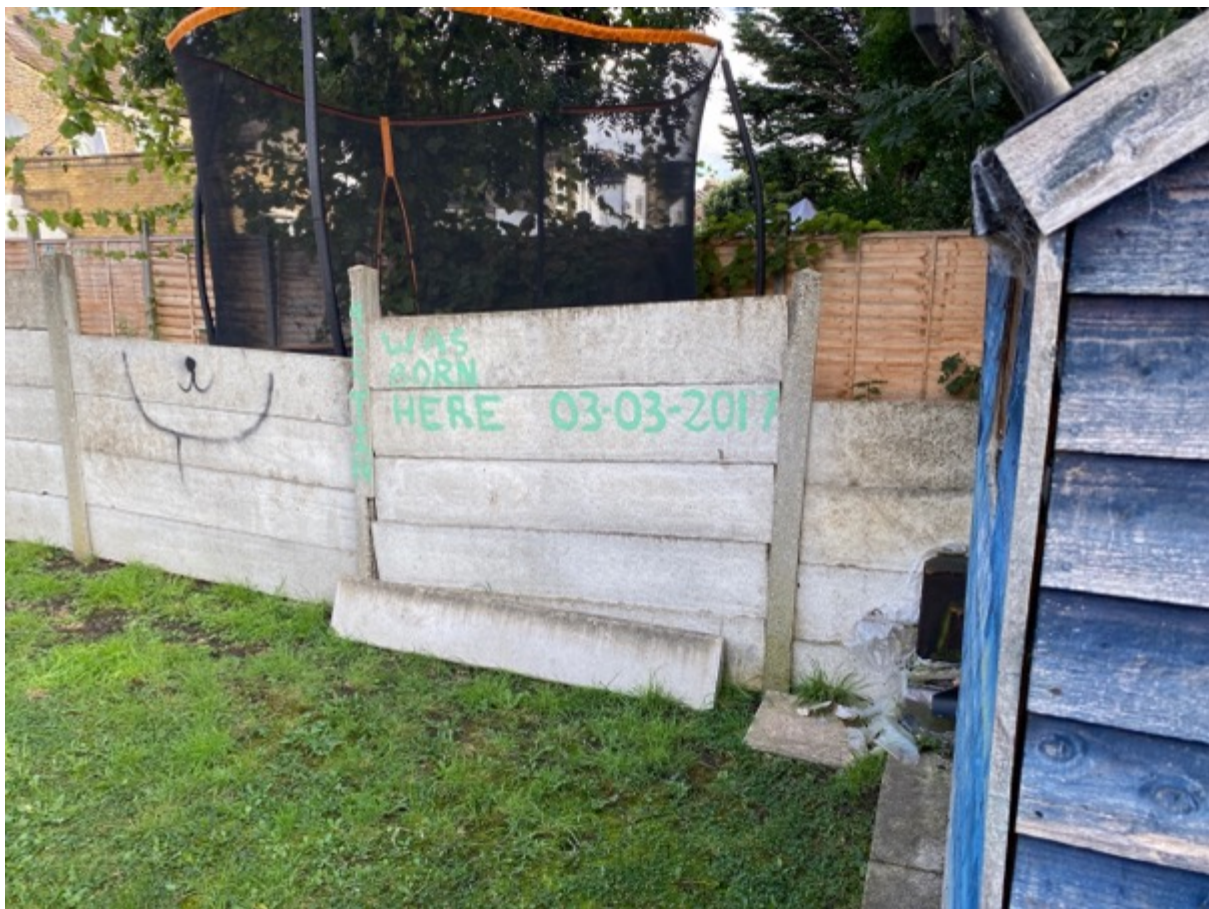
Fences towards the rear garden are a mix of concrete panels and concrete posts and concrete posts and timber panels. Overall, the fences themselves are out of alignment and with a number of panels having failed.

The fences to both the left and right sides appear to also meander both on and off the boundary wall and I would therefore advise making enquiries as to whether there have any boundary line disputes in the past.

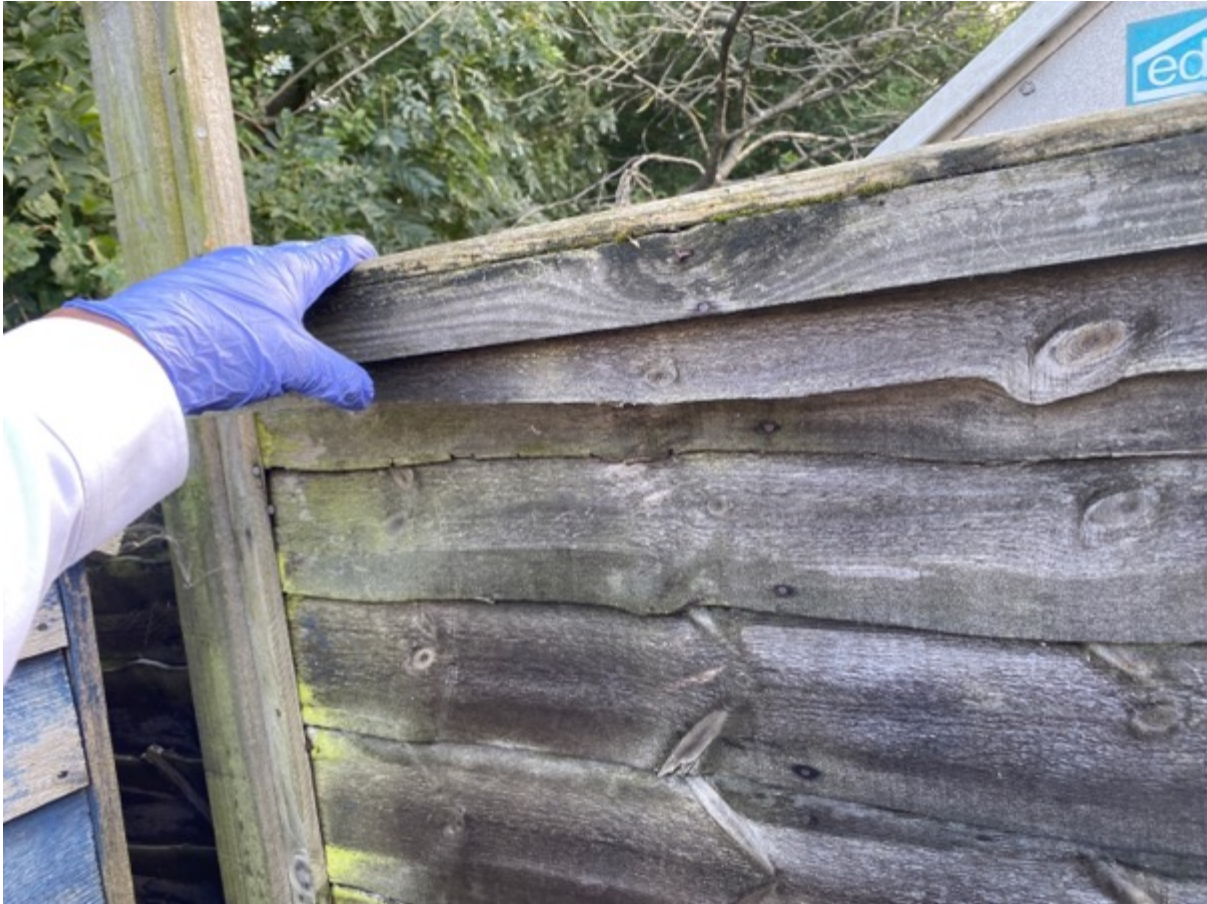
The fence panels themselves have completely failed and are significantly suffering from weather ingress, these will need to be replaced in the immediate future.

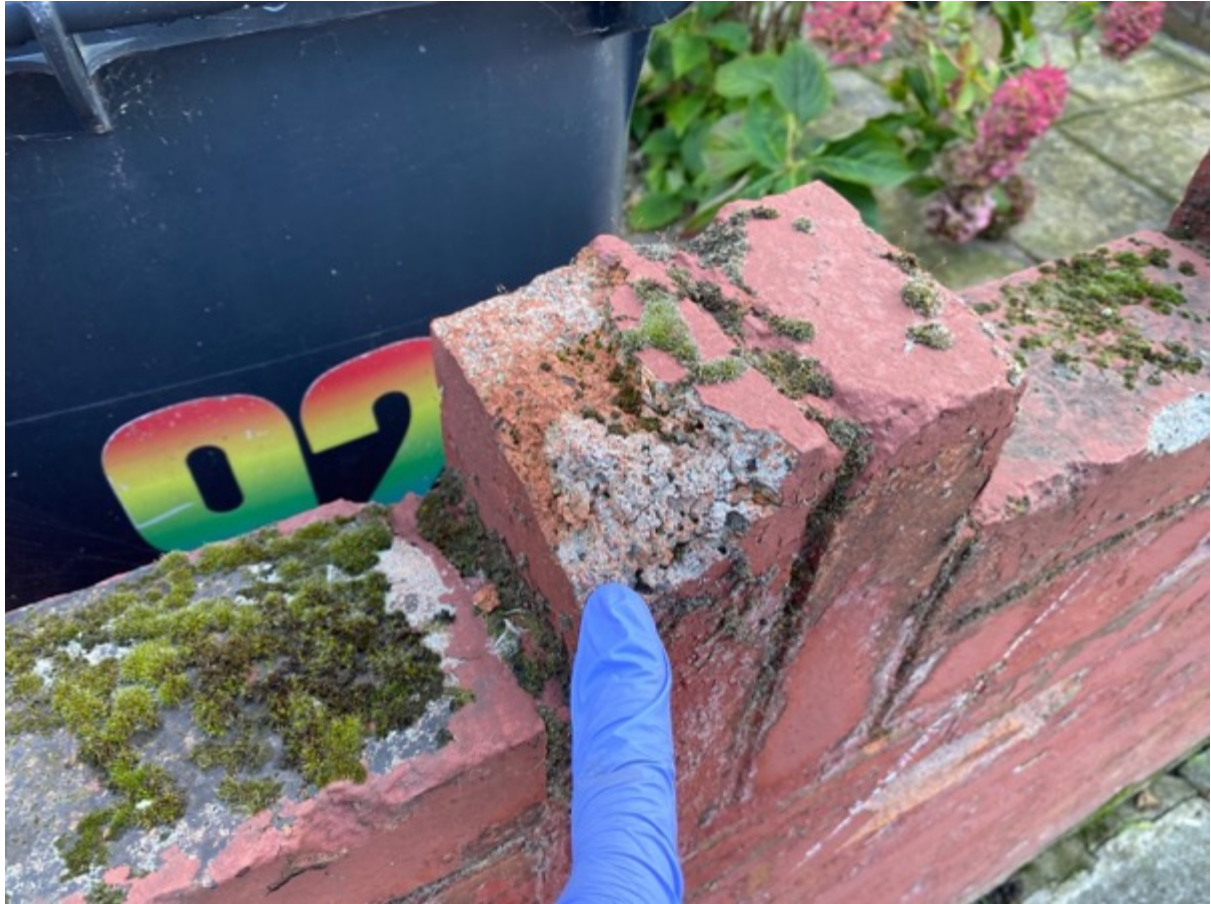
The boundary wall towards the front of the property adjoining the street is of the same single skin brickwork construction with bricks suffering from spalling and weather ingress intermittently throughout.

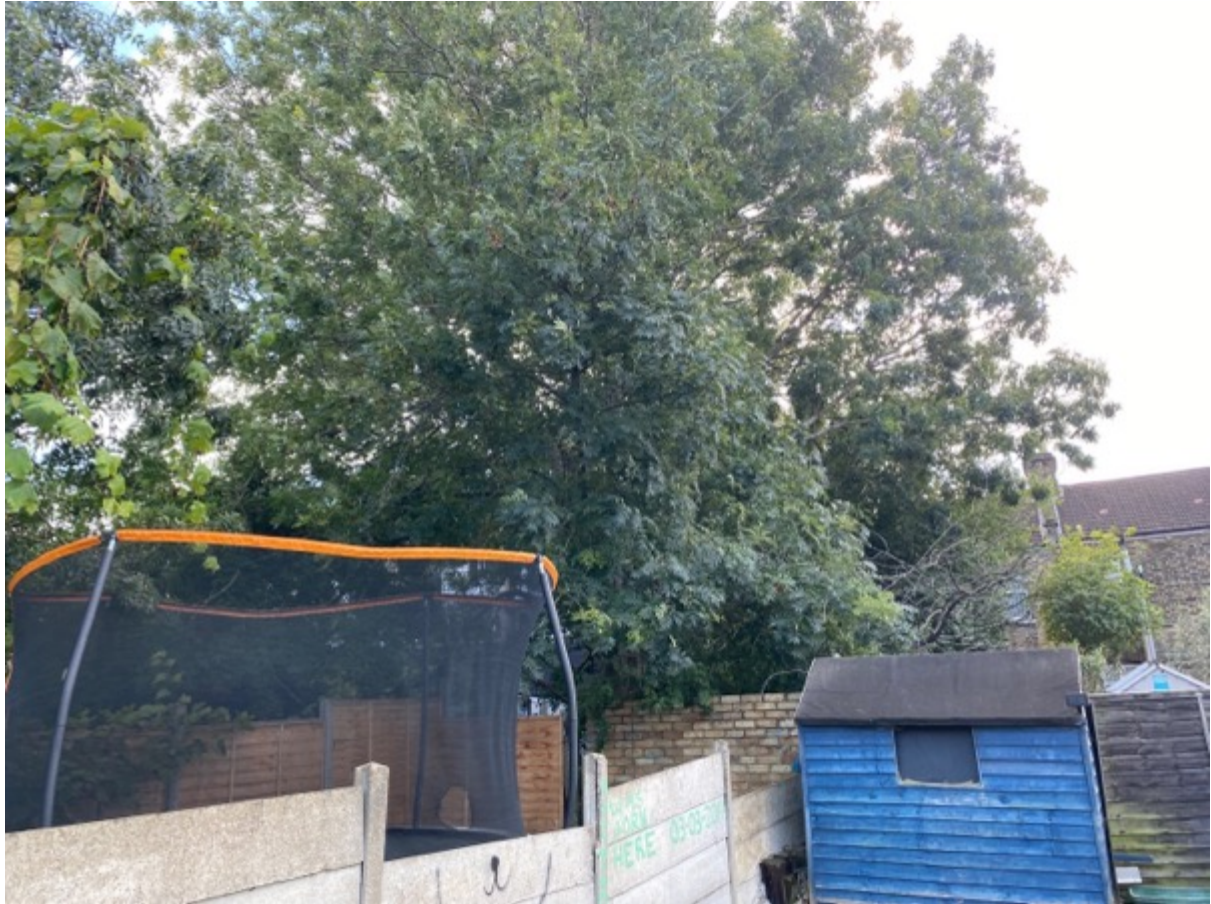
It is also worth noting that there is a very large tree towards the rear of the property's garden to the left of the subject property.

A tree of this height and stature will likely be drawing significant levels of moisture from the soil each and every day and therefore, should you proceed with the property, I would advise that you make your insurer aware of the presence of this tree so that they can take that into account.

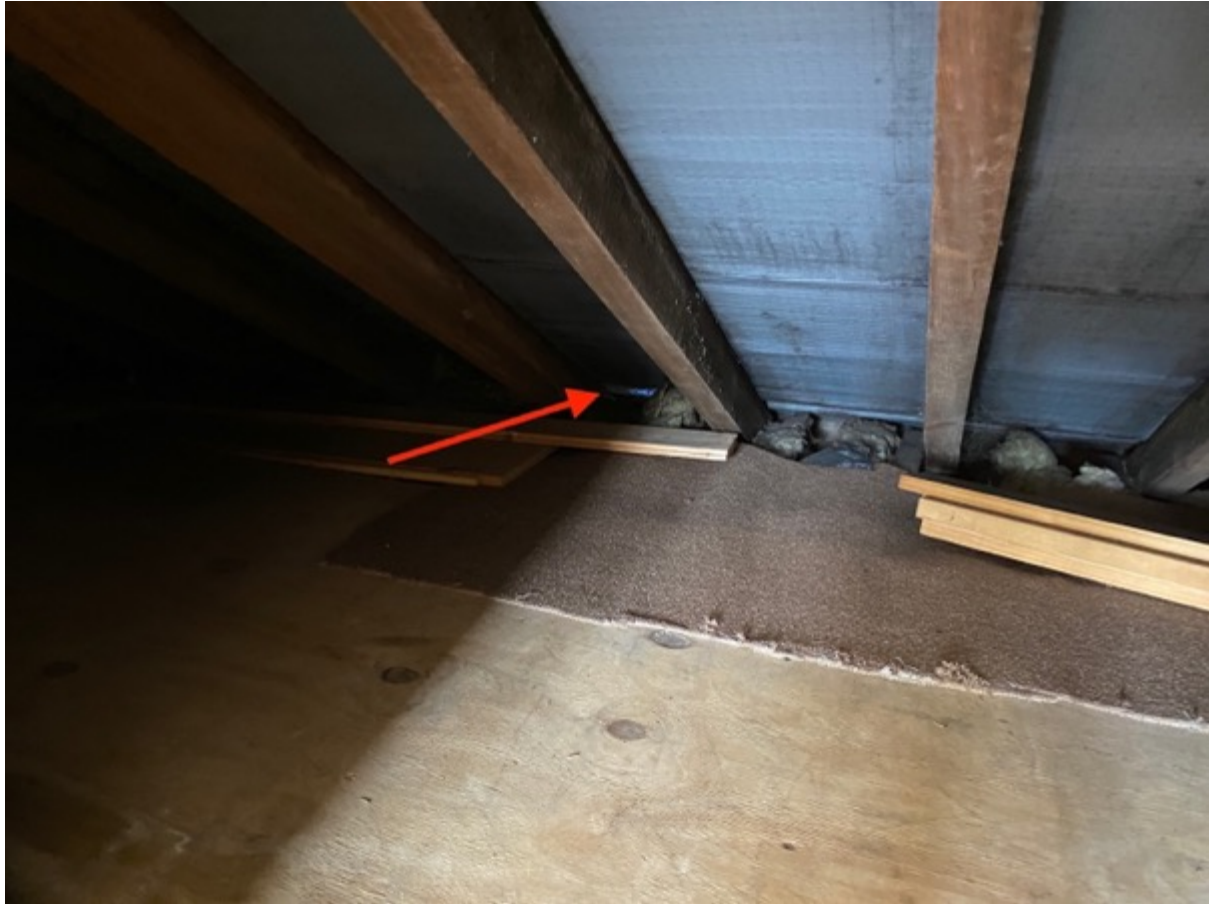
Within the eaves itself I was able to note that there is a sarking felt beneath the tiles and there were also signs of light coming through which is not ideal as it likely means that some tiles have become undulated and are sitting proud.

This could result in pest ingress and weather ingress and therefore I would advise that a competent roofer inspect this area to ensure that the tiles are properly laid and level throughout.
