RICS Full Building Survey Report

(Level 3 Survey)

Full Property Address:

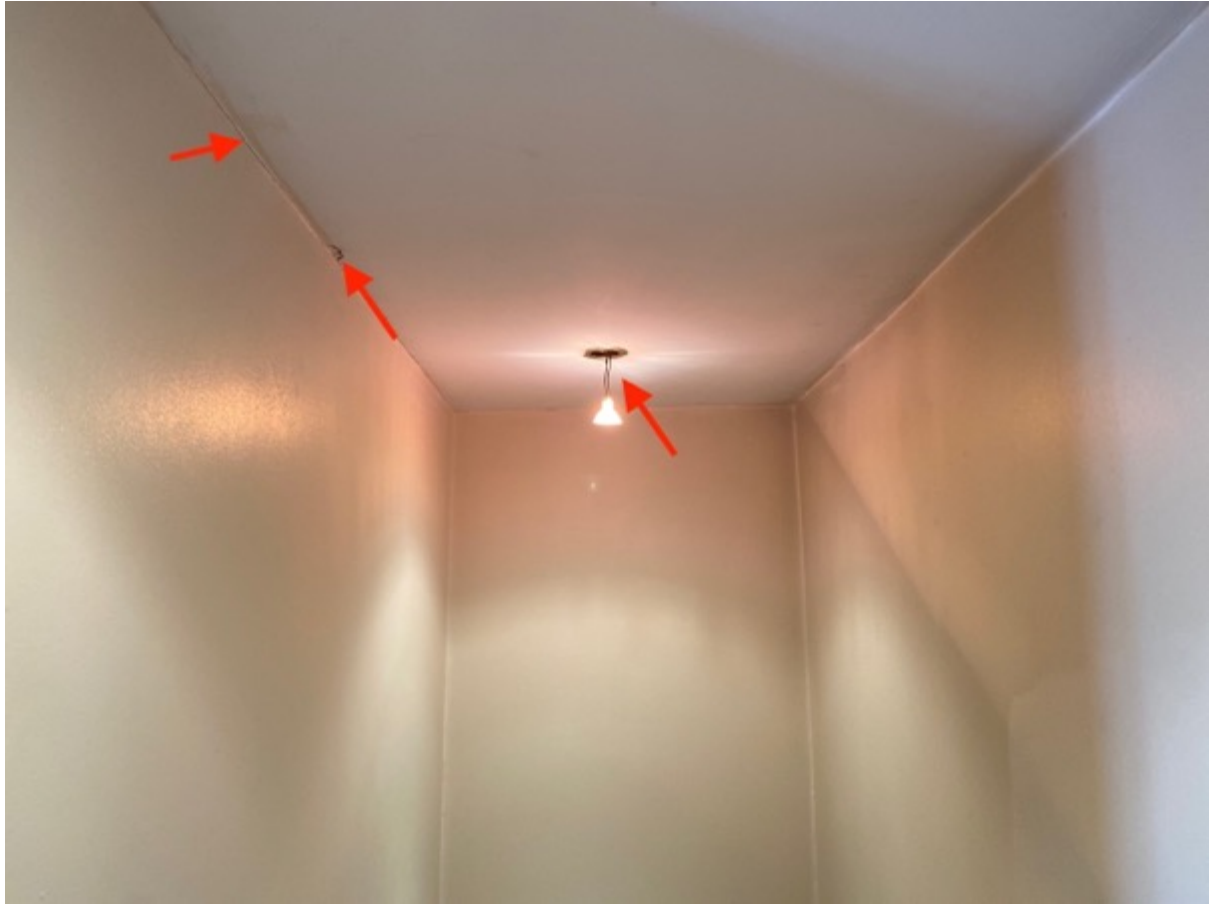
There were some signs of historic popped fixings/screws or nails as well as light separation cracks noted to the junction of one board to another.

These are all relatively normal decorative defects and will need to be addressed through the normal course of painting and upkeep.

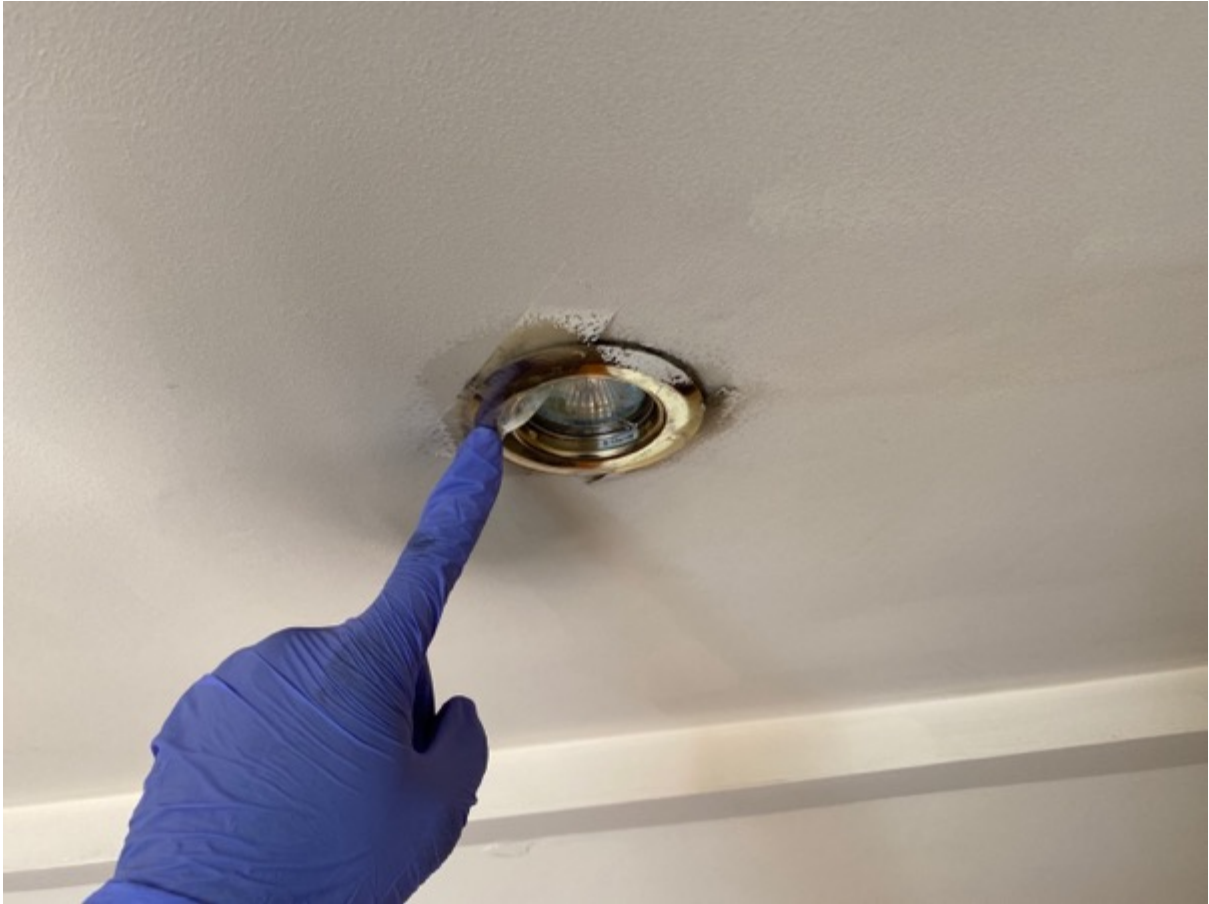
The spotlights within the loft room are taped and sellotaped in place meaning that the clips holding the spotlights in place have likely failed and will need to be replaced.

It is also worth noting that the light fitting towards the centre of the room projects from the ceiling itself meaning that for anyone in the region of 1.7m to 2m high they will have to lower their head, or travel around this light fitting.

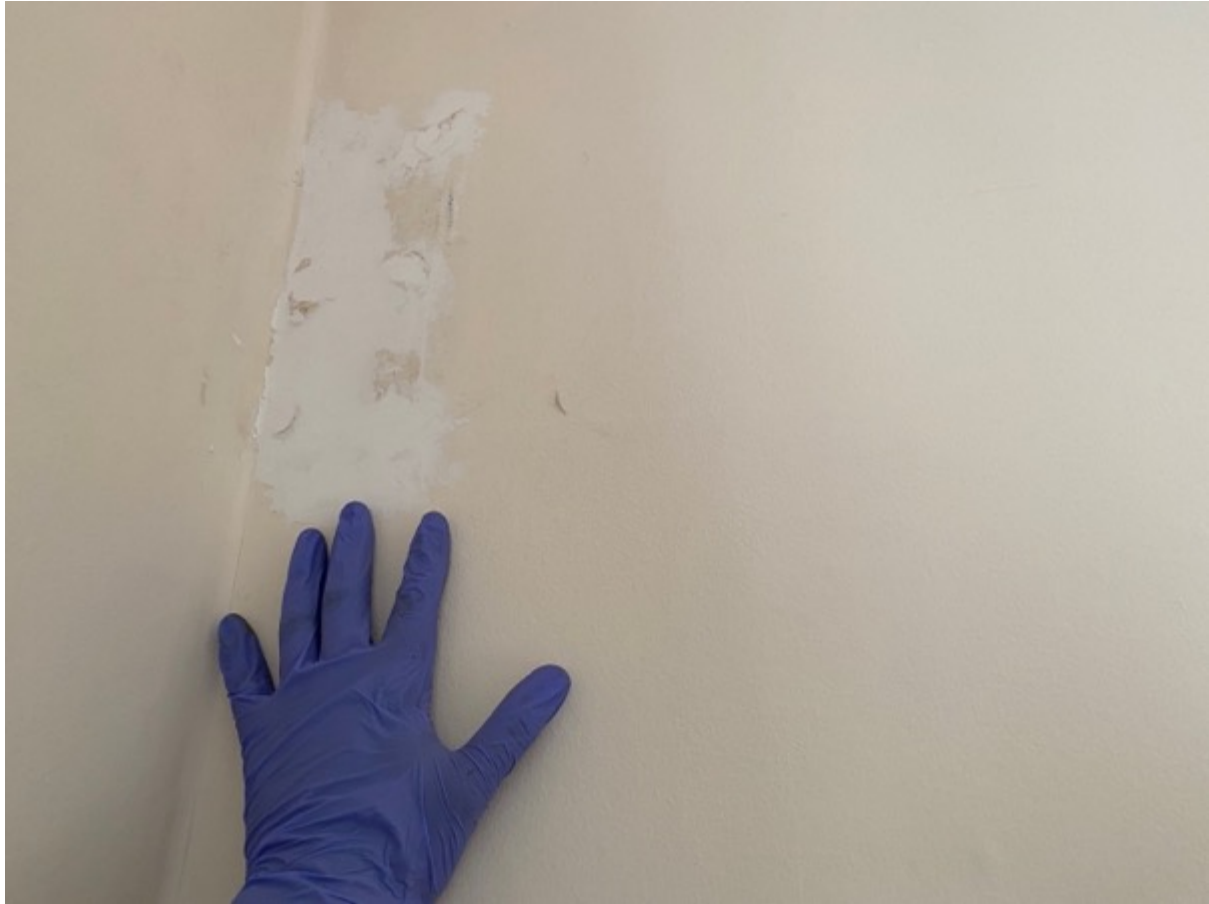
The rear chimney breast in the kitchen has been removed and it appears to be supported by a gallows bracket which is likely plaster boarded and skimmed over, I would advise making enquiries as to whether the necessary Building Regulations consents were in place in this regard and also the necessary Party Wall permissions and consents in regard to the property that this chimney breast adjoins.

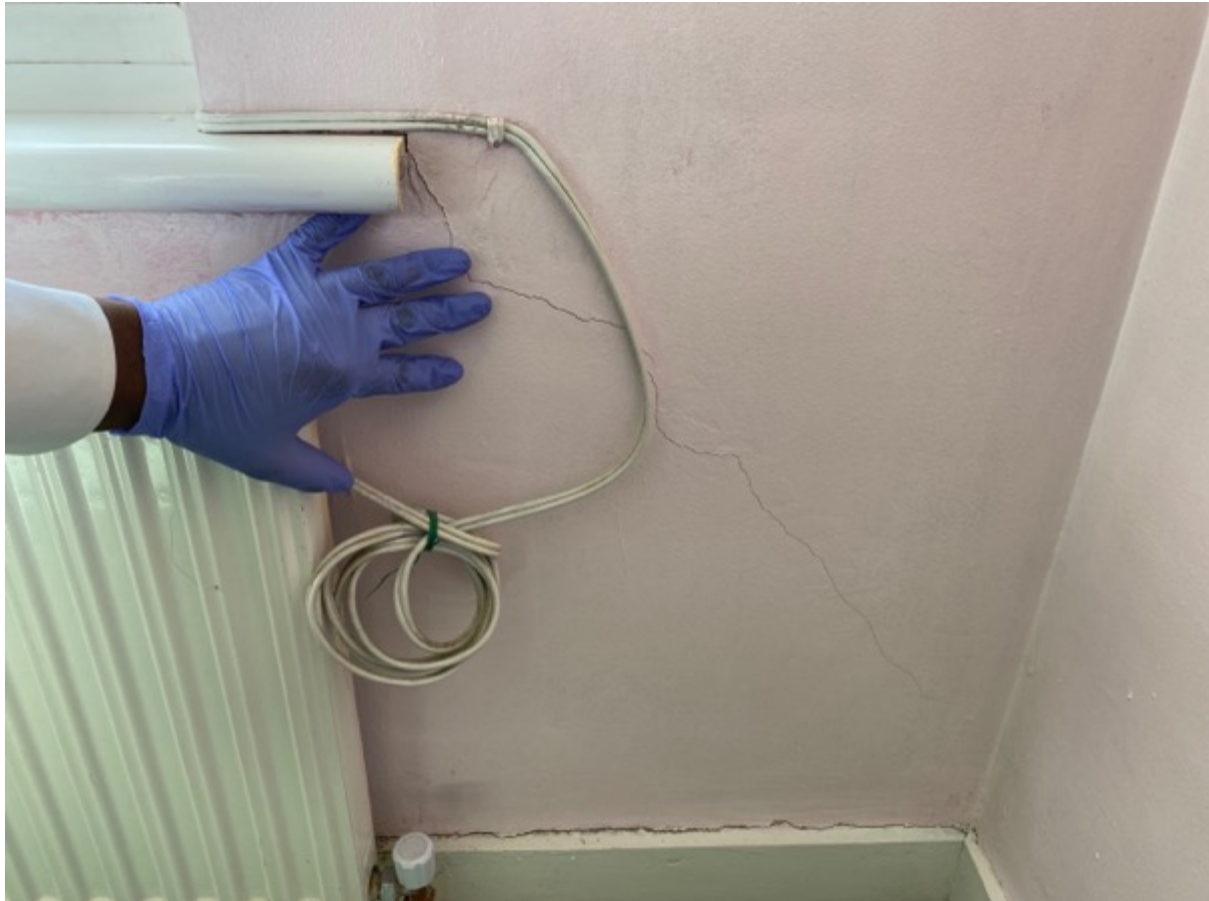
Cracks of this nature are relatively common and to be expected in a property of this age, however, I would advise making enquiries as to when this room was decorated as the crack itself pops and penetrates through the decoration and that would be a very good way to ascertain how recent and modern this crack is.

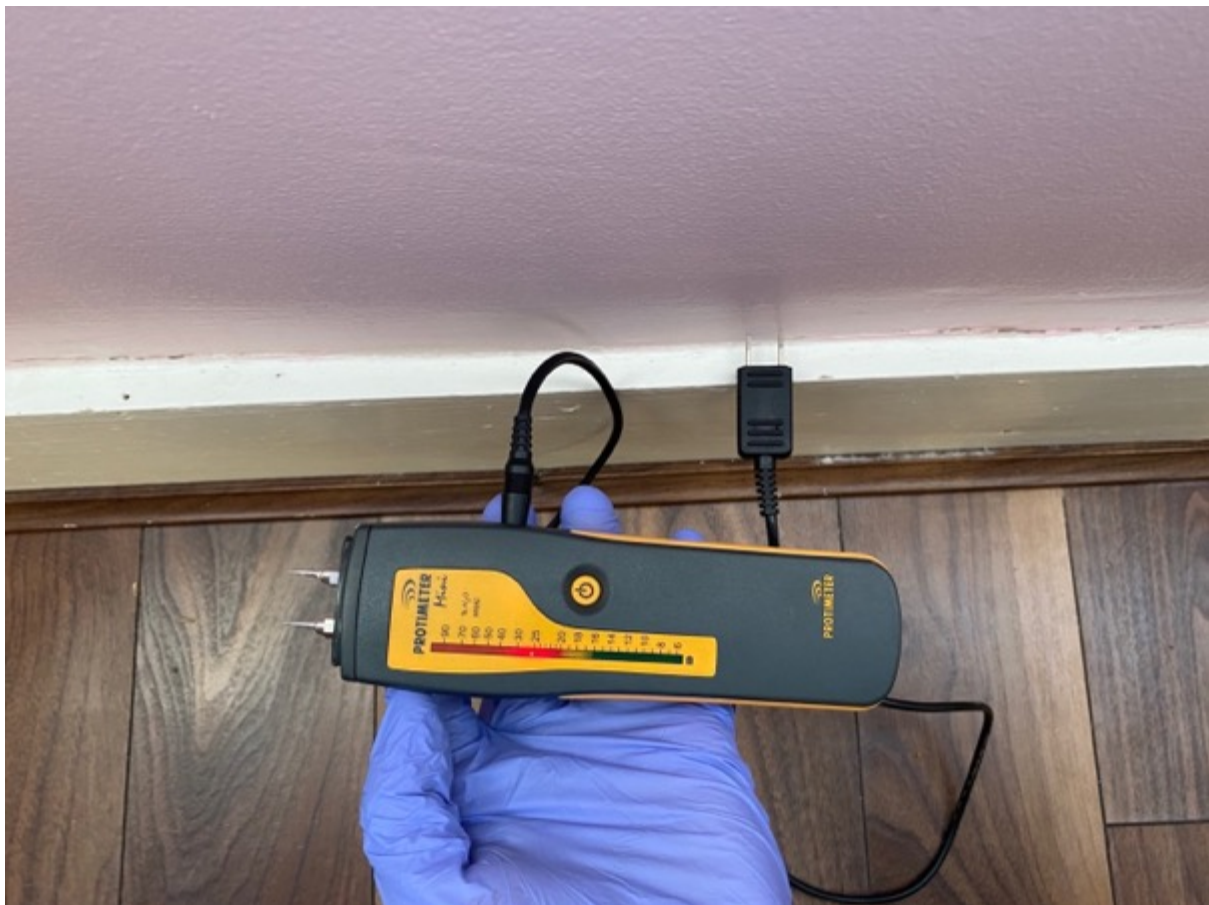
A red reading on the Protimeter confirms that the percentage level of moisture within the wall is at the higher end of the spectrum and in this case, I suspect the damp penetration is a result of the bridging of the damp proof course.

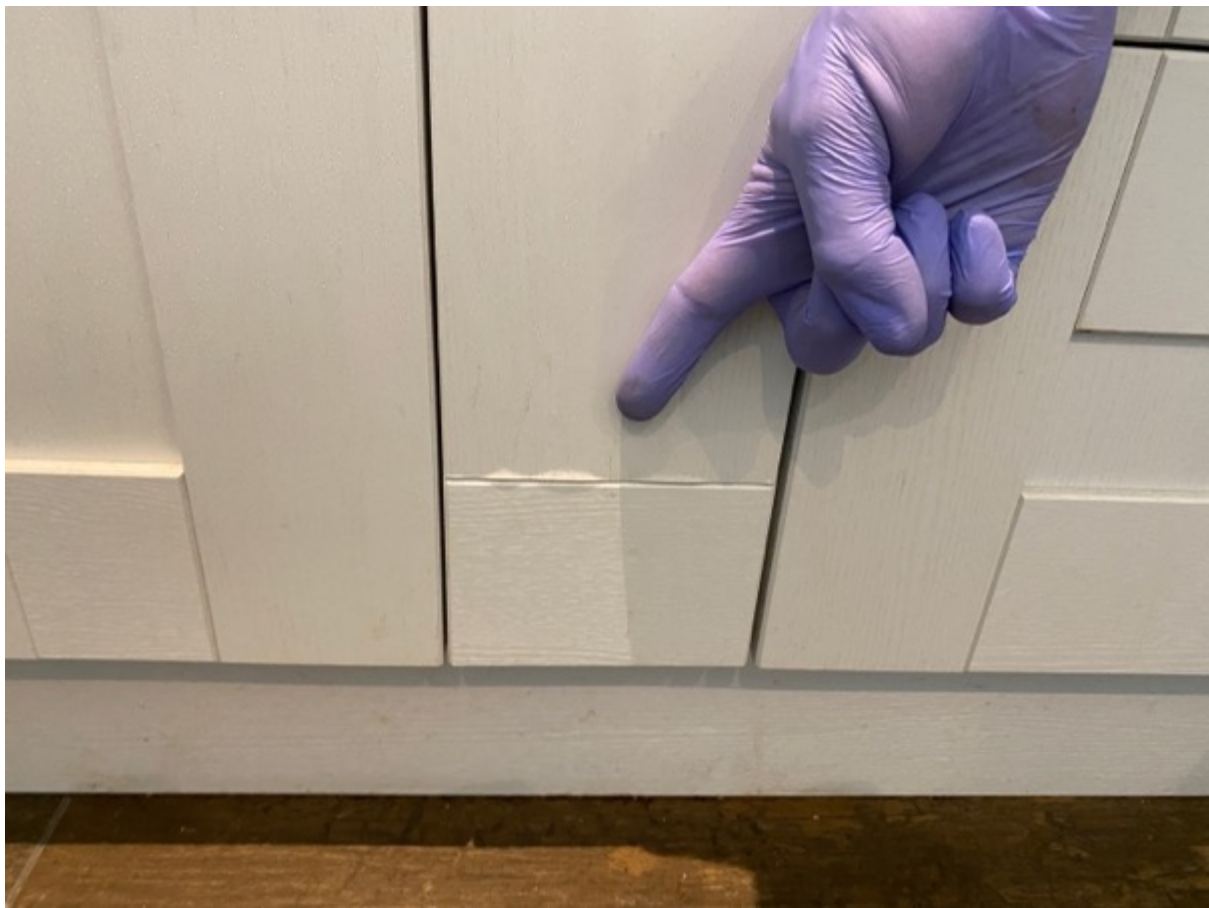
This is likely a manufacturer's error, and you could find that in due course further areas of the kitchen will likewise peel and raise in this manner and therefore you may want to consider that in respect of any Warranties that may exist.

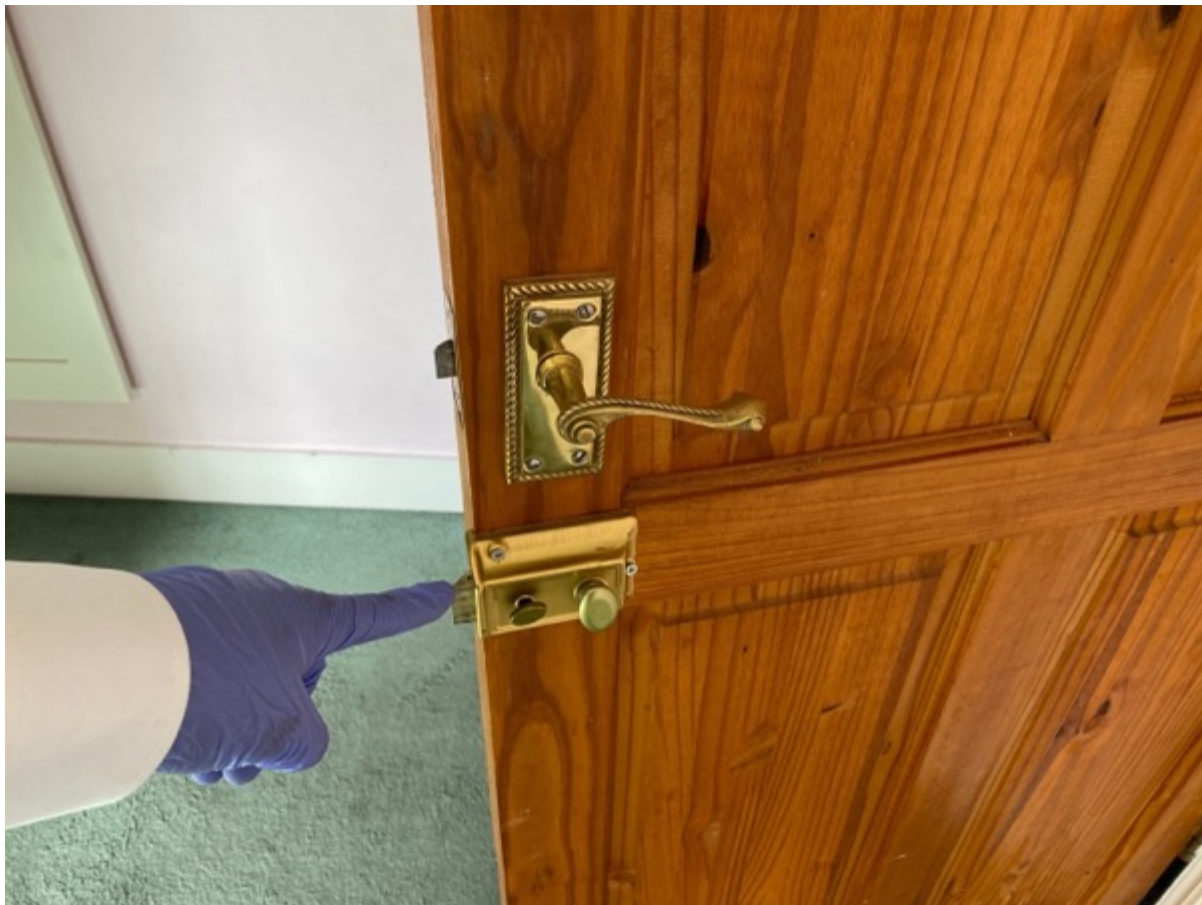
This is a relatively unconventional installation for a house, and it is likely that at some point in the past this property was a flat share or joint occupancy property. In any event, should you proceed with the property, I would advise that the locks are removed so that the property can be used in a conventional way.

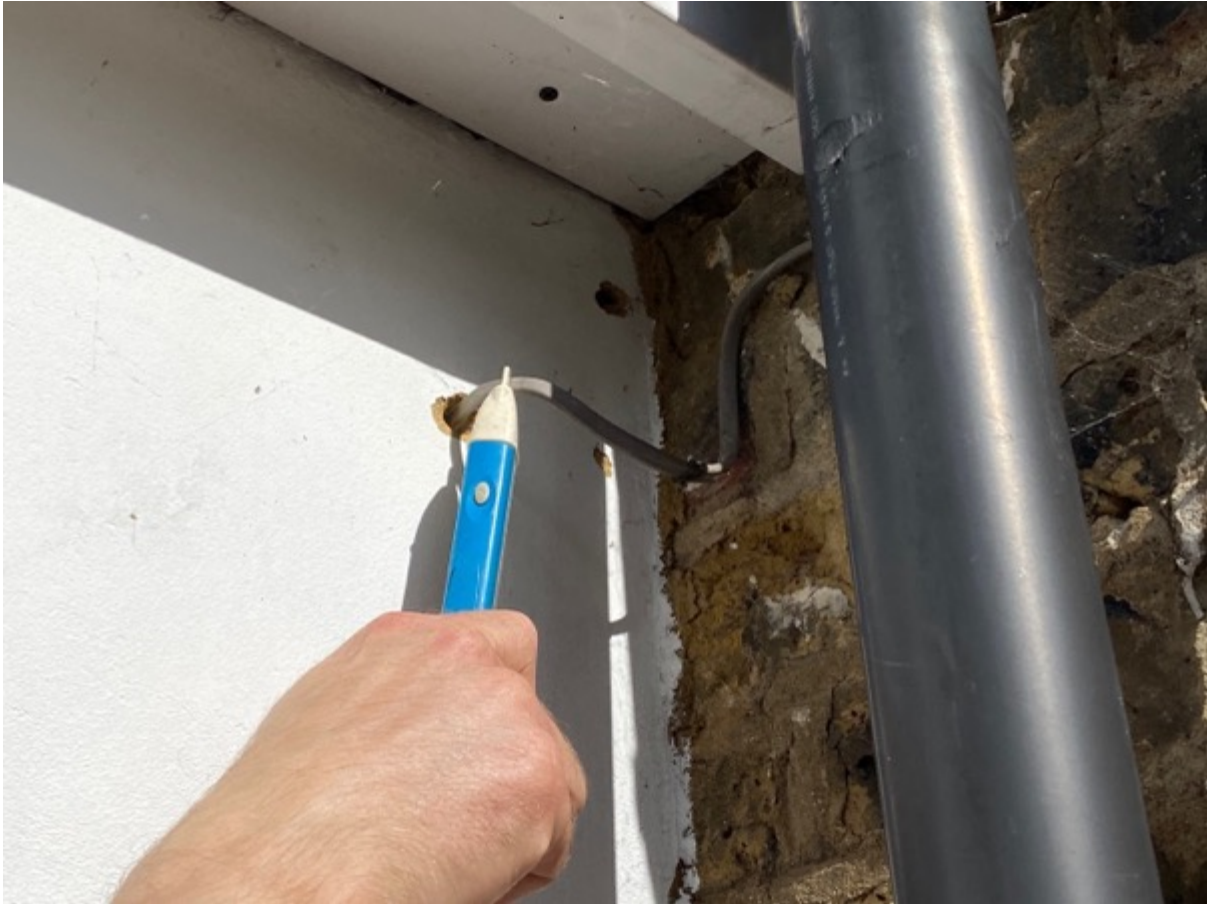
As previously advised, I would suggest that these are correctly installed and trunked in or alternatively, run internally to avoid a health and safety issue. It is worth noting that within the property there are a number of electrical sockets which are installed in unconventional places and at unconventional heights such as the flank of the chimney breasts.

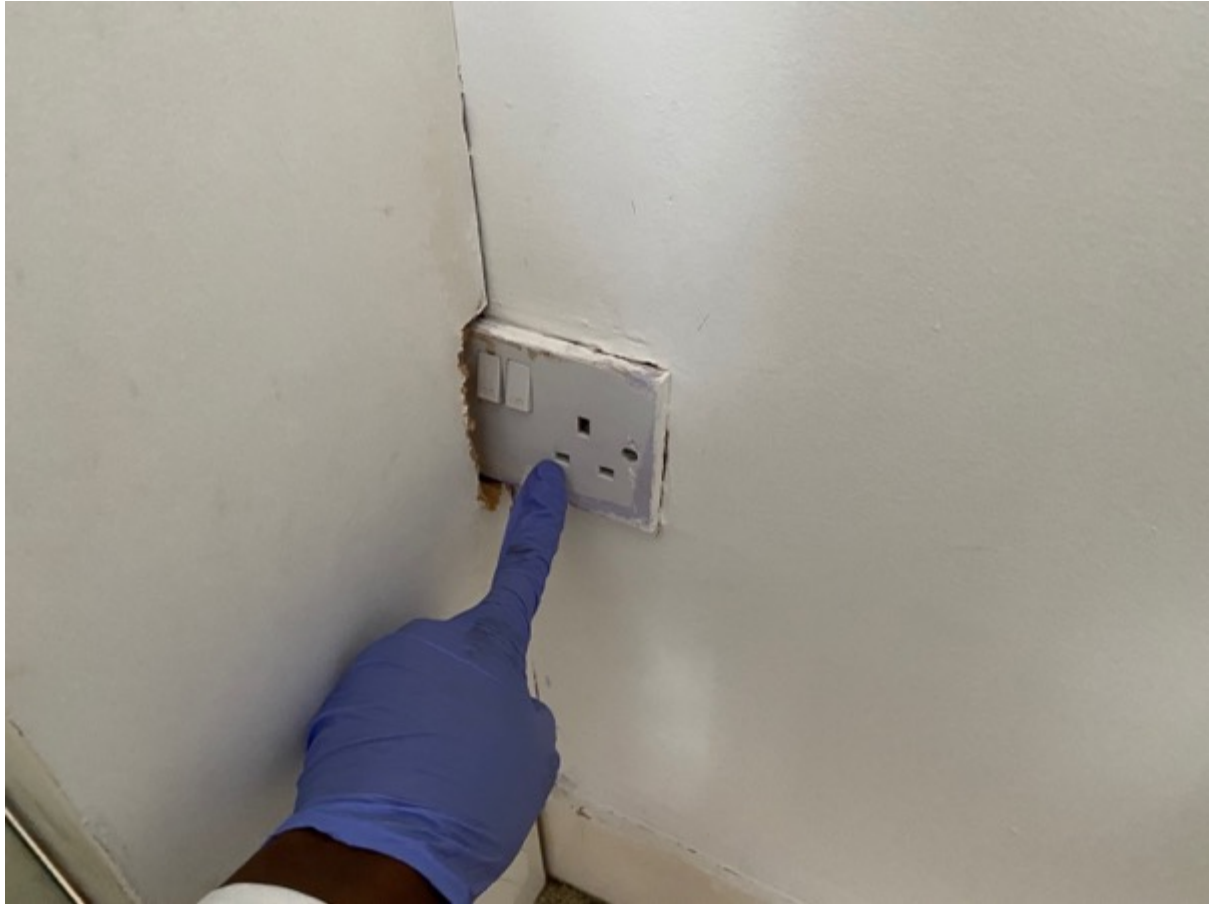
This would not be health and safety compliant and in any event, would mean that there are insufficient sockets within the front bedroom area and therefore to accommodate modern day use you will need to have further electrical sockets installed.

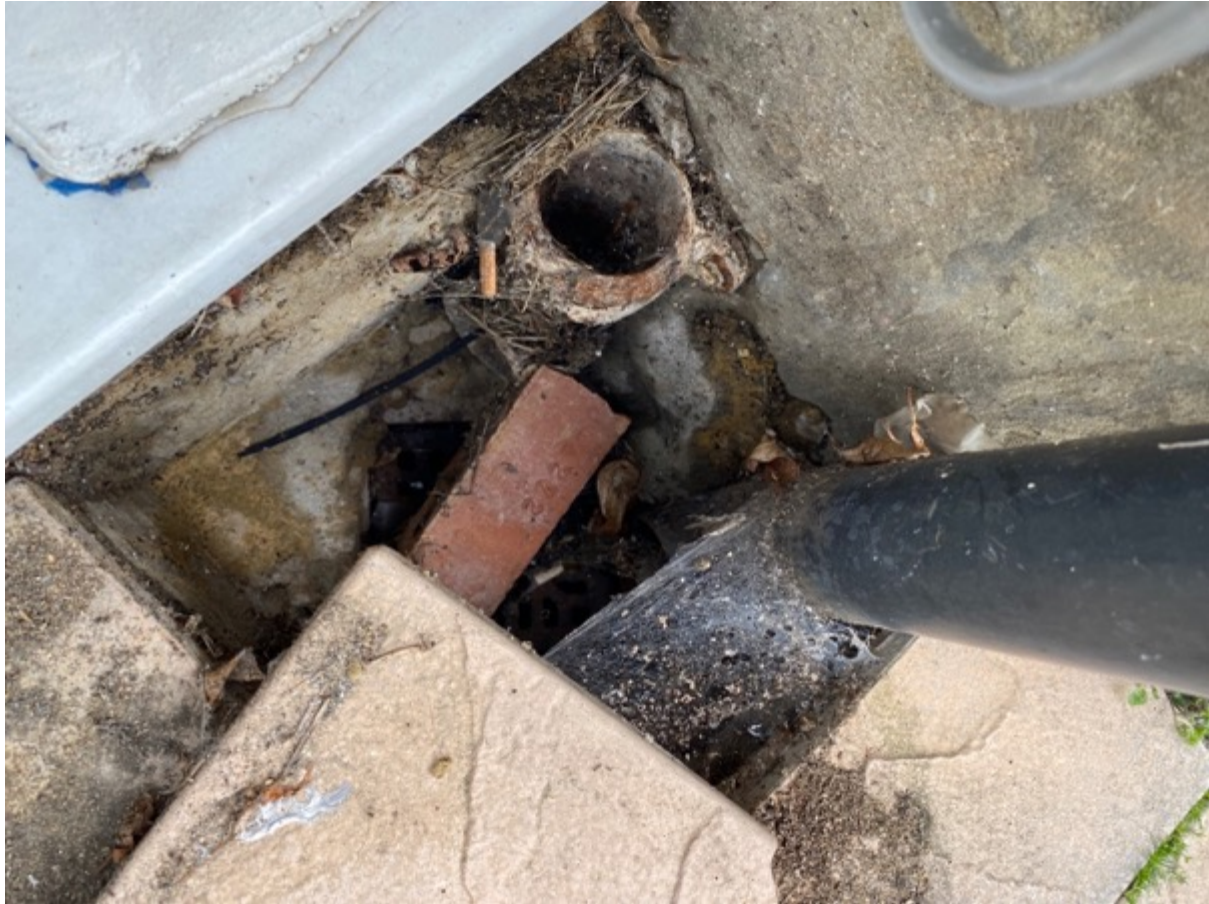
This is a slightly unconventional finish and generally speaking, they should be covered with a grate or drain cover.
