## **RICS HomeBuyer Report:**

Address of Purchase Property

## **RICS Home Surveys RICS HomeBuyer Report**

**00-00-0000**

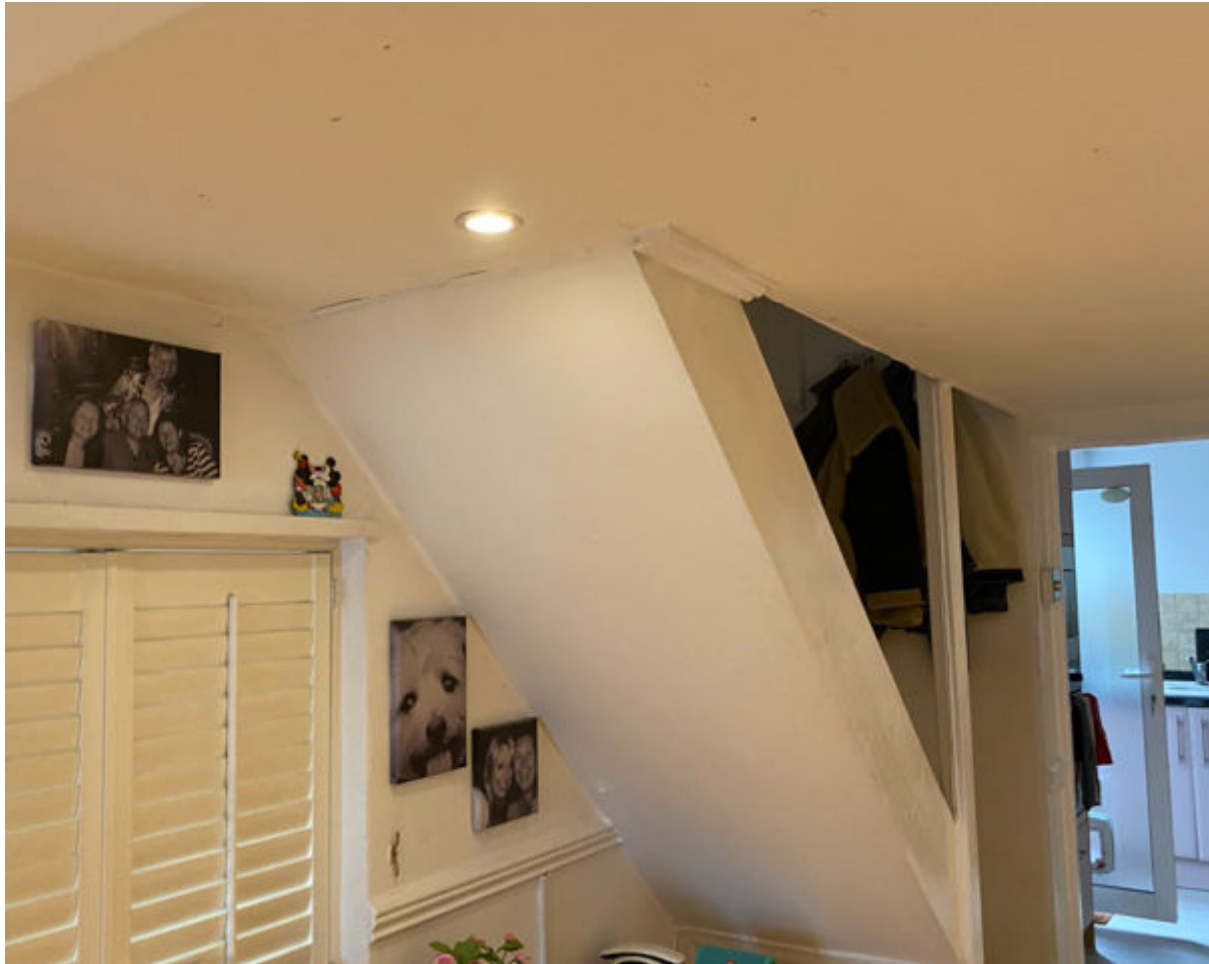
## F7 Woodwork (e.g. Staircase and Joinery):

### Staircase

The staircase is a timber type. There are no spindles running down the flank of the stair which could be a safety issue for smaller children.
