Building Survey Report

Building Survey Report Contents:

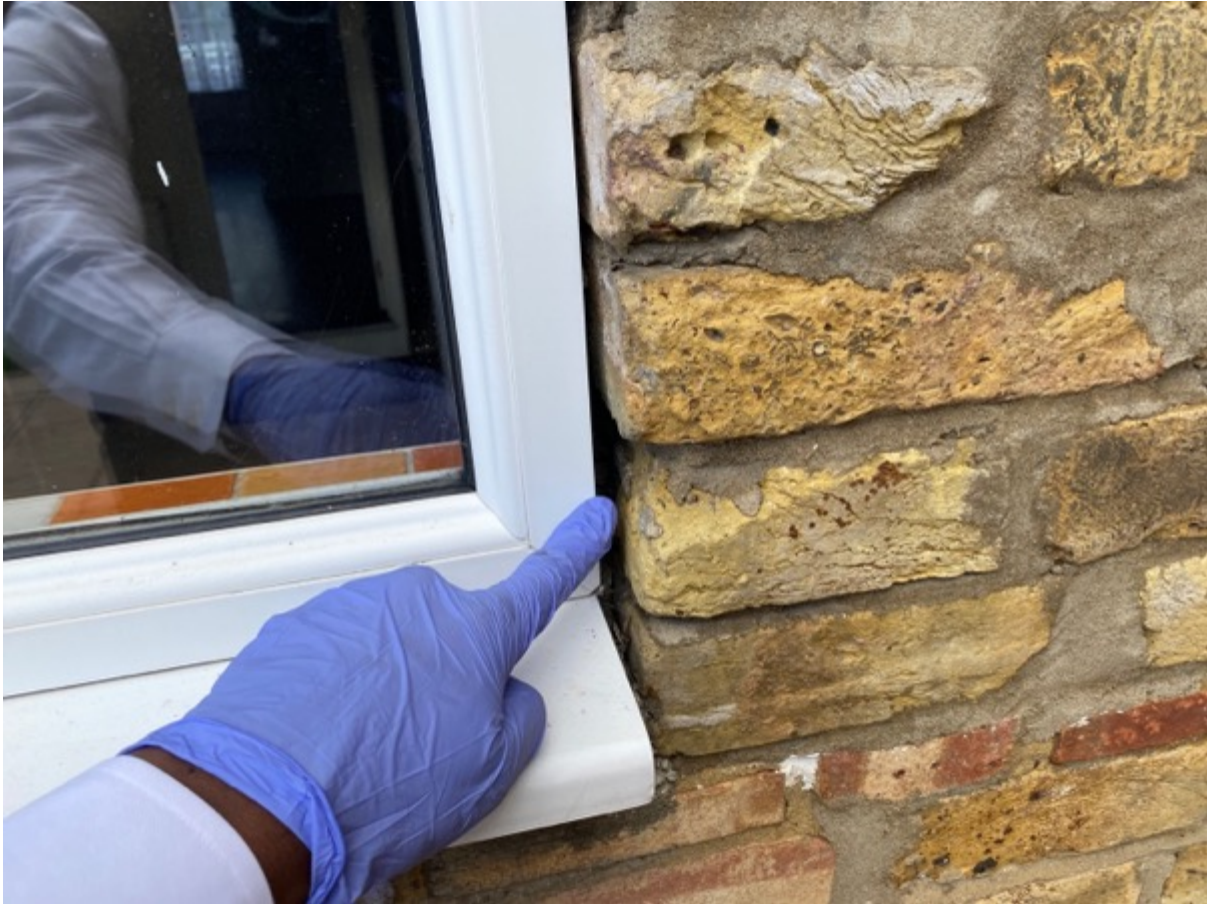
To the perimeter of the kitchen uPVC window there are gaps at the junction of the uPVC frame and brickwork itself.

These should be filled with a neat bead of cement or neat bead of mastic to ensure weather and pest ingress is not able to penetrate the internal parts of the property.

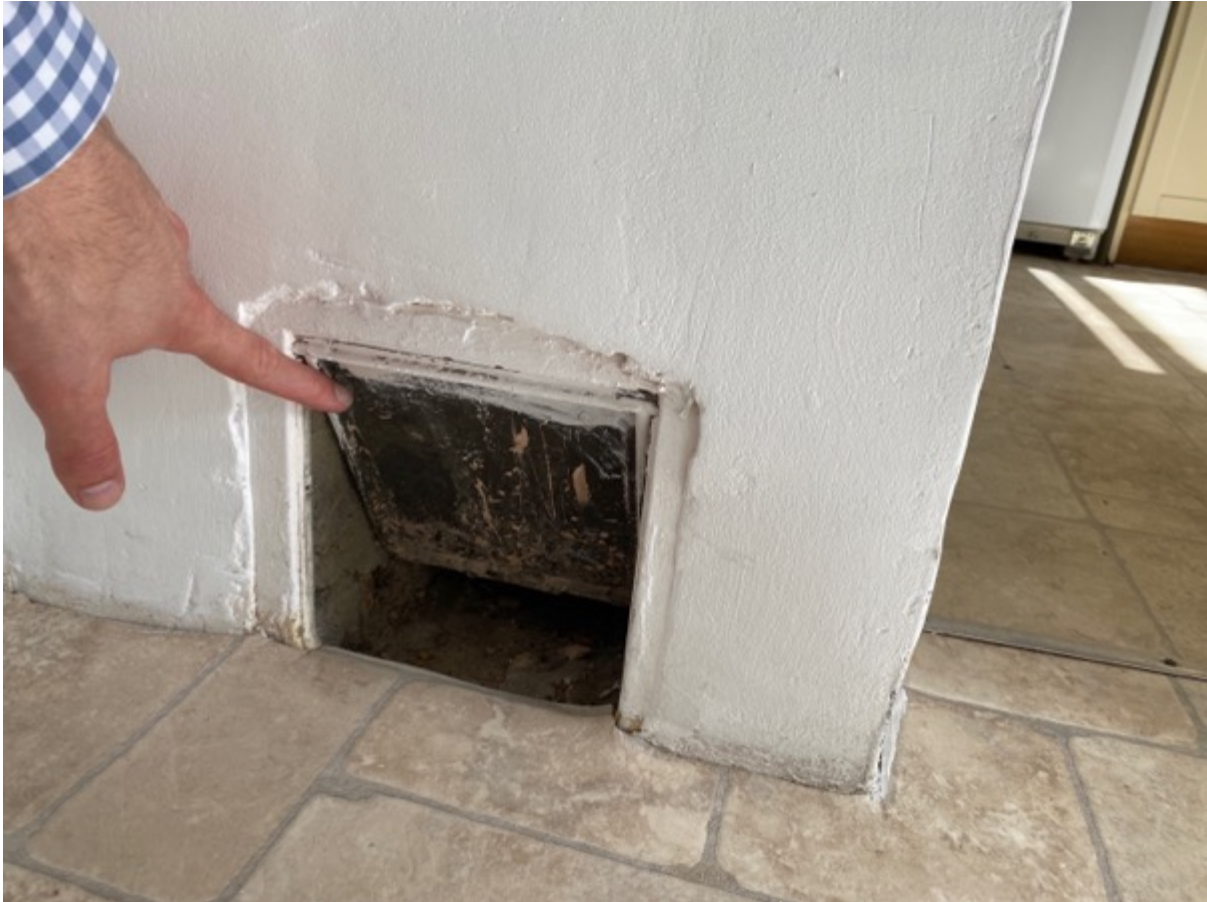
To the flank rear of the property there is a single level rear extension built, to the extension itself, there are signs of historic parts of the original building remaining, in particular an air brick and a cat flap.

This is a relatively unconventional arrangement, and I would have expected that these would have been blocked and bricked up and therefore, as they no longer serve any purposes, that is something that will need to be done to ensure a neat and conventional finish.

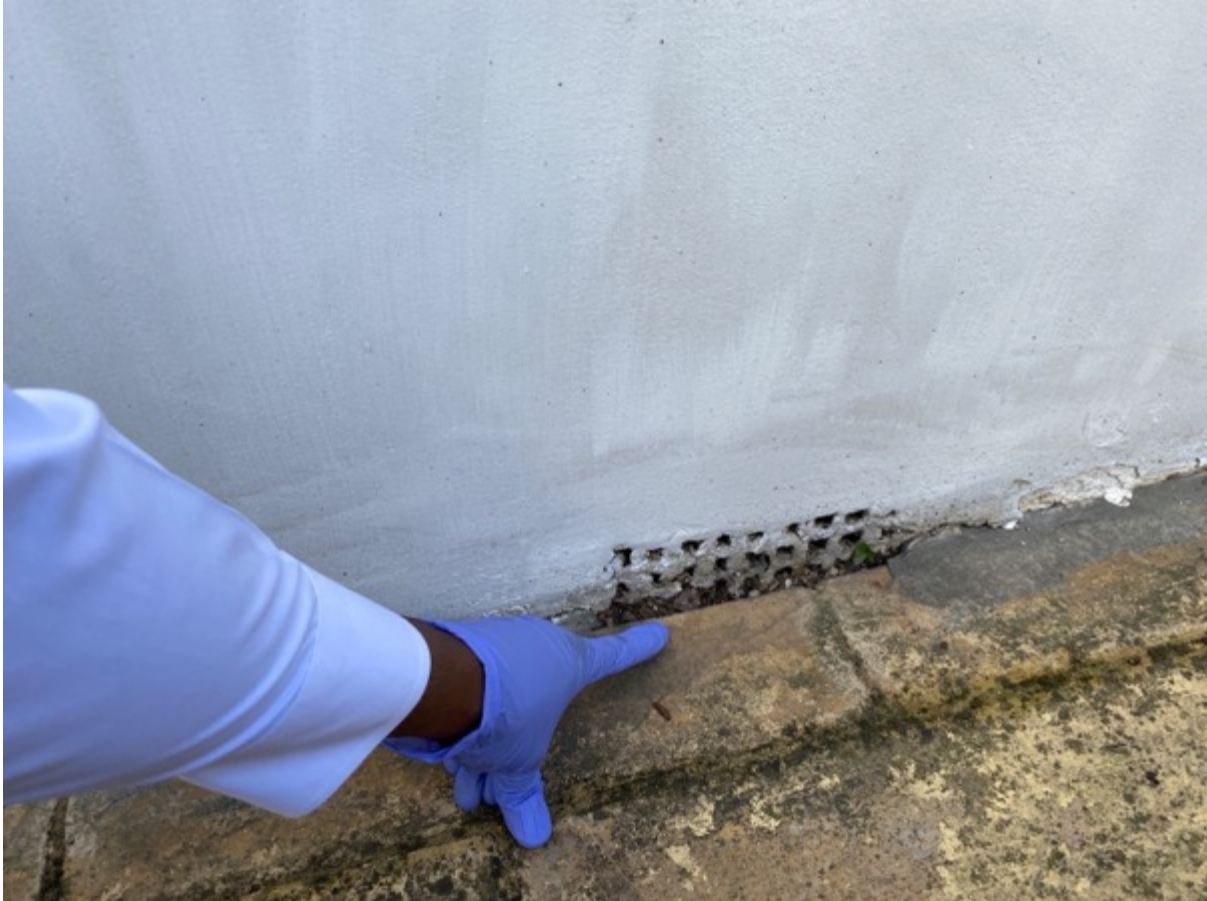
The ground towards the front of the property in the front garden is laid concrete paving slabs, these paving's slabs abut the front bay window, it partly bridges the air brick present hindering the use and it is likely that they bridge any damp-proof course that was present.

Generally speaking, the perimeter of all properties should have a sufficient void between the property itself and the ground to ensure that weather ingress and damp penetration does not penetrate the internal parts of the property.

You therefore may want to budget into the maintenance costs in the near future the reinstatement of the void itself to ensure that the property is best protected from any damp ingress in the near future.

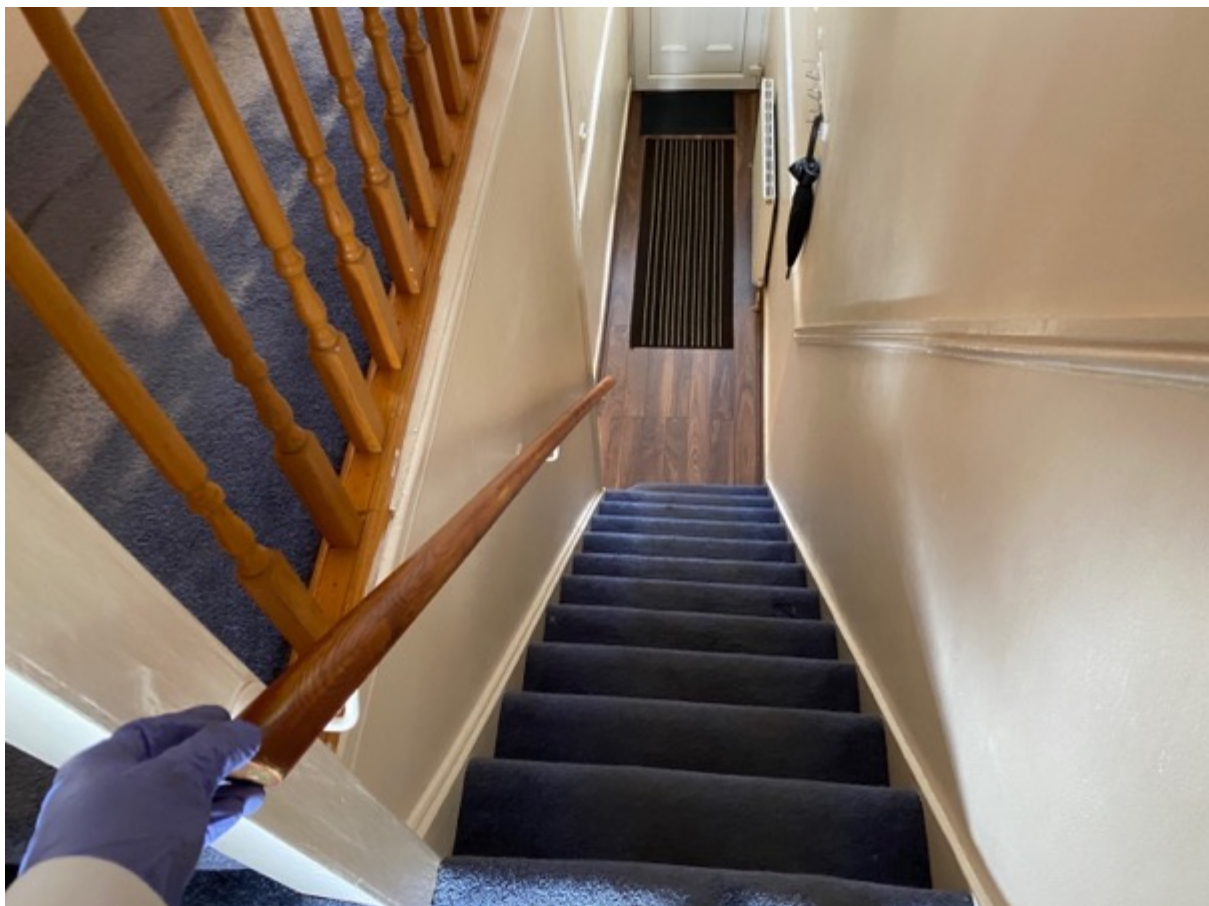
The stairs towards the ground floor appear to have been reconfigured in the past and are now exceptionally steep and I would advise making enquiries as to whether this, as currently set out, would be in accordance with Building Regulations compliances.

Furthermore, I would suggest making enquiries as to when the modification and adjustment to the stairs was undertaken and if there are any contractor's Guarantees in place for the workmanship that has been done.

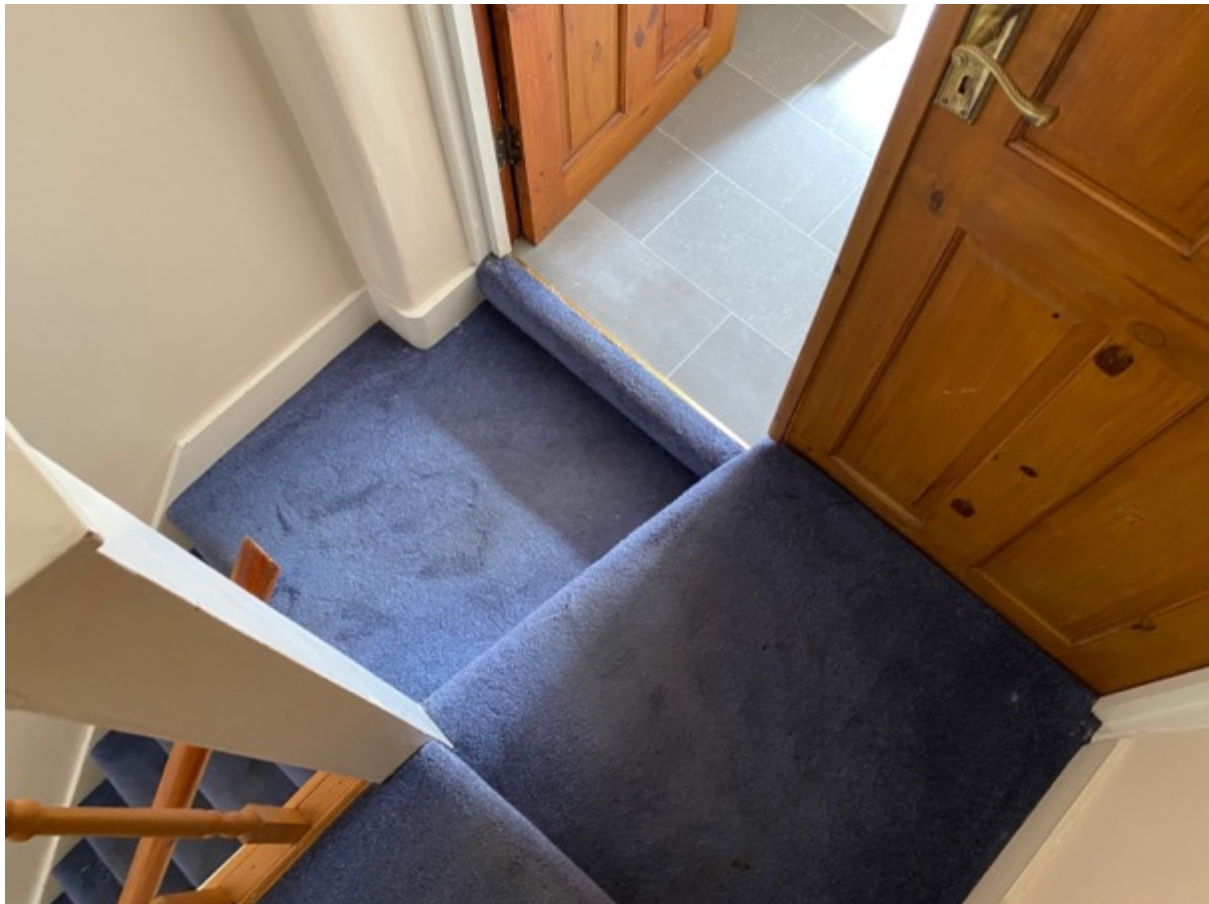
Throughout the floor areas itself there are a number of different stepped areas predominantly the main bathroom at first floor level is on a raised platform and there are a further two steps up to the first-floor bedroom area.

This is relatively unconventional and generally speaking, when development works do take place to a property, Architects tend to design around and avoid this type of issue as they can be tripping hazards and generally are quite awkward to work around and I would therefore suspect that the works that have taken place were poorly considered at the time of their conception and that could be an indication that the necessary statutory consents could not be in place.

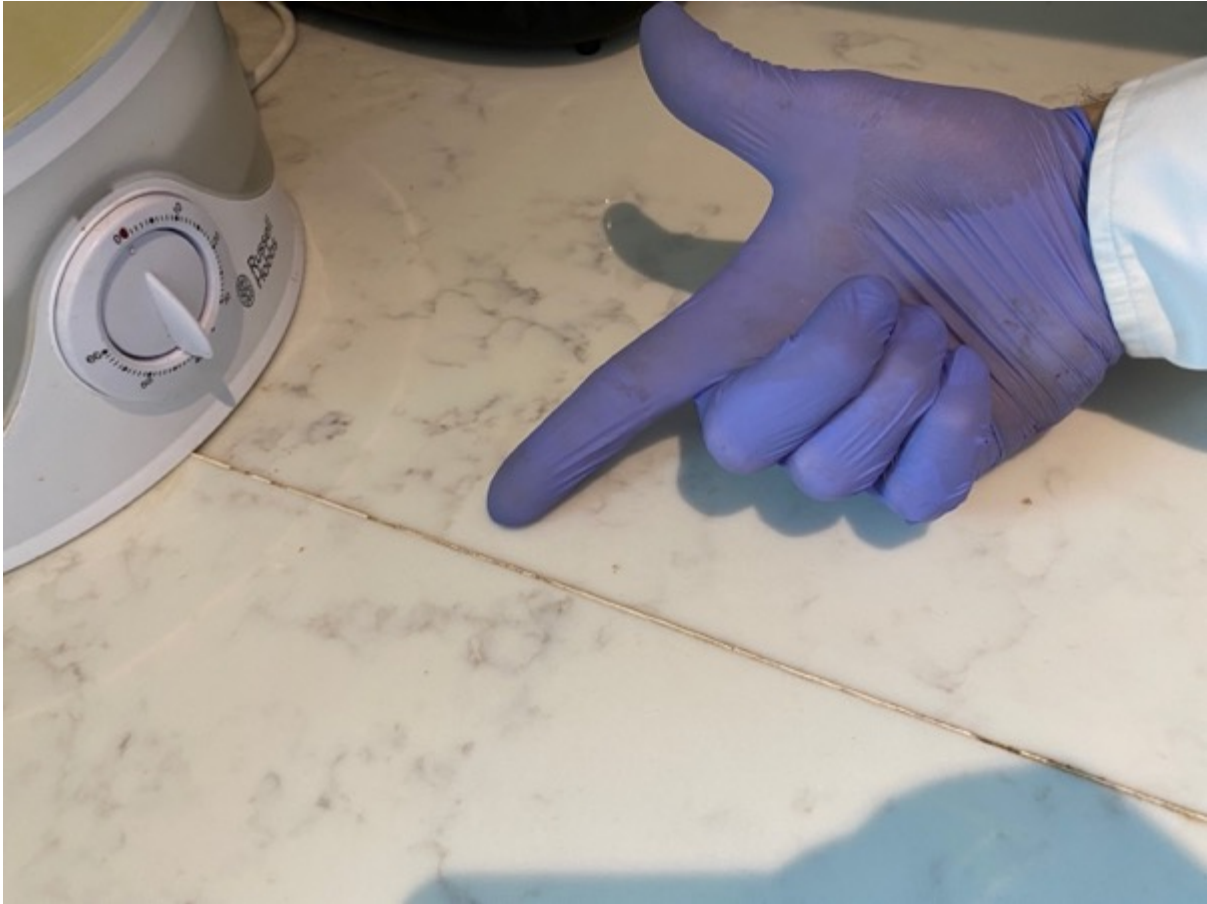
The kitchen worktop is a quartz Carrera imitation marble type.

Overall, it was free from any staining, however, the junctions of one section of the quartz finish to another are raised and sit proud which will result in a dirt build-up at the junctions and you therefore may want to consider having a kitchen specialist and worktop specialist revisit to level out the installation of the worktop to ensure that this does not happen in the future.

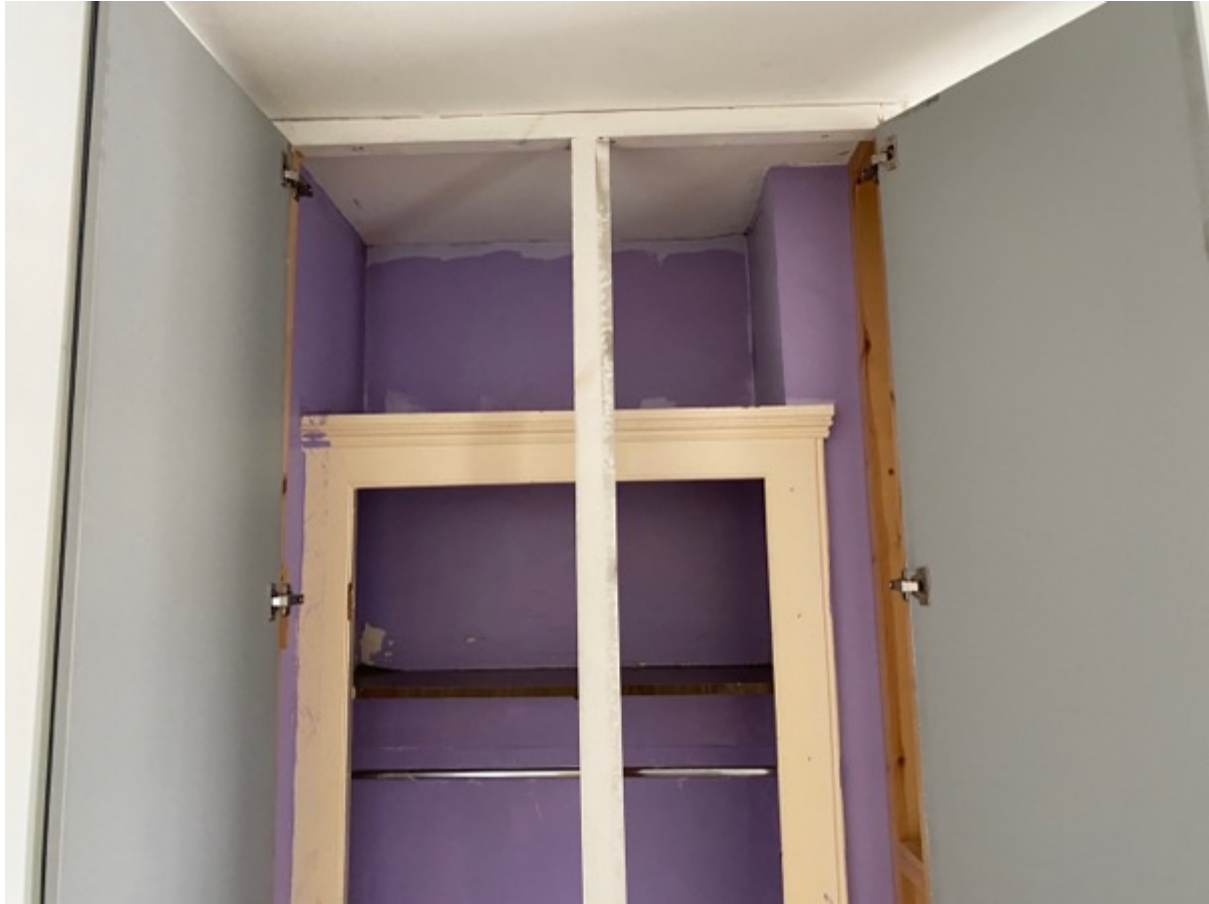
These wardrobes themselves are crudely installed and actually installed over the older fitted wardrobes so that there is an awkward wardrobe within a wardrobe effect.

Should you proceed with the property I would advise that the older wardrobes are removed and that the fitted wardrobes are replaced with a neater and sounder fit to maximise the storage space within the property.

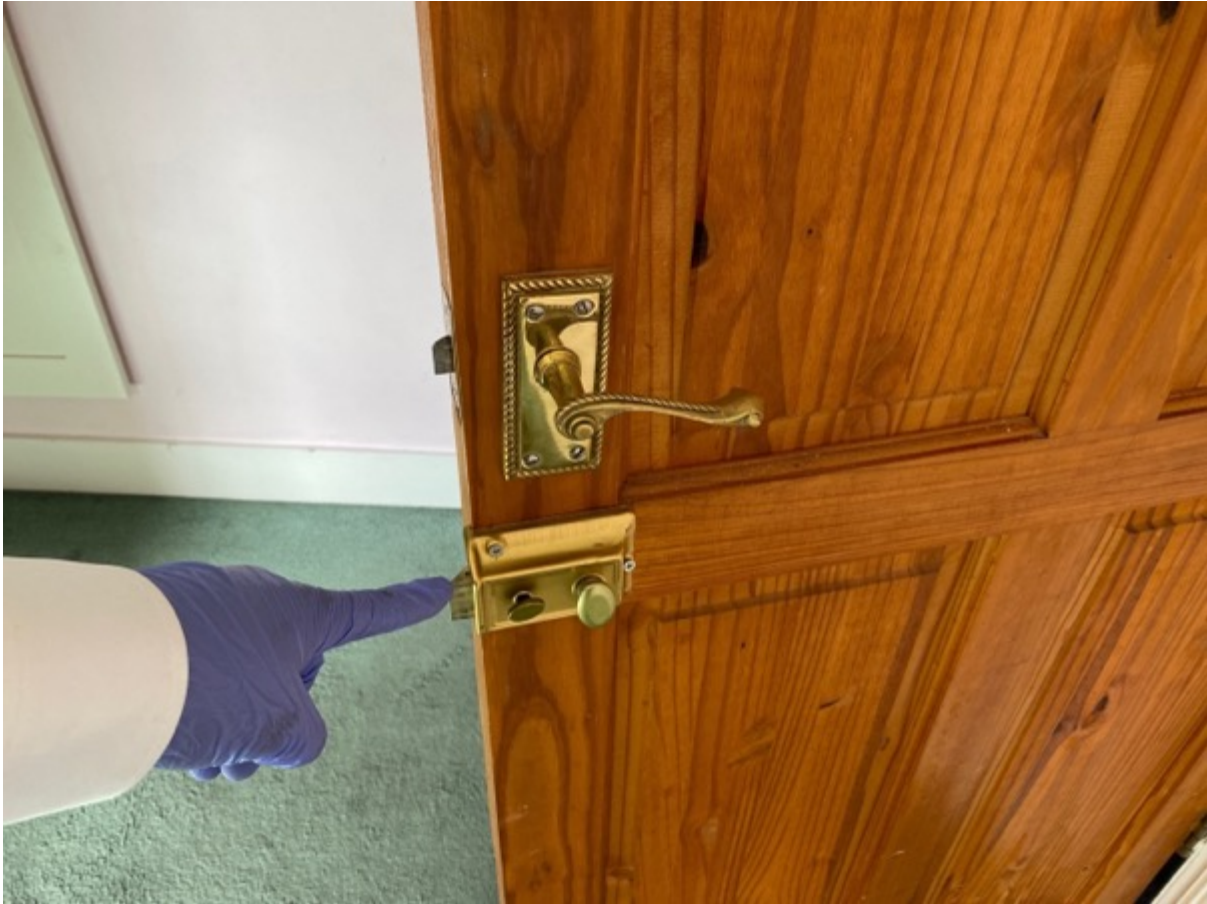
Throughout the bedrooms it is worth noting that there are individual locks installed on the respective doors.

This is a relatively unconventional installation for a house, and it is likely that at some point in the past this property was a flat share or joint occupancy property. In any event, should you proceed with the property, I would advise that the locks are removed so that the property can be used in a conventional way.

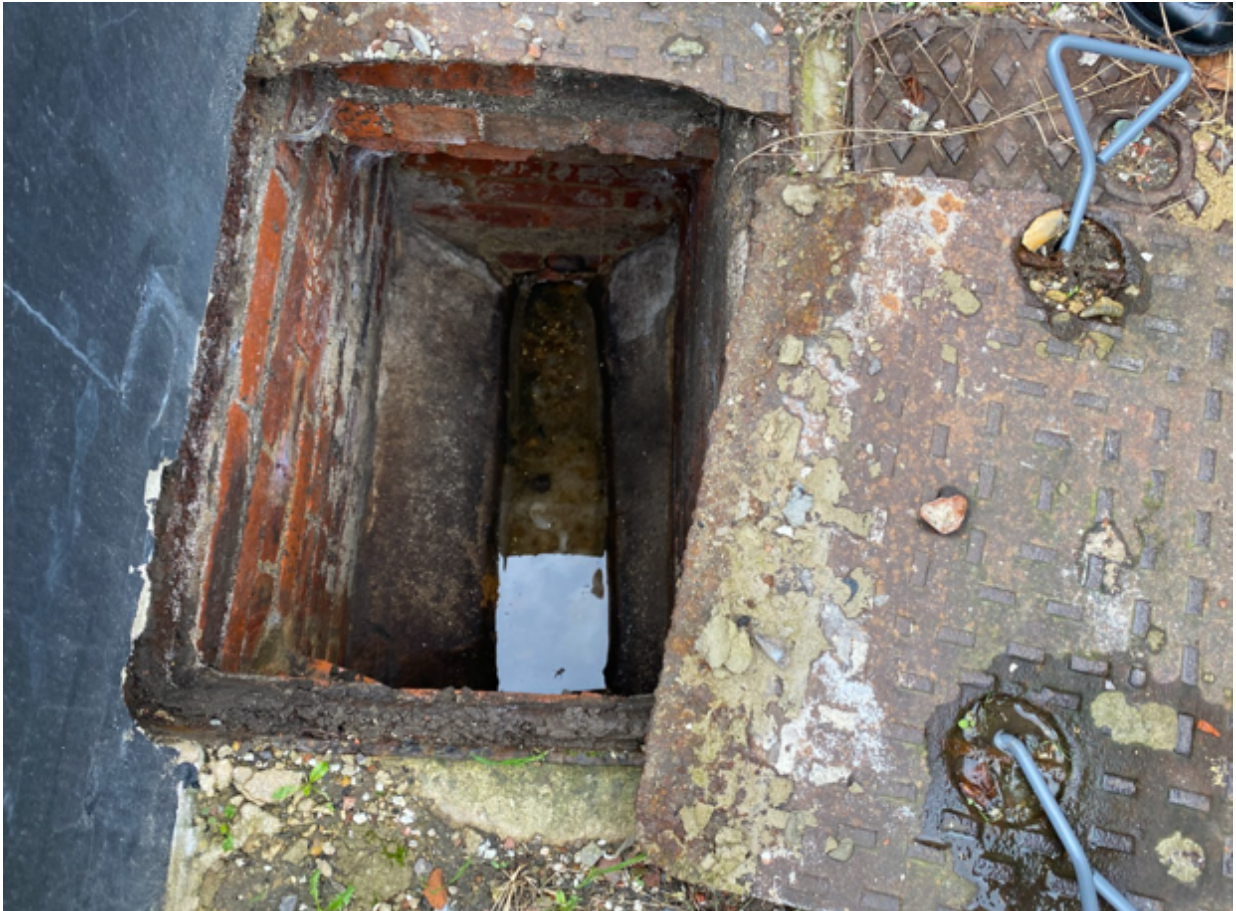
The drainage within the bathroom appeared to be sufficient and the taps did not back up and likewise in the kitchen area.

Towards the rear of the property the drainage and downpipes at the junction where they run into the rear drainage gullies was covered over with a concrete paving slab.

When these slabs were lifted there were signs of blockage noted to both respective rear drains and therefore I would advise, as previously suggested, that the manhole cover is located and potentially a CCTV drain survey is undertaken to ascertain exactly what the condition is of the drain and if there are any signs of blockage or defect noted.
