RICS HomeBuyer Report (Level 2 Survey)

Address of Purchase Property

Date of Inspection:

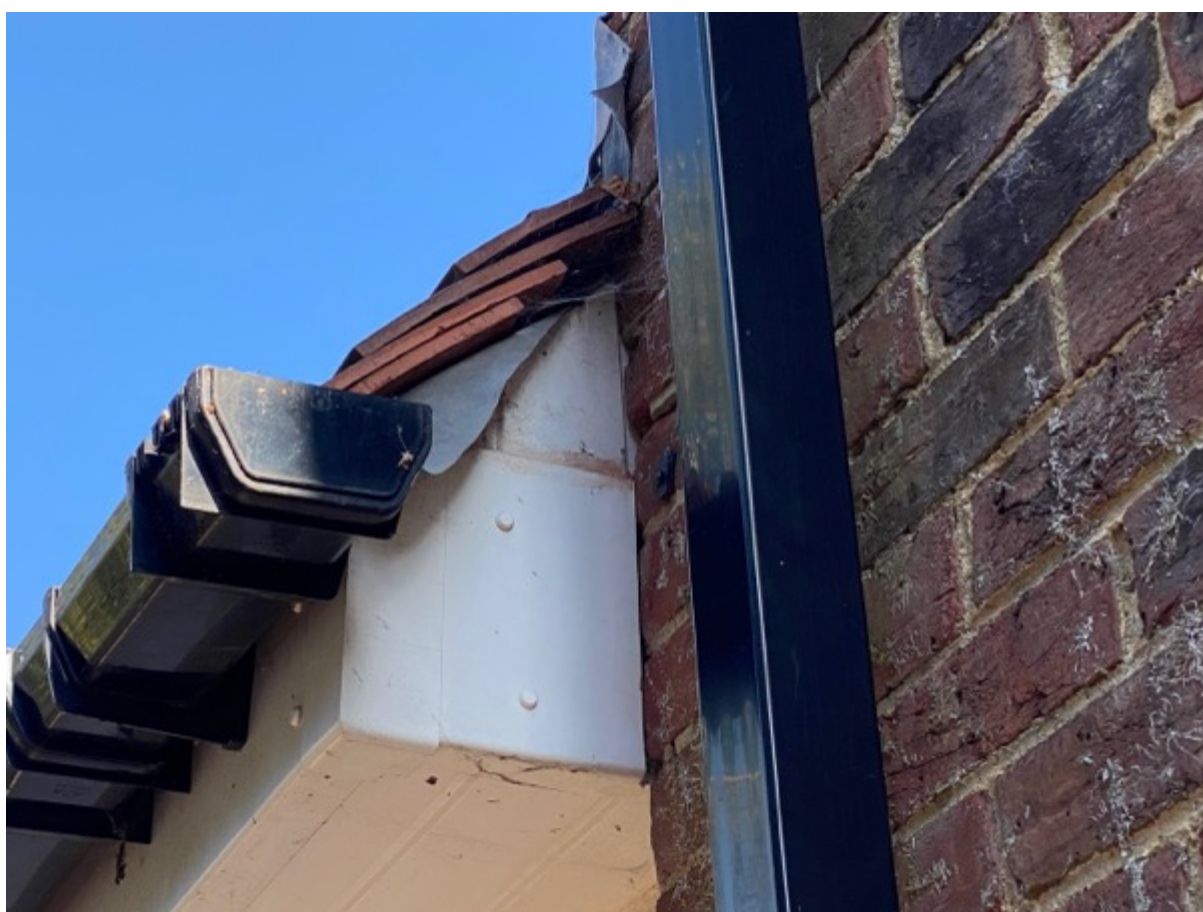
Rainwater pipes and gutters are uPVC plastic type and appear to have been replaced at some time in the near past.

At the time of inspection, these appeared to be level throughout and free from any signs of leaks or issue noted.

The soffit beneath is a timber type and was showing signs of blistering and peeling paint noted throughout, prominent to the rear left side and front left corner of the property. It is likely that these soffits will need to be treated and painted to ensure their longevity and reduce the chance of water ingress to the property itself.

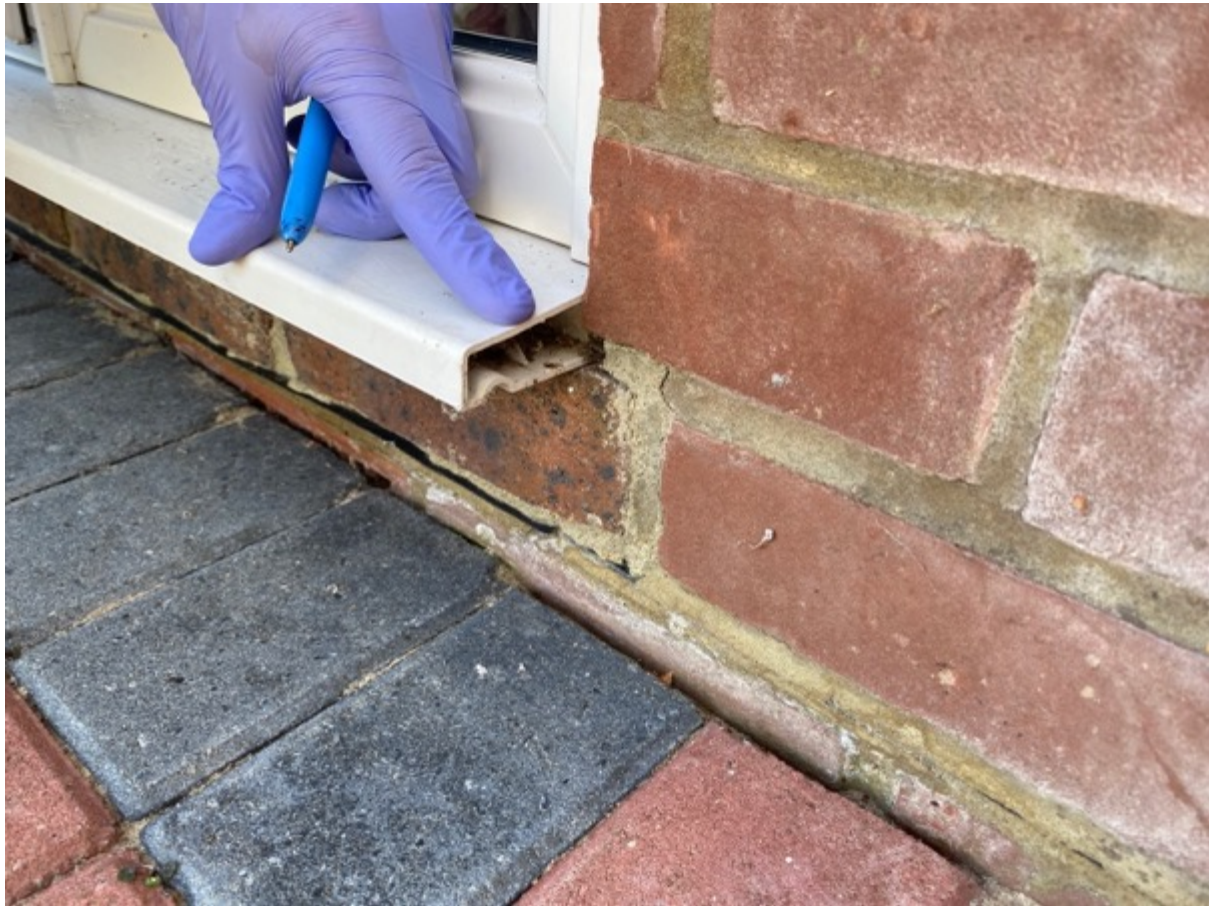
I would advise making enquiries with the sellers to ascertain if indeed that is the case, and as well as any contractor's installation warranty that may exist. Some of the window sills were missing the outer edge covering to the window sills.

Some of the windows have trickle vents which is favourable as it ensures that airflow can naturally move through the property without windows being open, reducing condensation build up within the demise itself.

These will, over time, allow pests to build up and can be a mucky clean, and I would therefore advise that these are filled in with the appropriate end caps.

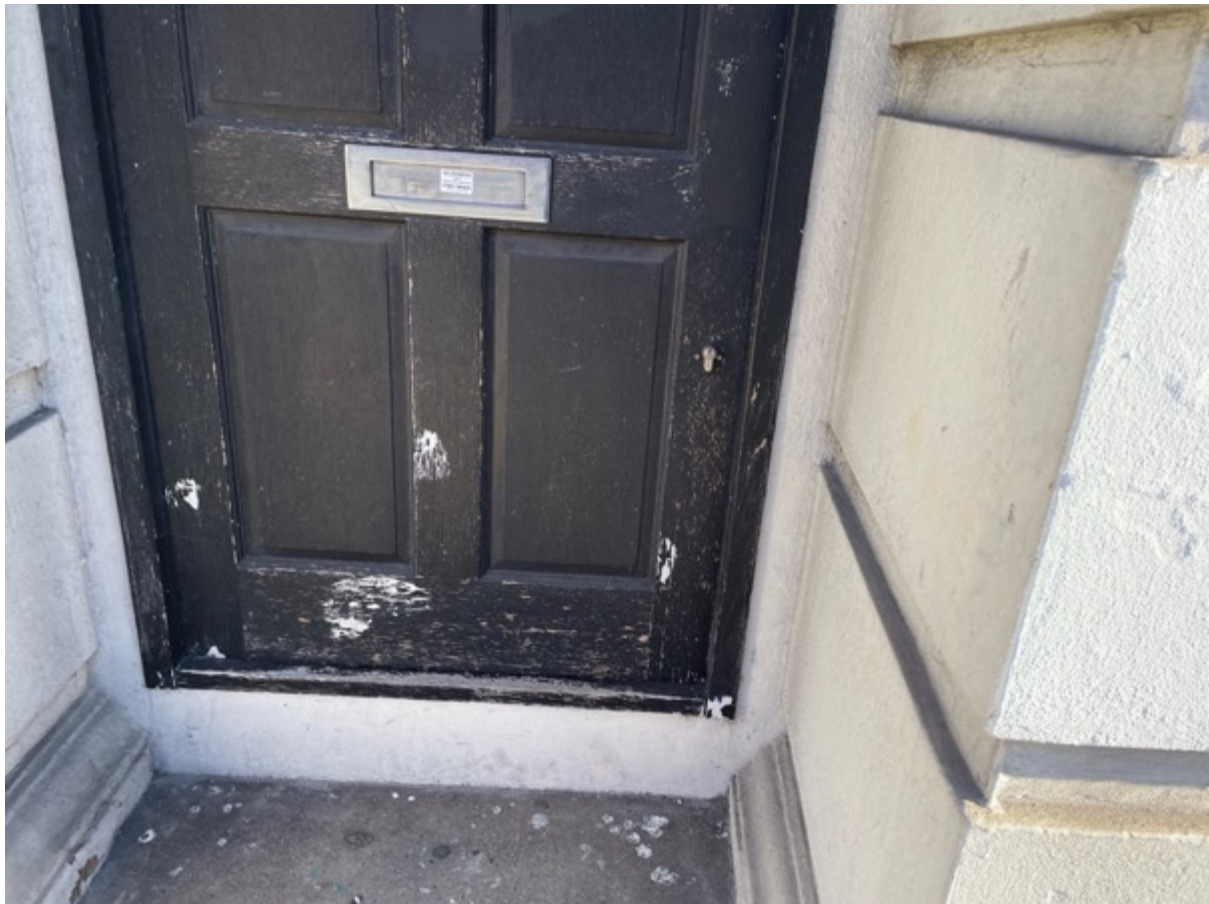
D6 Outside Doors (Including Patio Doors):

The main entrance door is of a timber type, and could benefit from repainting. However, the door was operational.

The door to the outside roof terrace is of a UPVC type, double-glazed. Glazing was intact. However, the door did not catch and close, and the locking mechanism would need to be adjusted to address this.

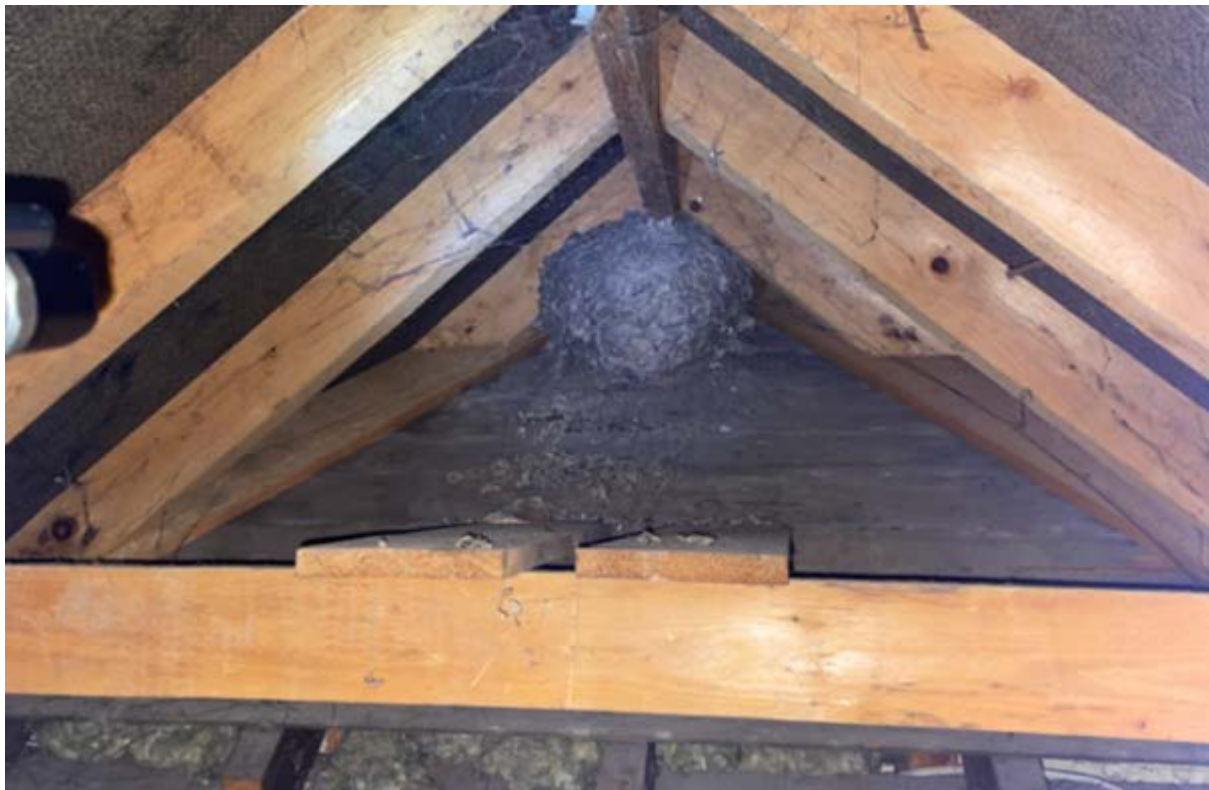
The roof structure is timber framed type. There is sarking felt visible beneath the outer slate roof covering and internal area of the roof void. The party wall appears to have been built up in breeze blockwork.

I did note a couple of different wasp's nests within the loft area which is normal for a property, however, it is worth noting that wasp's nests are seasonal and a nest will be used once and therefore this could be an ongoing issue.

It is also worth noting that I did locate a wasp on the first floor level which was dead and that is usually a sign that there is an ongoing wasp/pest problem.

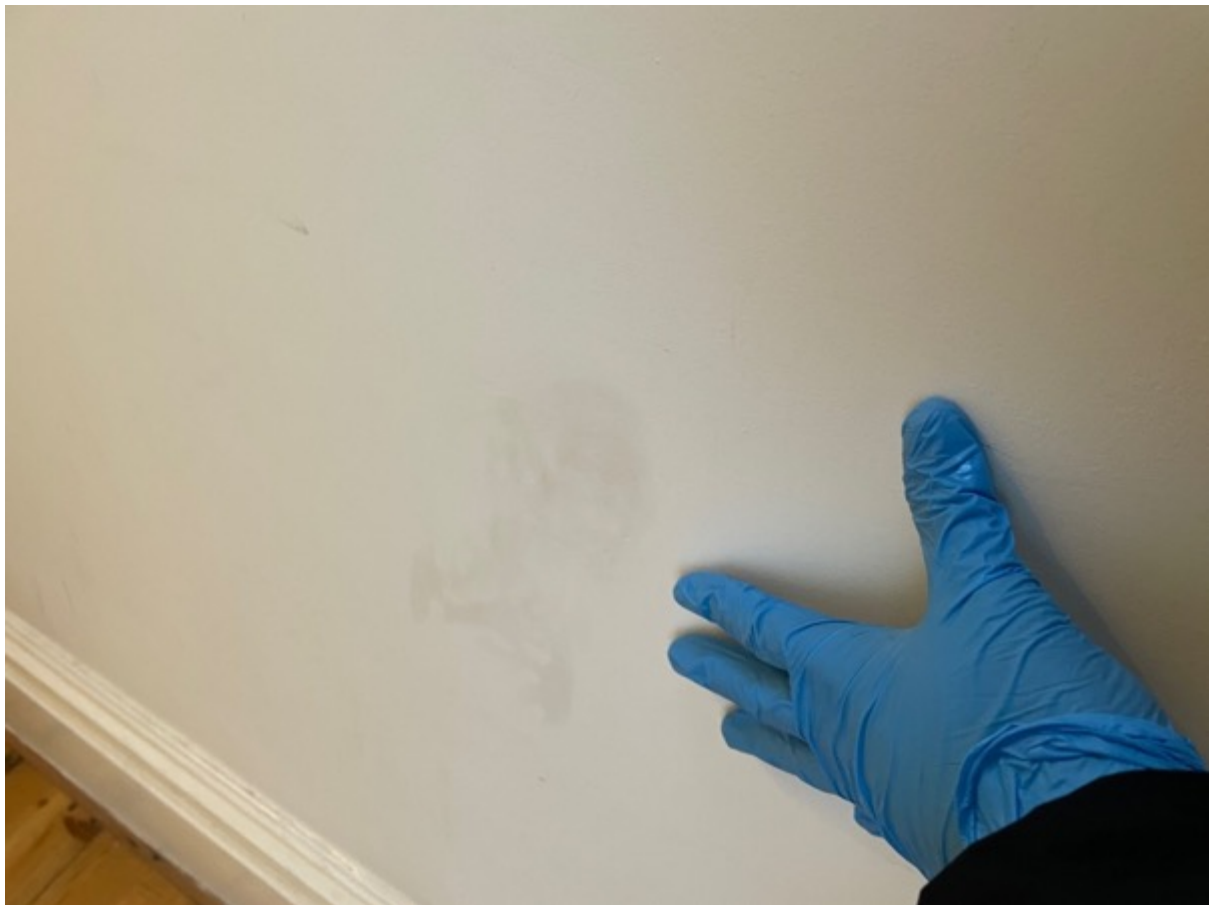
The walls throughout the property are a combination of solid brick construction and timber stud work, plastered and painted, with tiling to various sections.

Generally, throughout the property, there are scuff and traffic marks noted on the walls, which is generally conventional for an occupied property. This could be addressed by cleaning these areas away and painting them over.

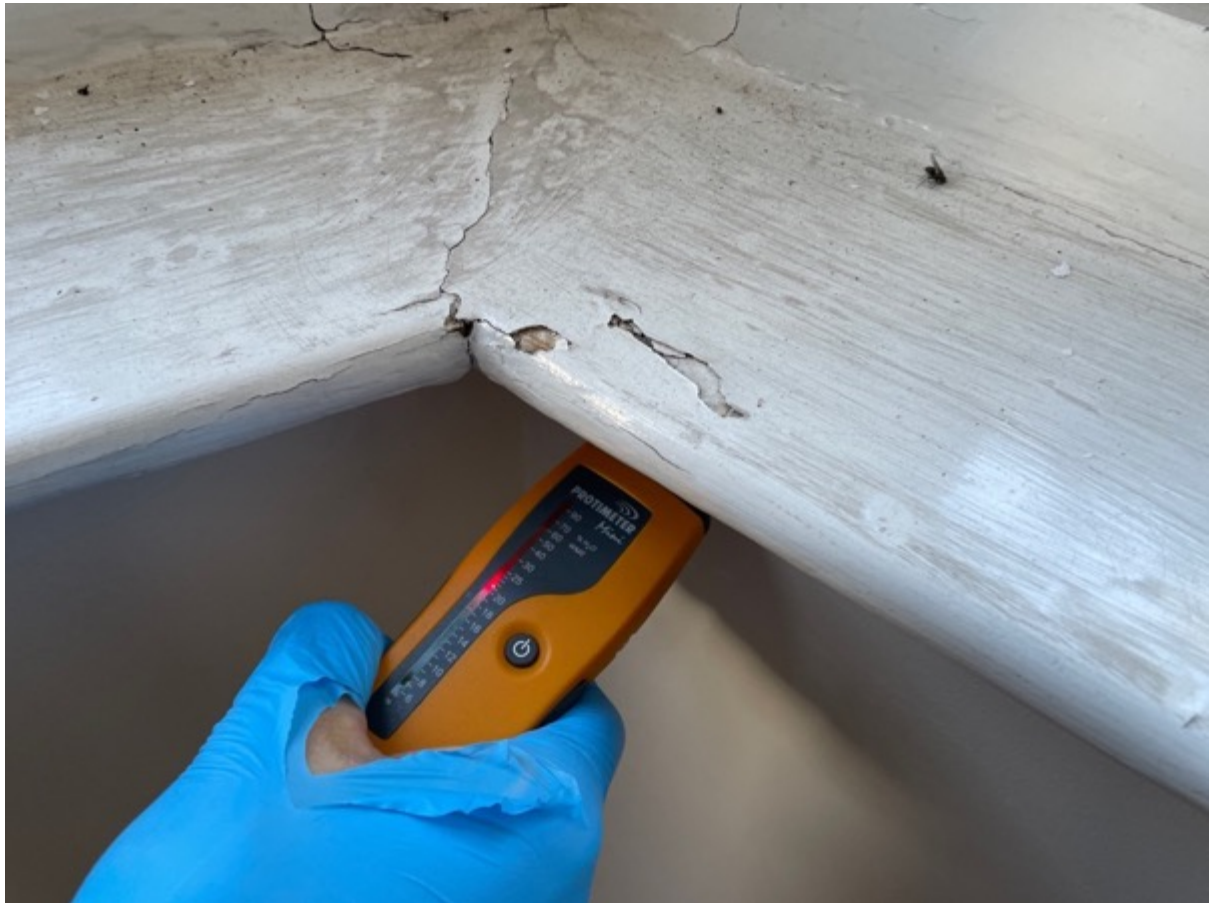
A further area of staining was noted within the left front room to the bay area. When probed with the Protimeter, I also obtained a red reading which confirms the presence of moisture.

From my observation of the external parts, this was most likely due to the failed external sill and rendering, all of which will need to be addressed.

Protimeter tests were undertaken throughout the property, and I was able to obtain red readings throughout, which all would be due to the aforementioned defects, such as the failed external sills, rendering, failed roof coverings and also the insufficient number of radiators throughout the property, which are not fit for purpose and are too small in size, relevant to the rooms.

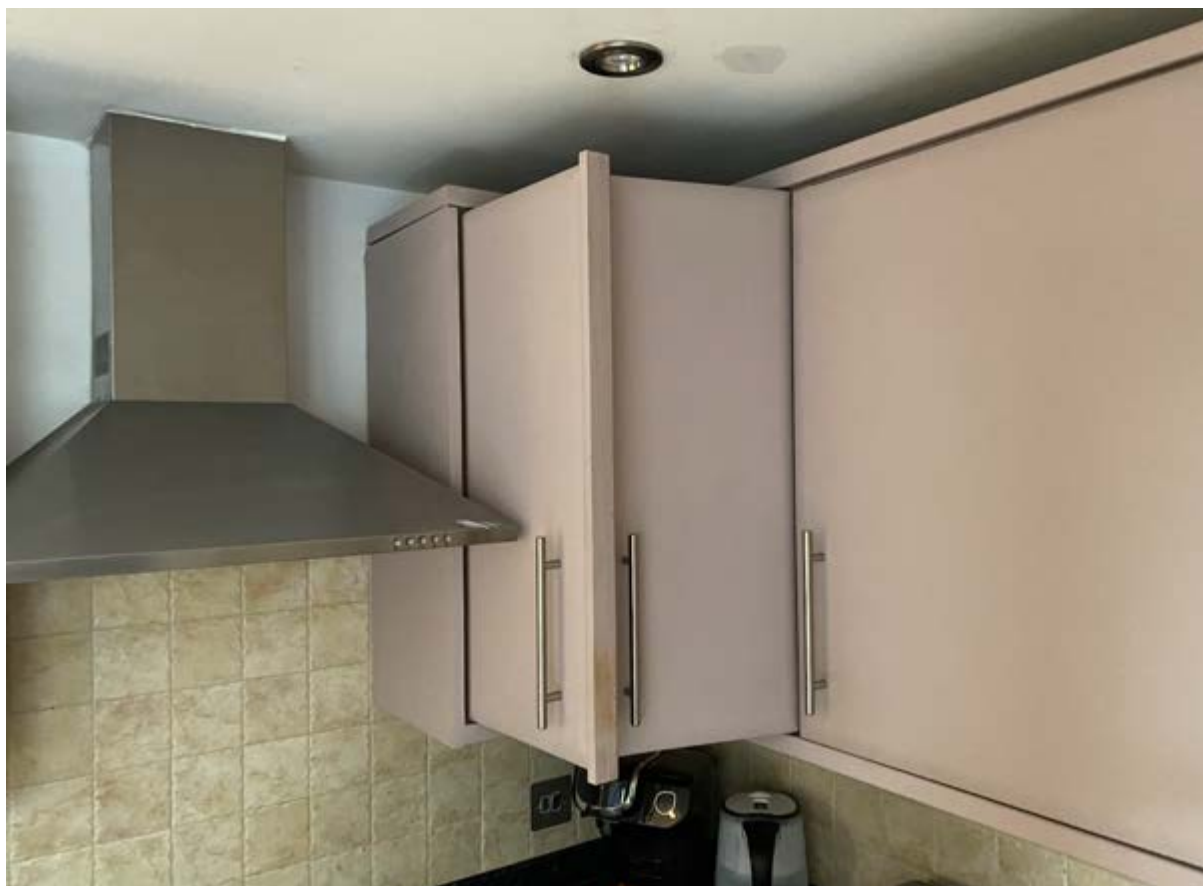
E6 Kitchen:

Fitted Kitchen

The kitchen appears to be a modern type with a laminate worktop.

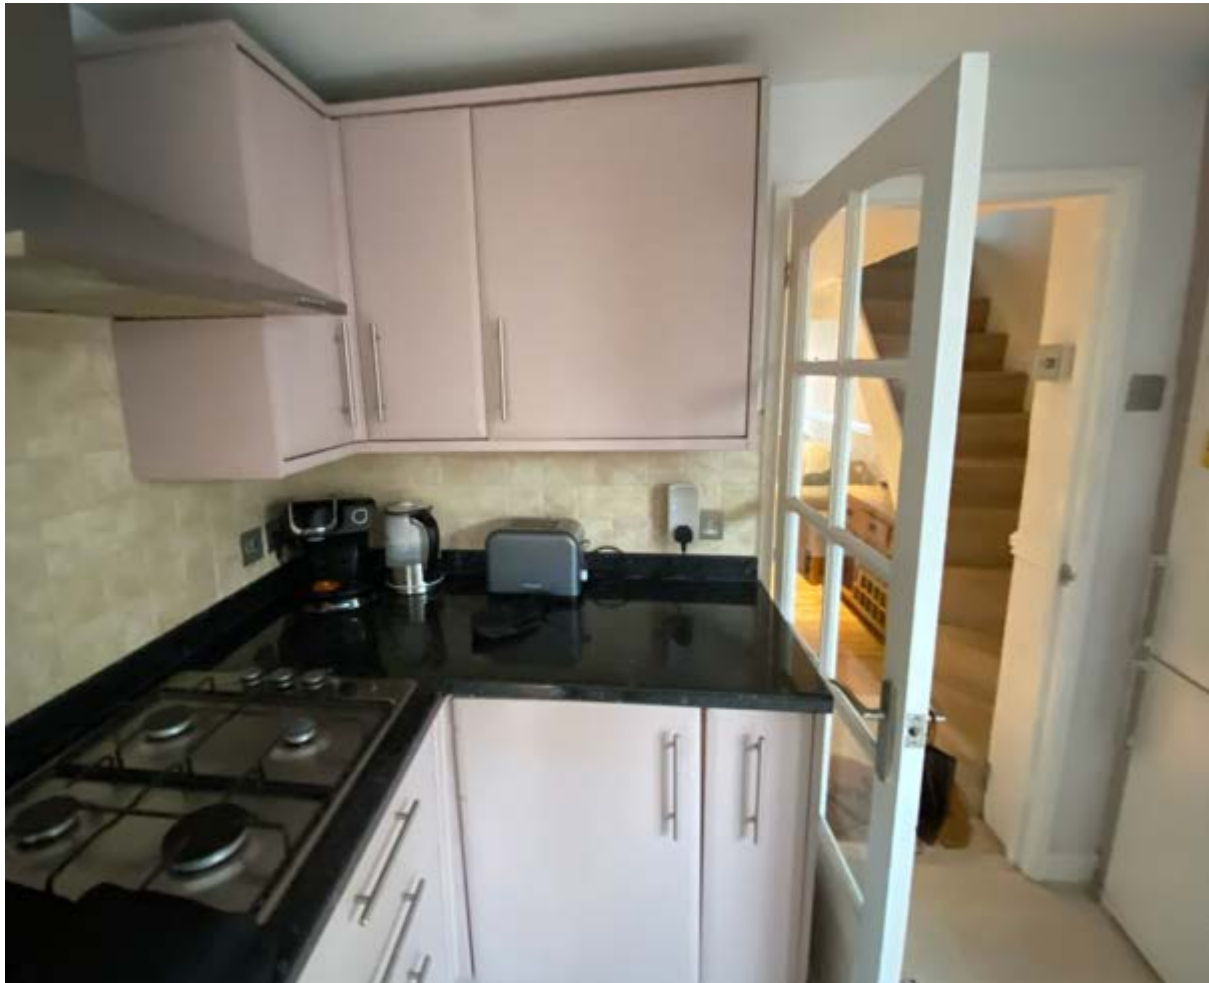
Ground floor kitchen door is a timber framed, single-glazed type. The glazing does not appear to be safety type.

Bathroom door is a timber framed, single-glazed type. Glass does appear to be toughened type, however you may want to enquire as to when it was installed and the specification to reassure yourself.

The door does bind when in operation and requires removing from its hinge and re-planing to ensure a smooth fit and operation.

Safety glass is recommended as it is tougher and more robust than normal glass and prevents shattering and smashing which can be used through the normal operation of the door.

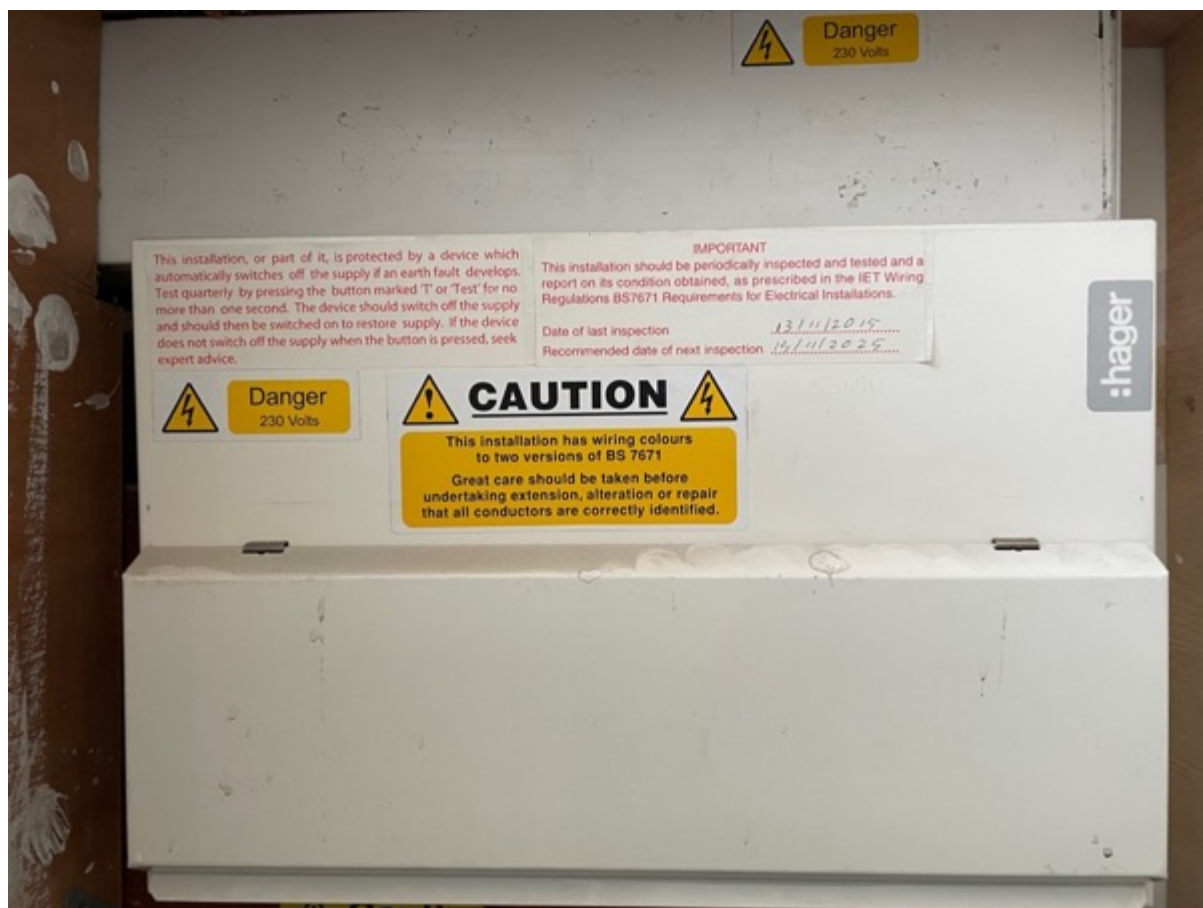
The RCD units and electrical meter are located within a timber cabinet by the entrance door to the subject property. The inspection sticker confirms that the next recommended inspection be undertaken on 13th November 0000.

In the bedroom, there are two double sockets. In my opinion, this is insufficient for modern day use and you may wish to consider having more sockets installed.

The television aerial cover towards the front of the property is missing, meaning that the wires are exposed and unprotected.

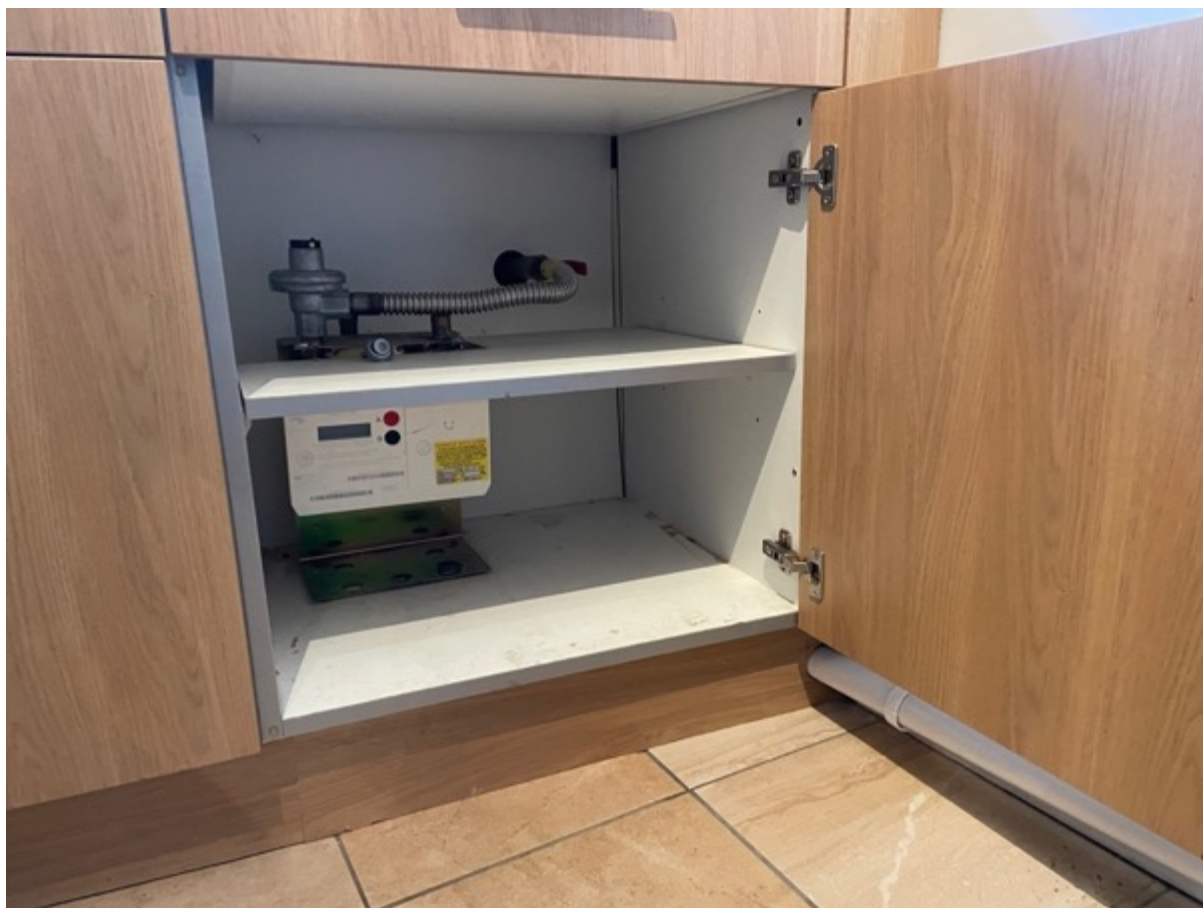
The gas meter is located to the underside of the kitchen sink.

I would advise that a Gas Safe engineer visits to ascertain if the installations are in accordance with current health and safety and Gas Safe standards.

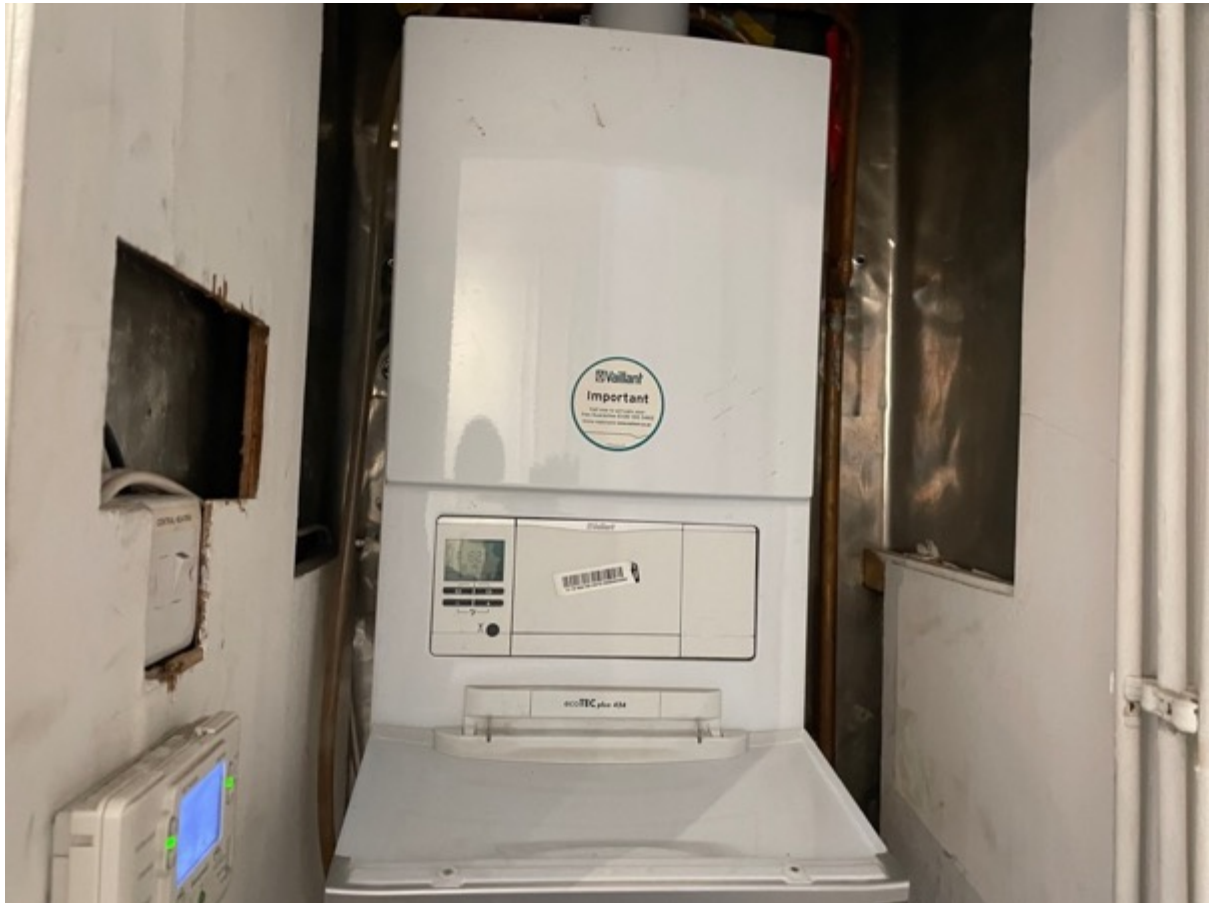
Heating is provided by a Vaillant boiler located within the services cupboard. At the time of the inspection, I was able to obtain a warm reading from the radiators.

However, as previously confirmed, the current radiator fixtures are not fit for purpose, as they are too small for the rooms that require heating.

Furthermore, at the time of the inspection, the boiler was making louder than conventional sounds, which indicates the requirement for maintenance or replacement.

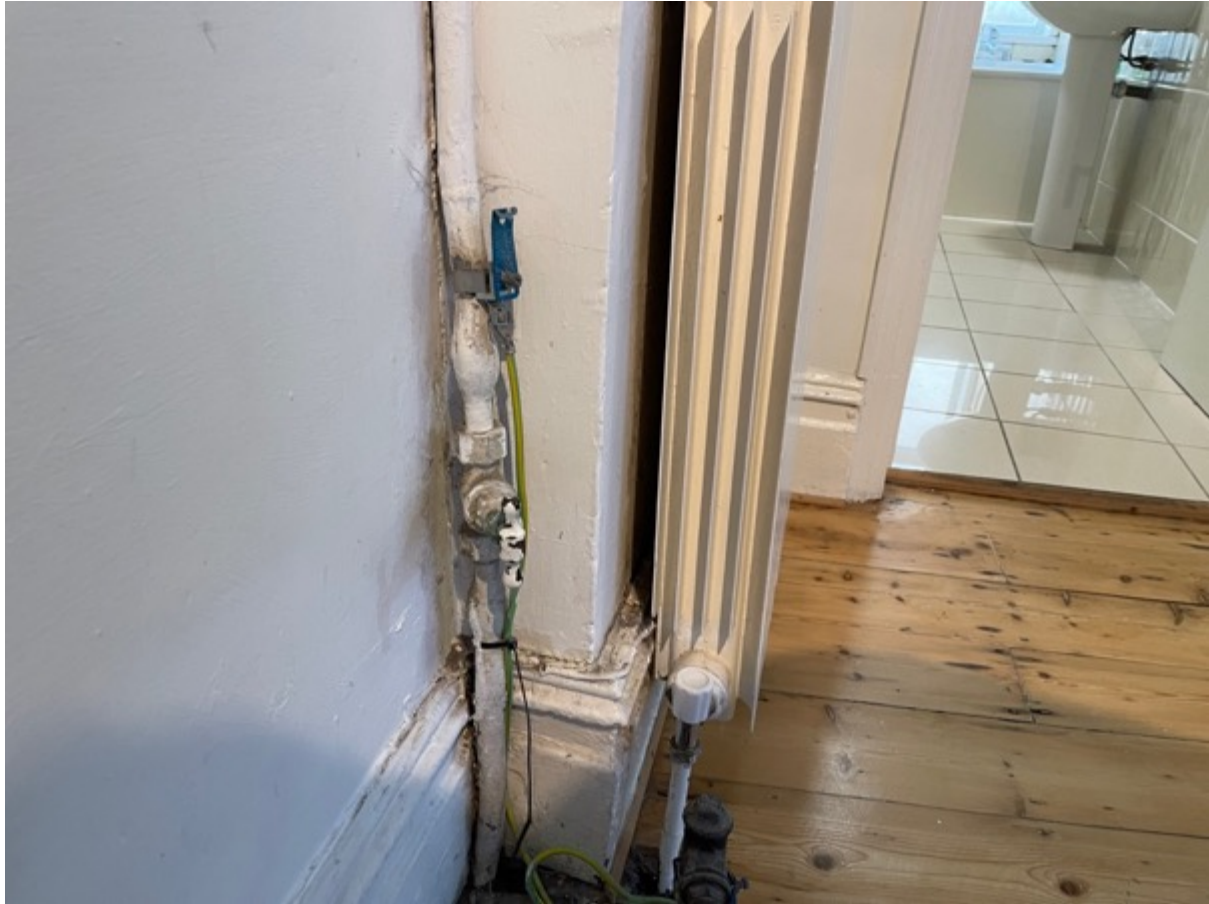
At the time of the inspection, I was not able to obtain a warm reading from the taps. This will need to be addressed as per previous advice.

The stopcock appears to be located within the reception room adjoining the bathroom.

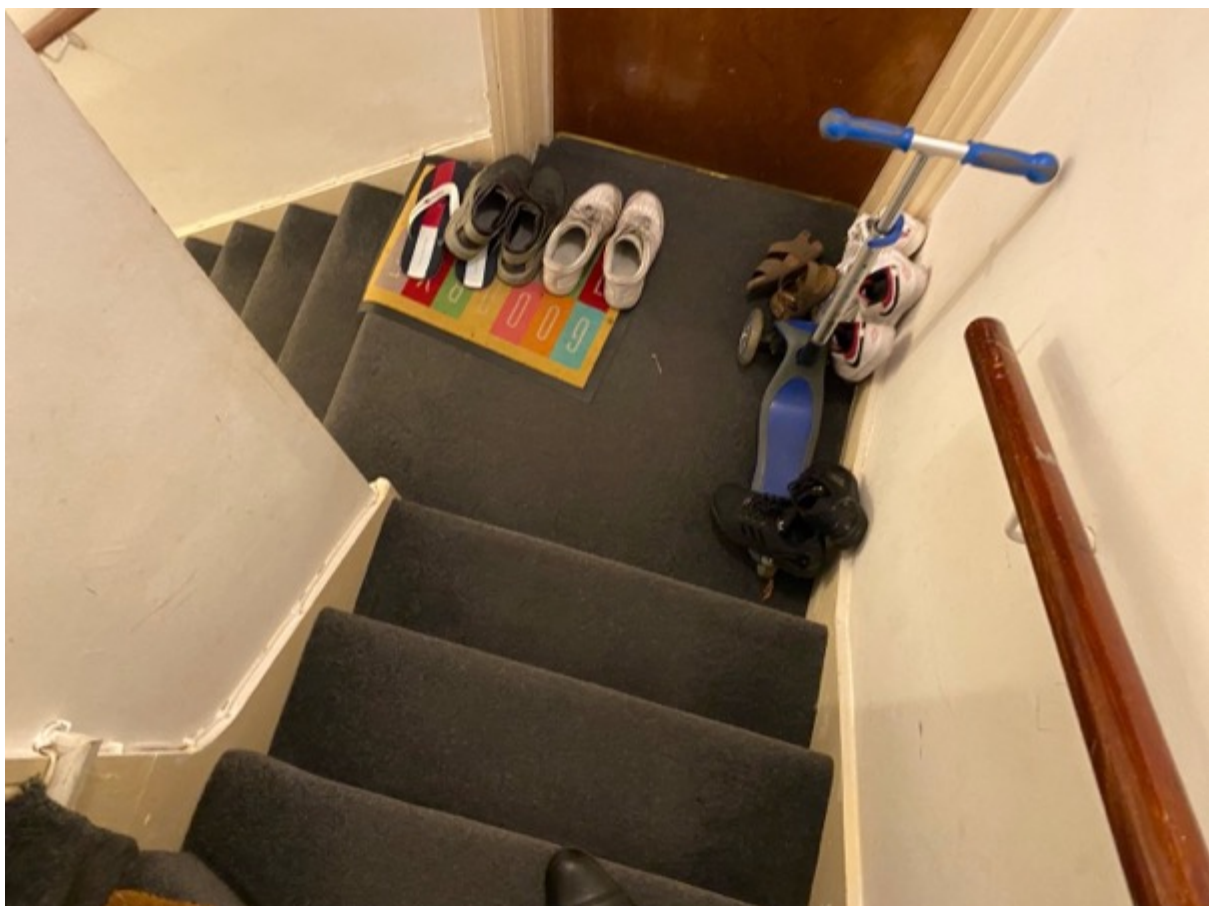
Within the communal areas running up to the flat itself, there were a number of other flat and occupant items including shoes and bicycle scooters.

I would advise that you make enquiries as to whether these have the right to be there, as dark at night it could be a sign of a tripping hazard, as well as generally being towards the unsightly end of the spectrum.
