RICS Full Building Survey Report

(Level 3 Survey)

Full Property Address:

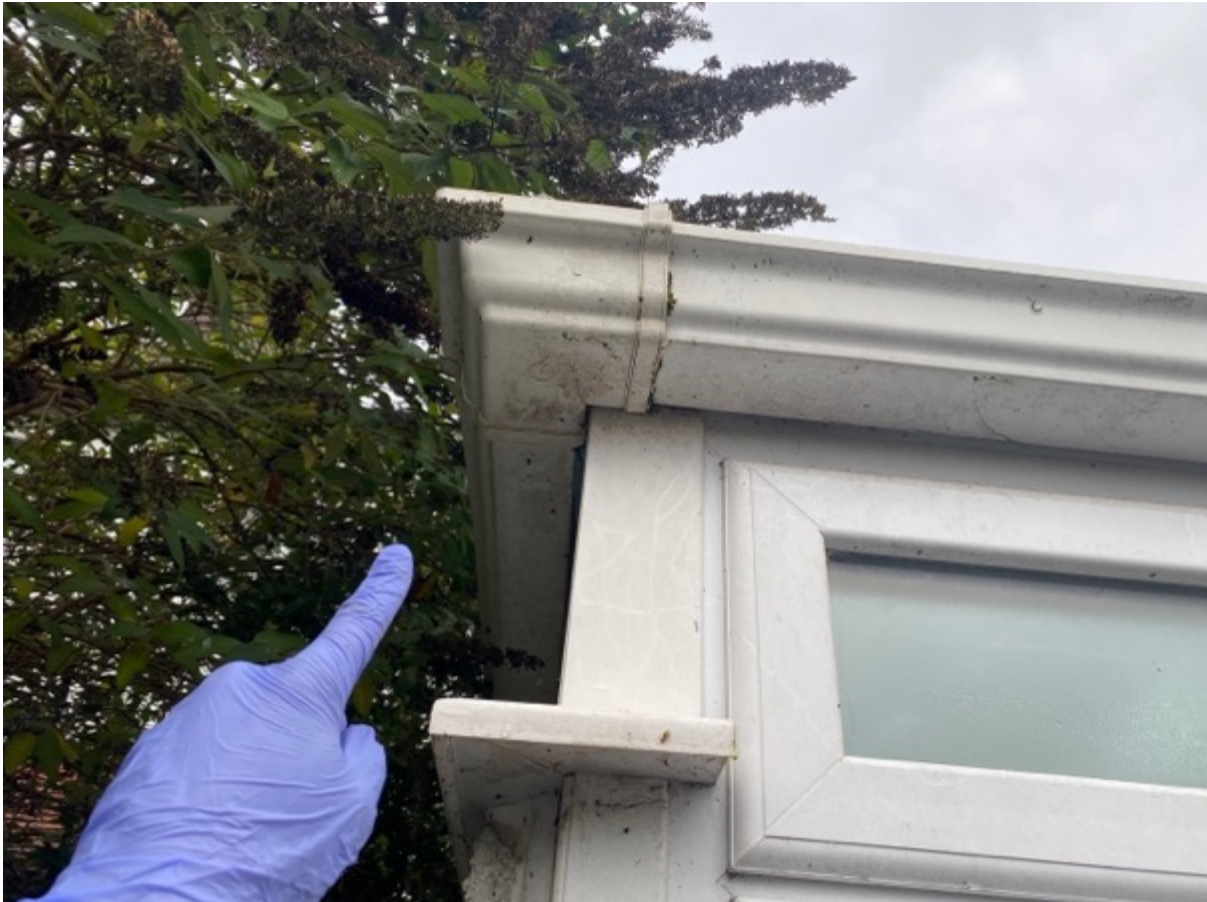
D3 Rainwater Pipes and Gutters:

Towards the front of the property the gutters are uPVC half moon type. These appear to have been recently installed. All gutter clips were intact and neatly spaced.

The uPVC downpipe towards the junction of the property likewise appears to be recently installed and are modern type.

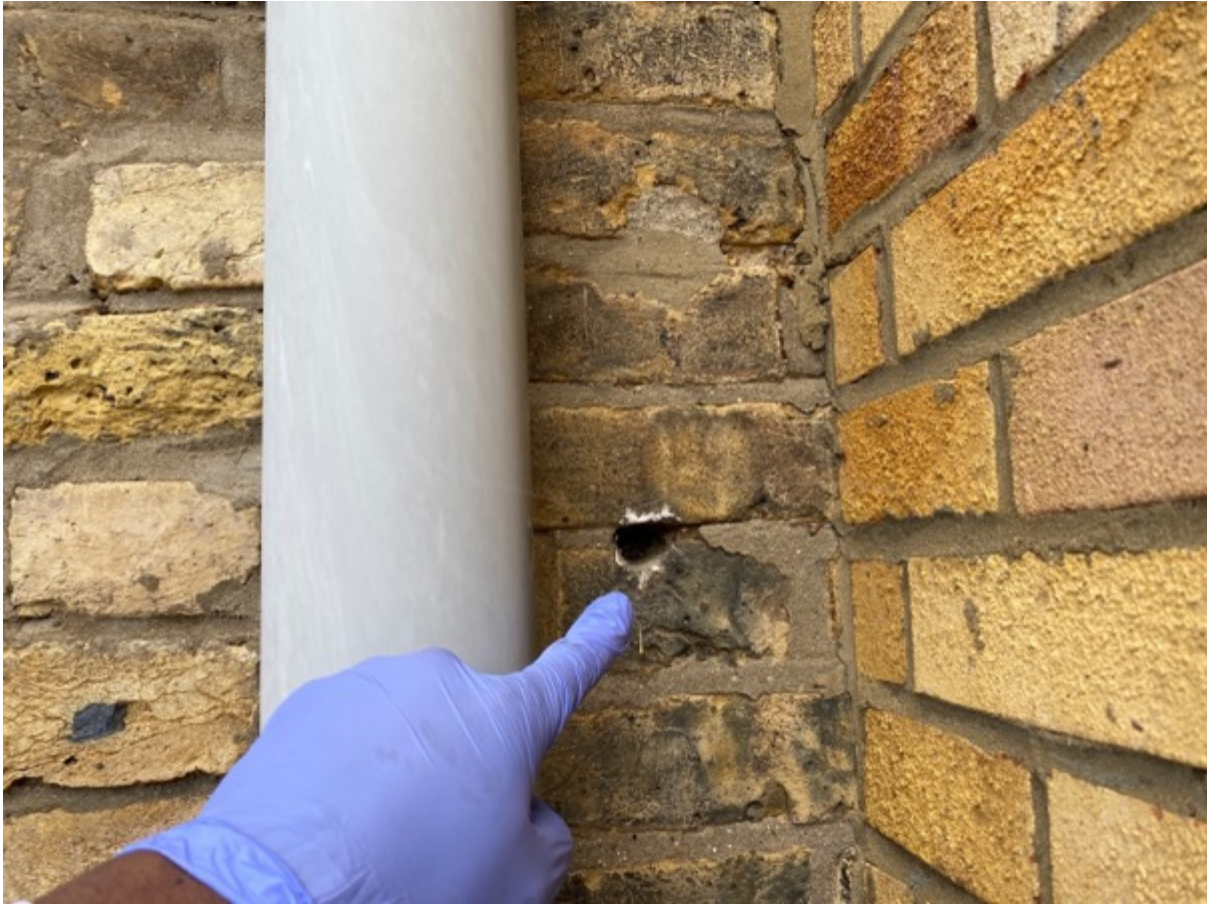
It is also worth noting that generally speaking to the areas where the brickwork has been partially rebuilt there are a number of what would appear to be large drill holes or fixings and areas where pointing has popped away.

It is also worth noting that on the rear wall of the rear addition there is a drilled pole through the lower right corner whereby a wire is protruding and then running back into the flank wall of the kitchen itself.

This entire area will need to be re-pointed as a matter of urgency to ensure a safe and weathertight property.

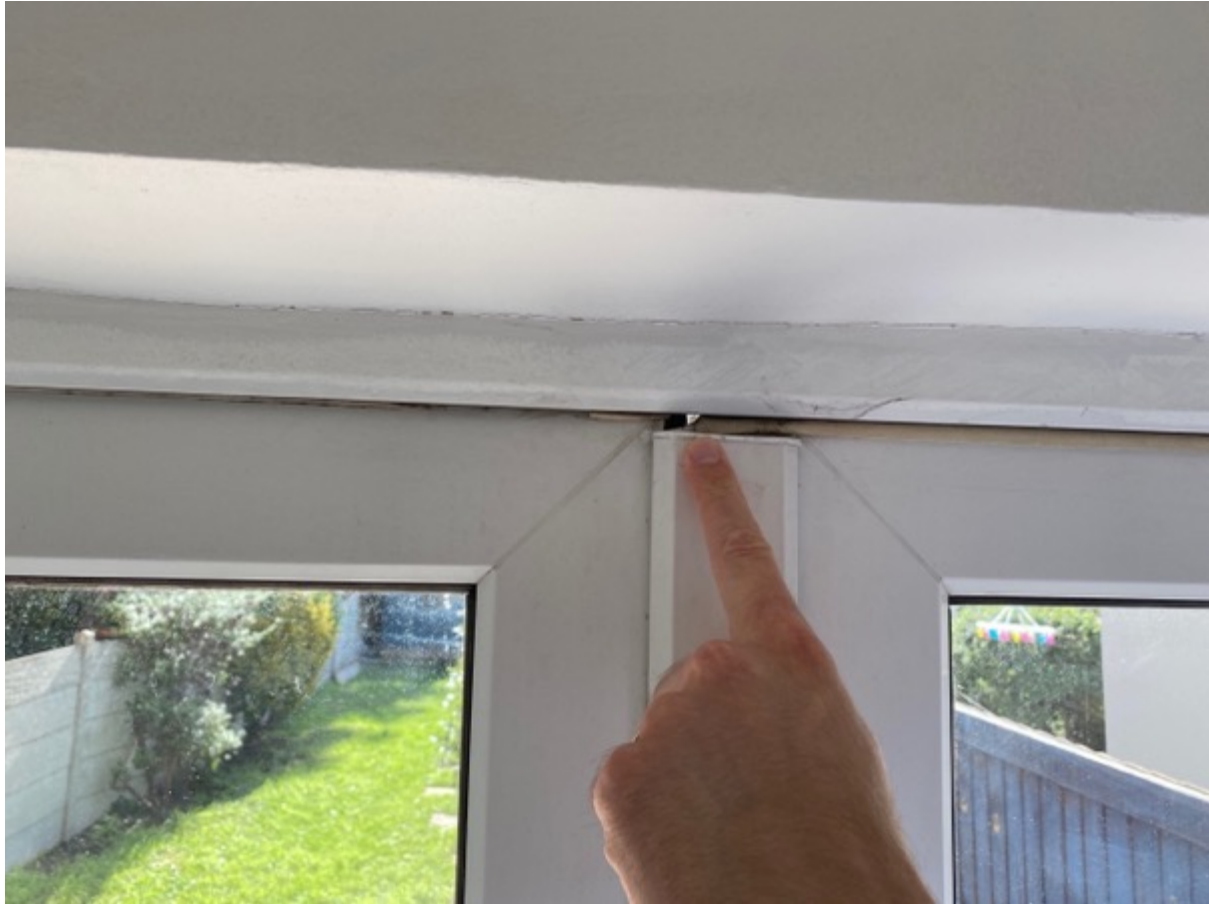
Towards the rear of the property the extension doors are uPVC type, the doors themselves are out of alignment and there is a gap at the upper head of the doorframe itself whereby it has been crudely filled with foam roll insulation.

The doors will need to be adjusted to ensure that there is a weatherproof seal to their perimeter thereby stopping pests and weather from penetrating the internal parts of the property.

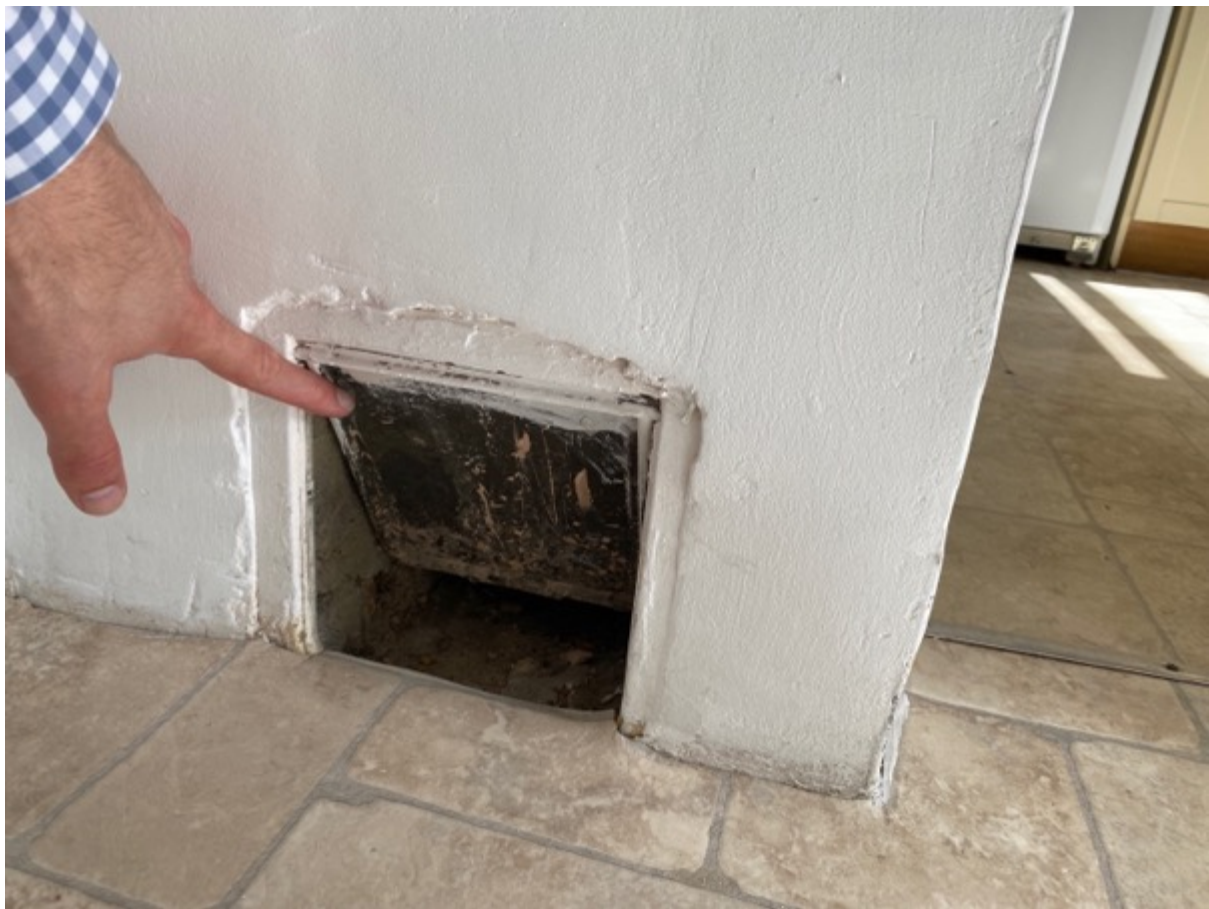
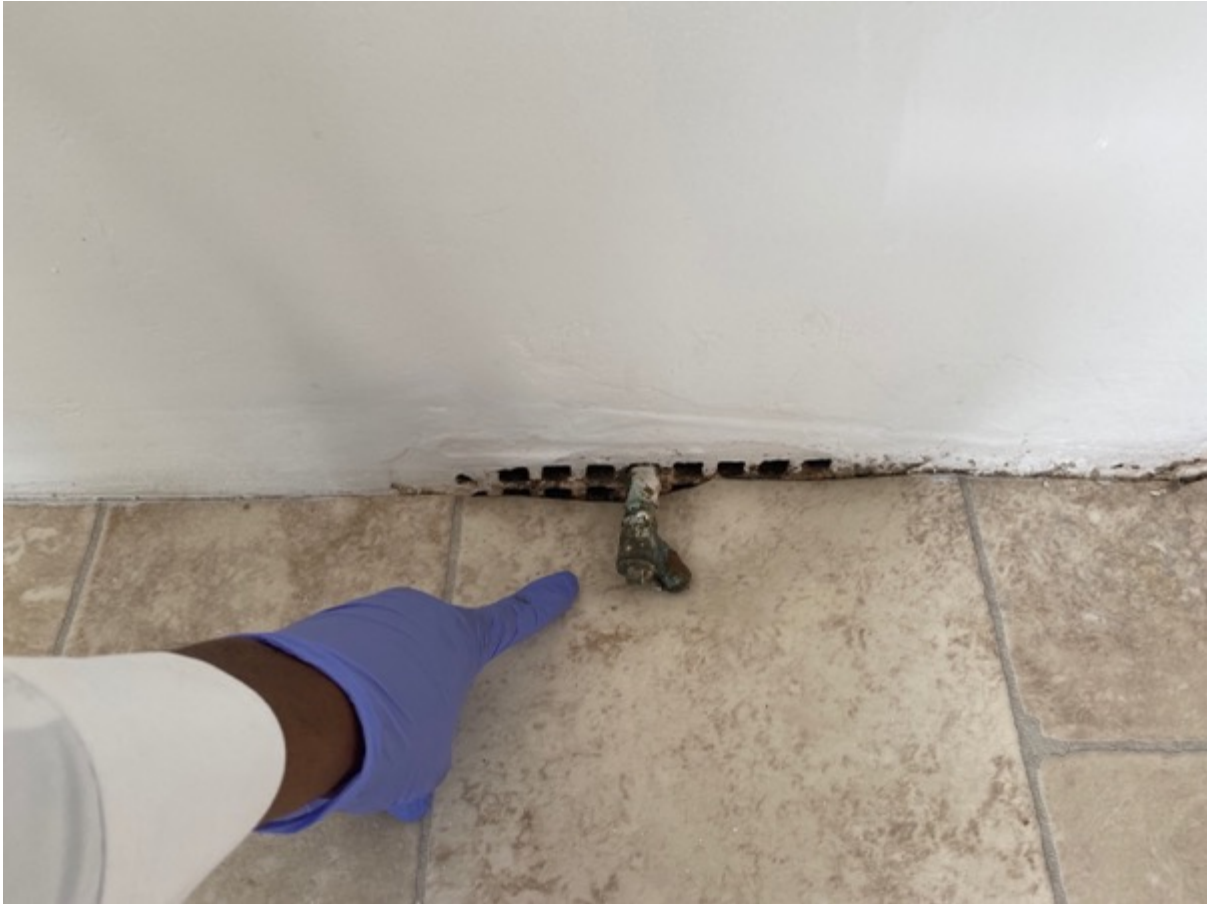
To the flank rear of the property there is a single level rear extension built, to the extension itself, there are signs of historic parts of the original building remaining, in particular an air brick and a cat flap.

This is a relatively unconventional arrangement, and I would have expected that these would have been blocked and bricked up and therefore, as they no longer serve any purposes, that is something that will need to be done to ensure a neat and conventional finish.

I would also advise making enquiries as to whether the rear extension itself has the necessary Party Wall compliance, Building Regulations compliance, Health and Safety compliance, and statutory consents in place as it would appear to be built as a party wall astride the boundary line.

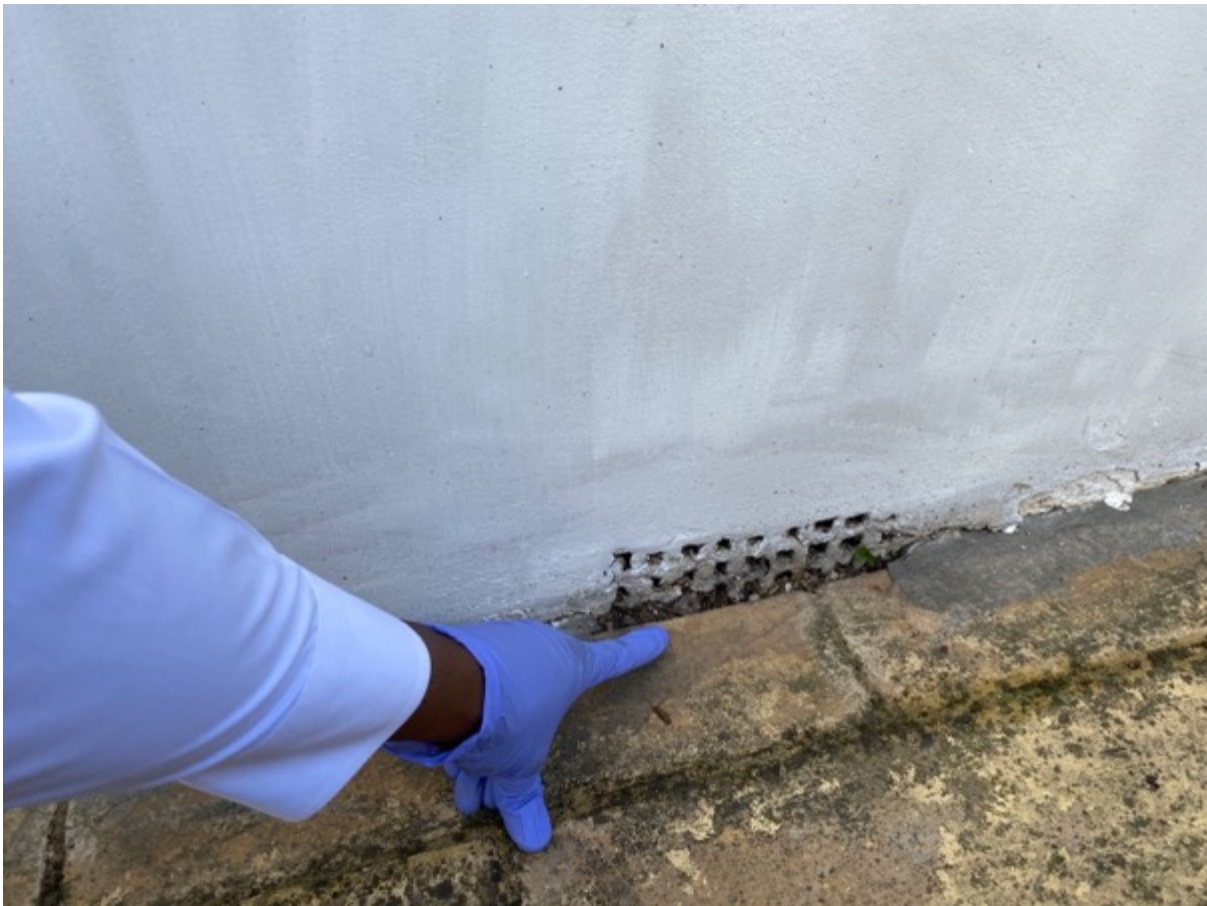
The ground towards the front of the property in the front garden is laid concrete paving slabs, these paving's slabs abut the front bay window, it partly bridges the air brick present hindering the use and it is likely that they bridge any damp-proof course that was present.

Generally speaking, the perimeter of all properties should have a sufficient void between the property itself and the ground to ensure that weather ingress and damp penetration does not penetrate the internal parts of the property.

You therefore may want to budget into the maintenance costs in the near future the reinstatement of the void itself to ensure that the property is best protected from any damp ingress in the near future.

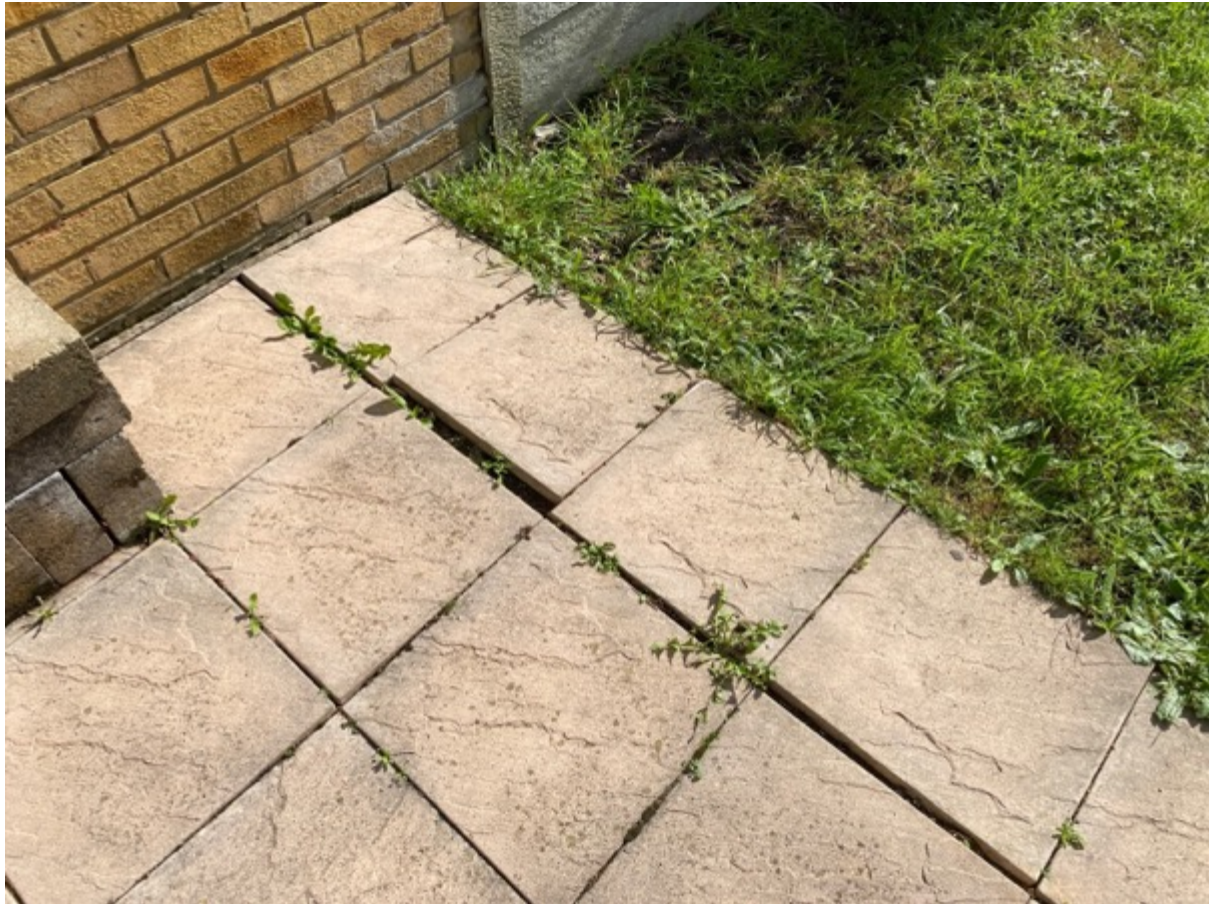
The concrete paving appears to be on a sand bedding and generally speaking is undulating and unlevel throughout.

This is a relatively common occurrence for concrete pavings and generally speaking you will need to piecemeal lift and bed down these paving slabs in the future.

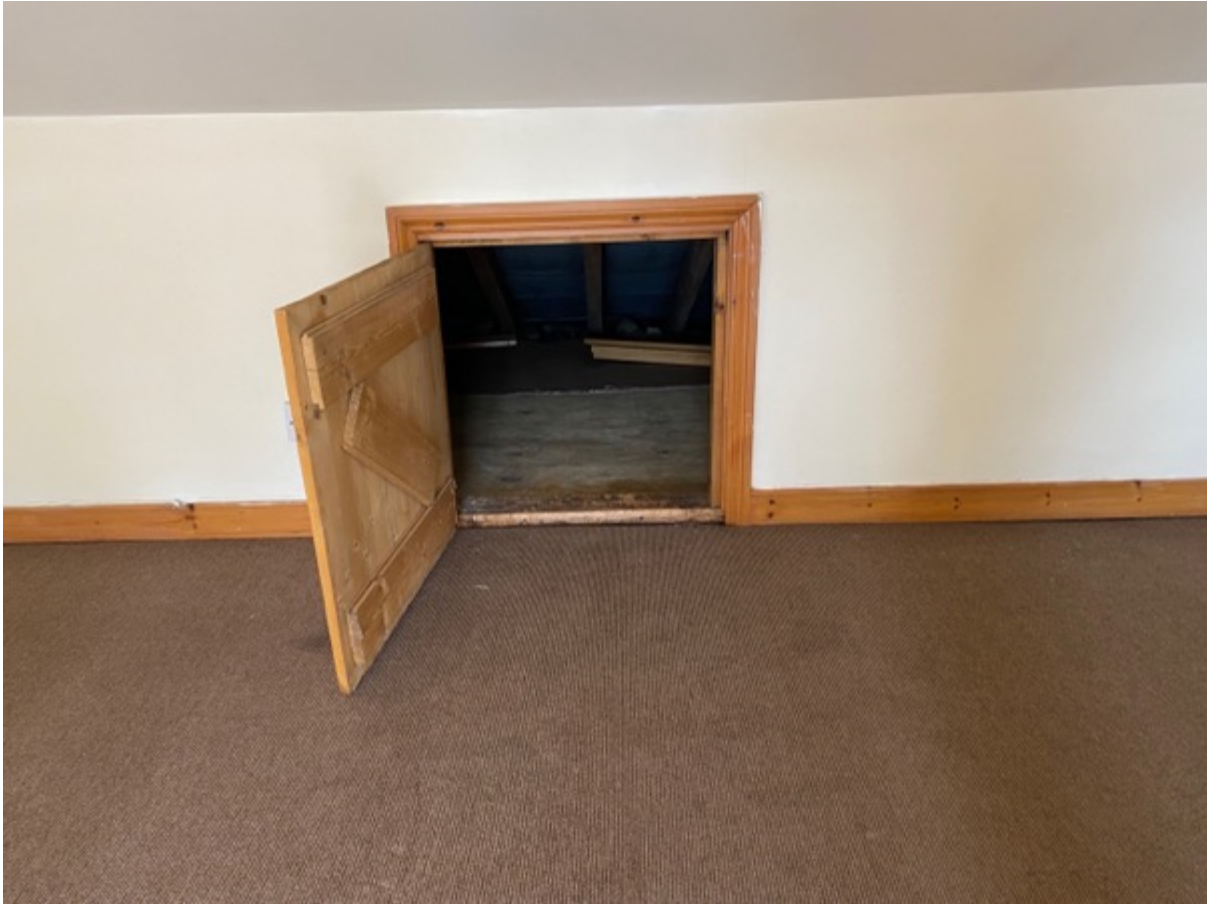
I would advise making enquiries as to whether these exist and are all in place. Towards the front of the roof space there is a hatch which allows view to the front eaves.

Within the eaves itself I was able to note that there is a sarking felt beneath the tiles and there were also signs of light coming through which is not ideal as it likely means that some tiles have become undulated and are sitting proud.

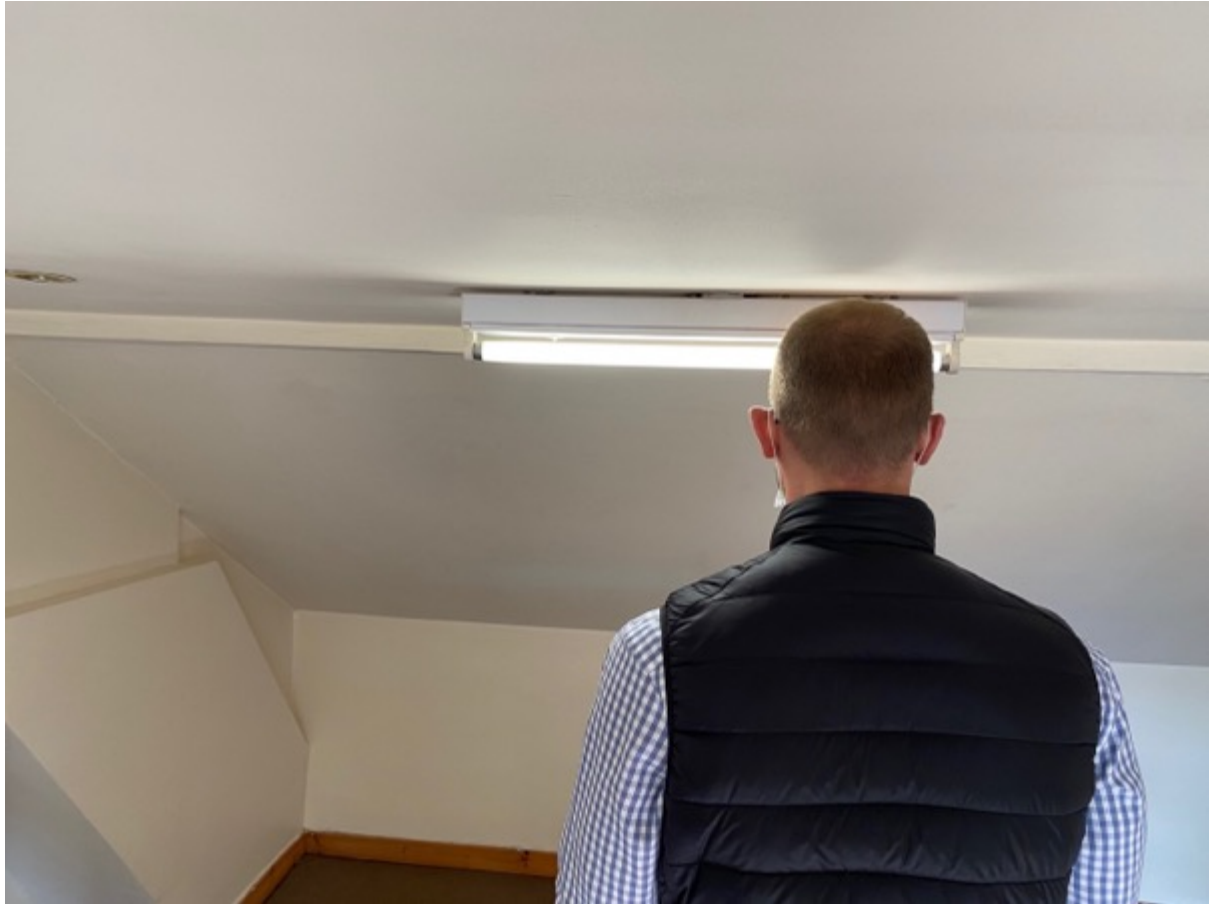
It is also worth noting that the light fitting towards the centre of the room projects from the ceiling itself meaning that for anyone in the region of 1.7m to 2m high they will have to lower their head, or travel around this light fitting.

I suspect that this could be a health and safety requirement as the bulb itself is not covered over and therefore could shatter or smash should it be knocked by an individual.

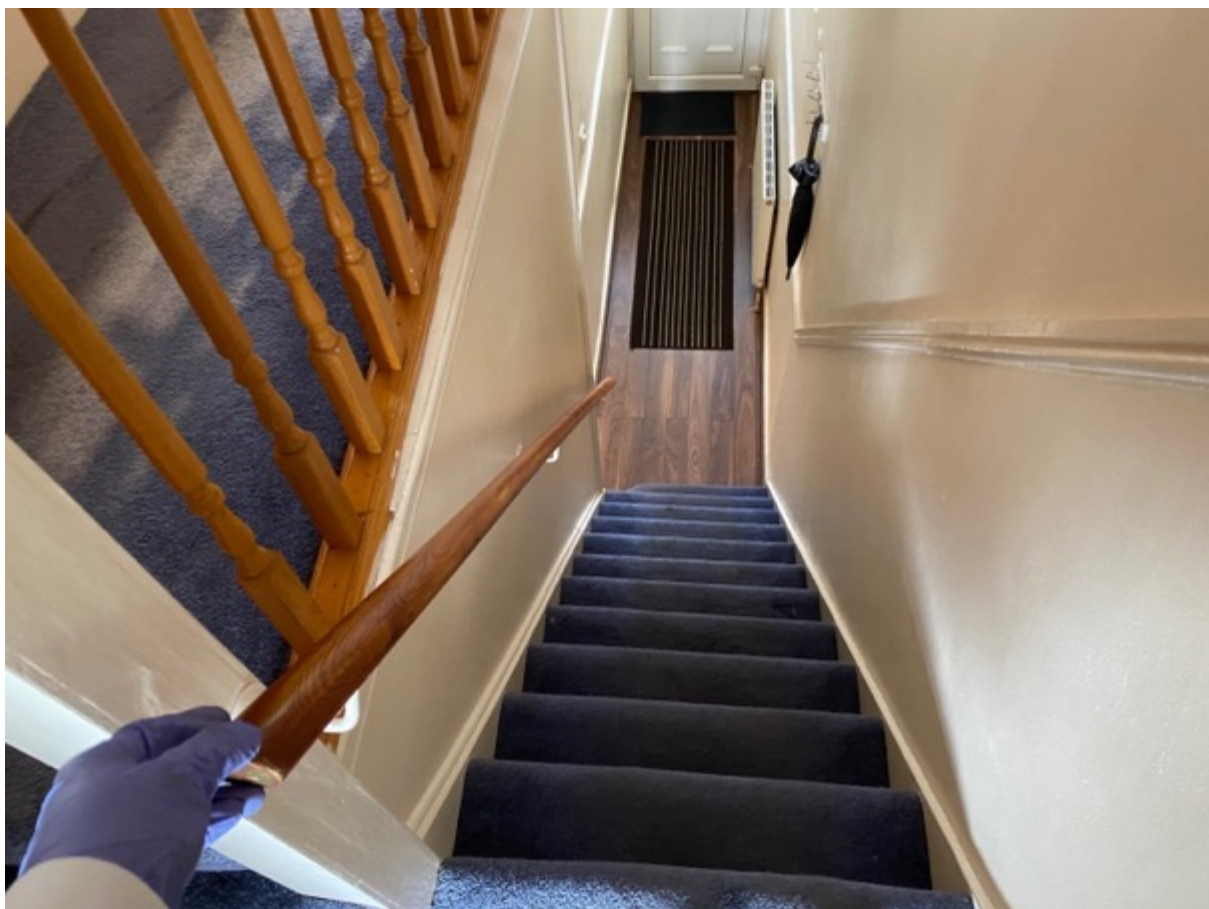
The stairs towards the ground floor appear to have been reconfigured in the past and are now exceptionally steep and I would advise making enquiries as to whether this, as currently set out, would be in accordance with Building Regulations compliances.

Furthermore, I would suggest making enquiries as to when the modification and adjustment to the stairs was undertaken and if there are any contractor's Guarantees in place for the workmanship that has been done.

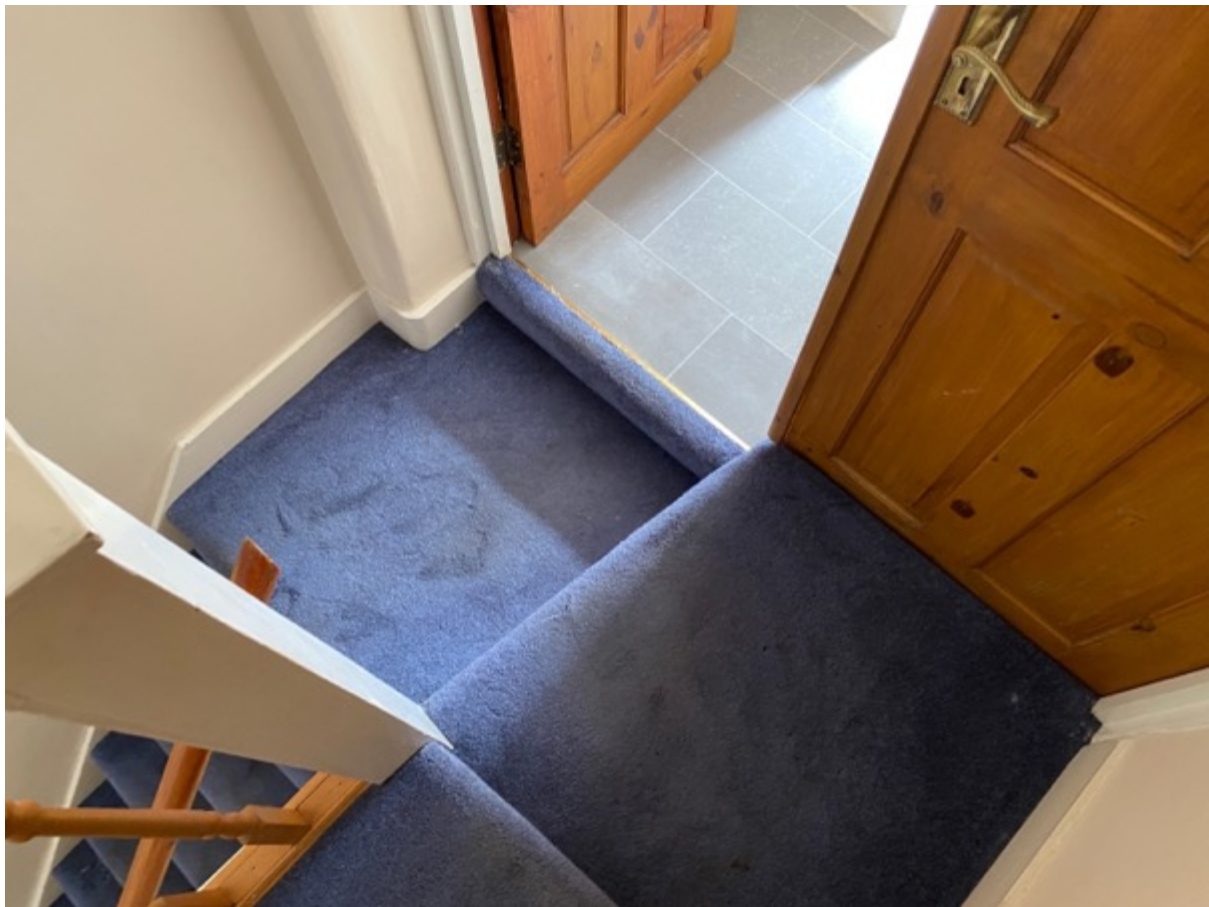
Throughout the floor areas itself there are a number of different stepped areas predominantly the main bathroom at first floor level is on a raised platform and there are a further two steps up to the first-floor bedroom area.

This is relatively unconventional and generally speaking, when development works do take place to a property, Architects tend to design around and avoid this type of issue as they can be tripping hazards and generally are quite awkward to work around and I would therefore suspect that the works that have taken place were poorly considered at the time of their conception and that could be an indication that the necessary statutory consents could not be in place.

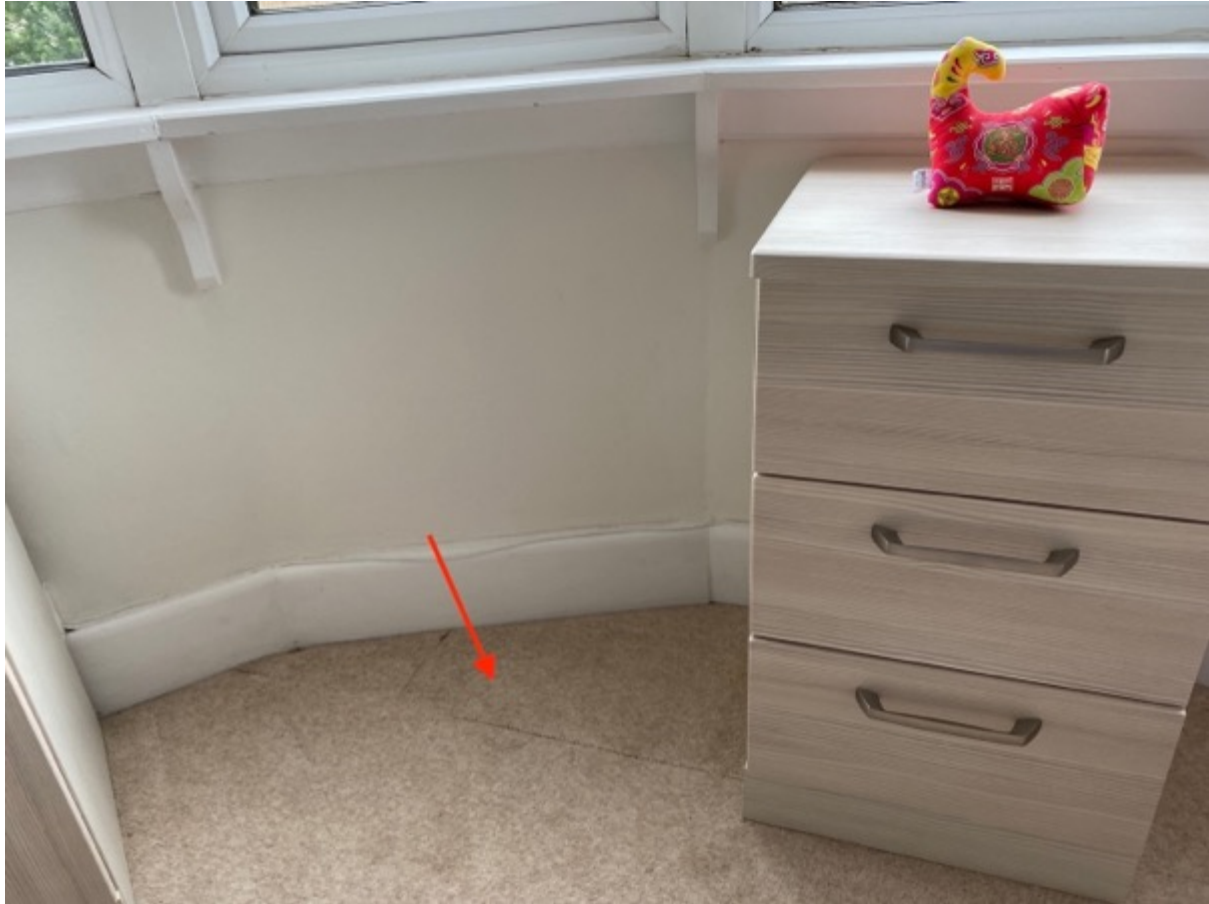
Within the first-floor front bedroom the front of the bay there are a number of different carpet joins noted and generally speaking, for a room of this size there should have been one continual sheet of carpet which would have then been cut to size.

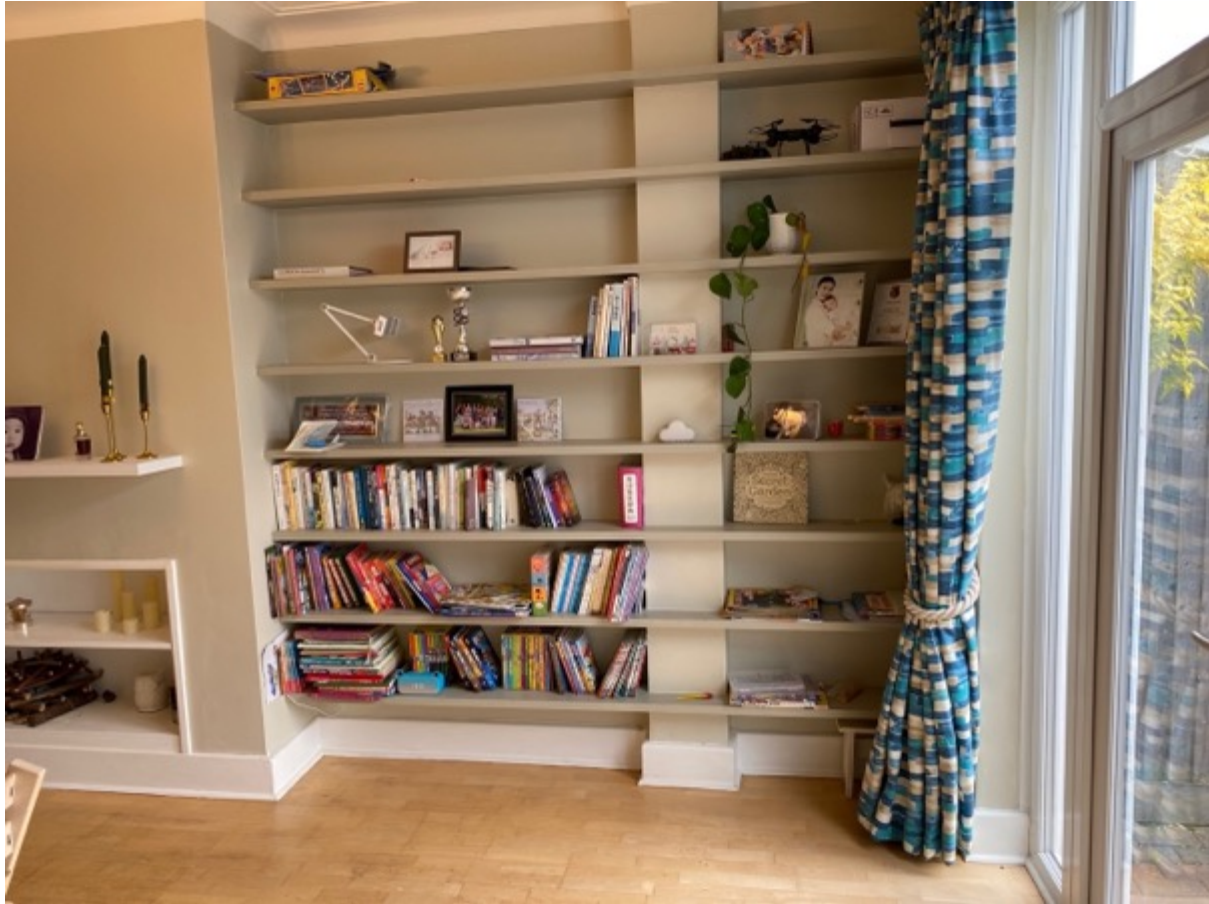
There are two fireplaces noted within the property. Within the ground floor reception room prominently the rear one has been covered over and is now acting as a shelving area; the front one has been fully covered over.

The chimney breasts at ground floor level in the reception room towards the front of the property there is a gas fire installed, however, this was not in operation at the time of my inspection and I would advise making enquiries as to whether there are the necessary gas safety certificates in place for this.

In any event, should you wish to proceed with this property, I would advise that a Gas Safe engineer fully inspects this and the other gas appliances to ensure that they are safe and sound and health and safety compliant.

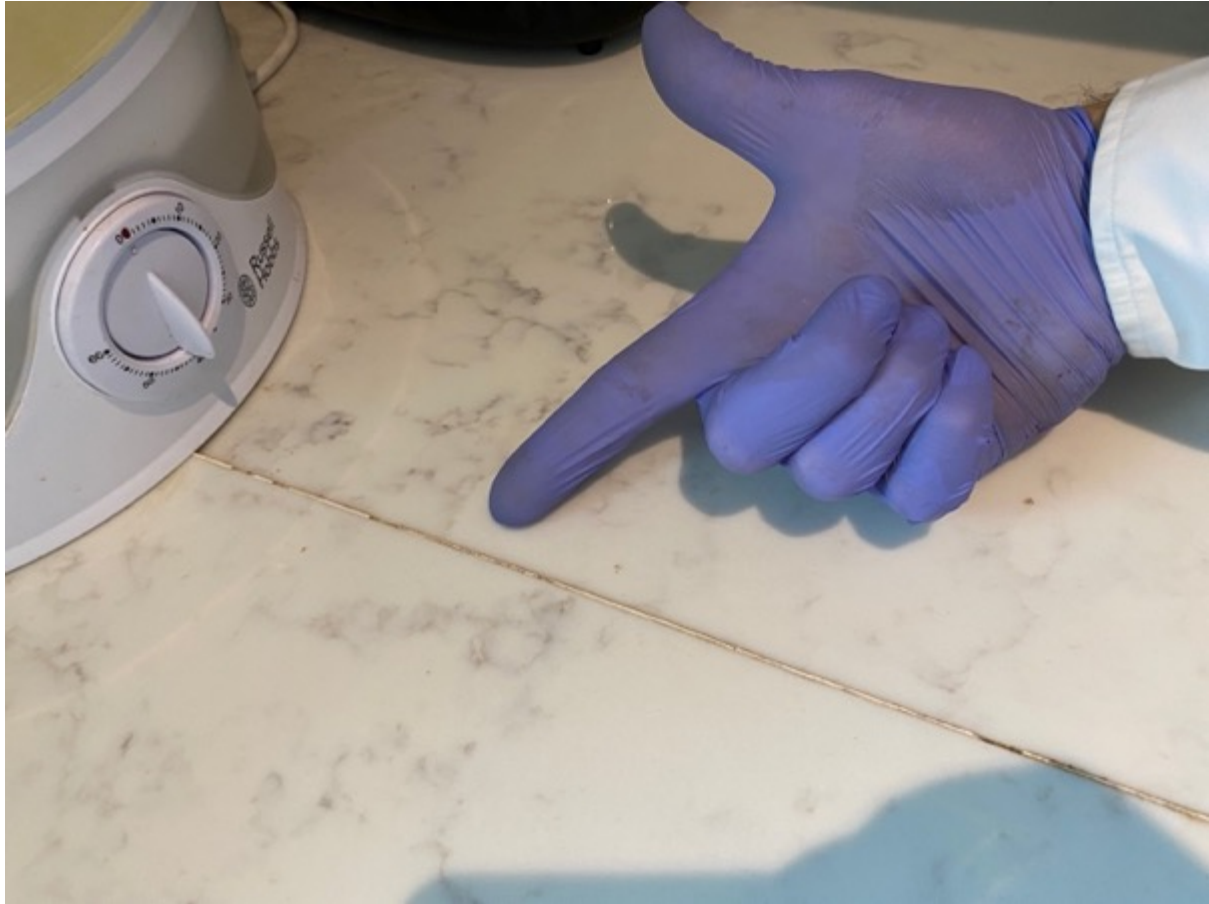
The kitchen worktop is a quartz Carrera imitation marble type.

Overall, it was free from any staining, however, the junctions of one section of the quartz finish to another are raised and sit proud which will result in a dirt build-up at the junctions and you therefore may want to consider having a kitchen specialist and worktop specialist revisit to level out the installation of the worktop to ensure that this does not happen in the future.

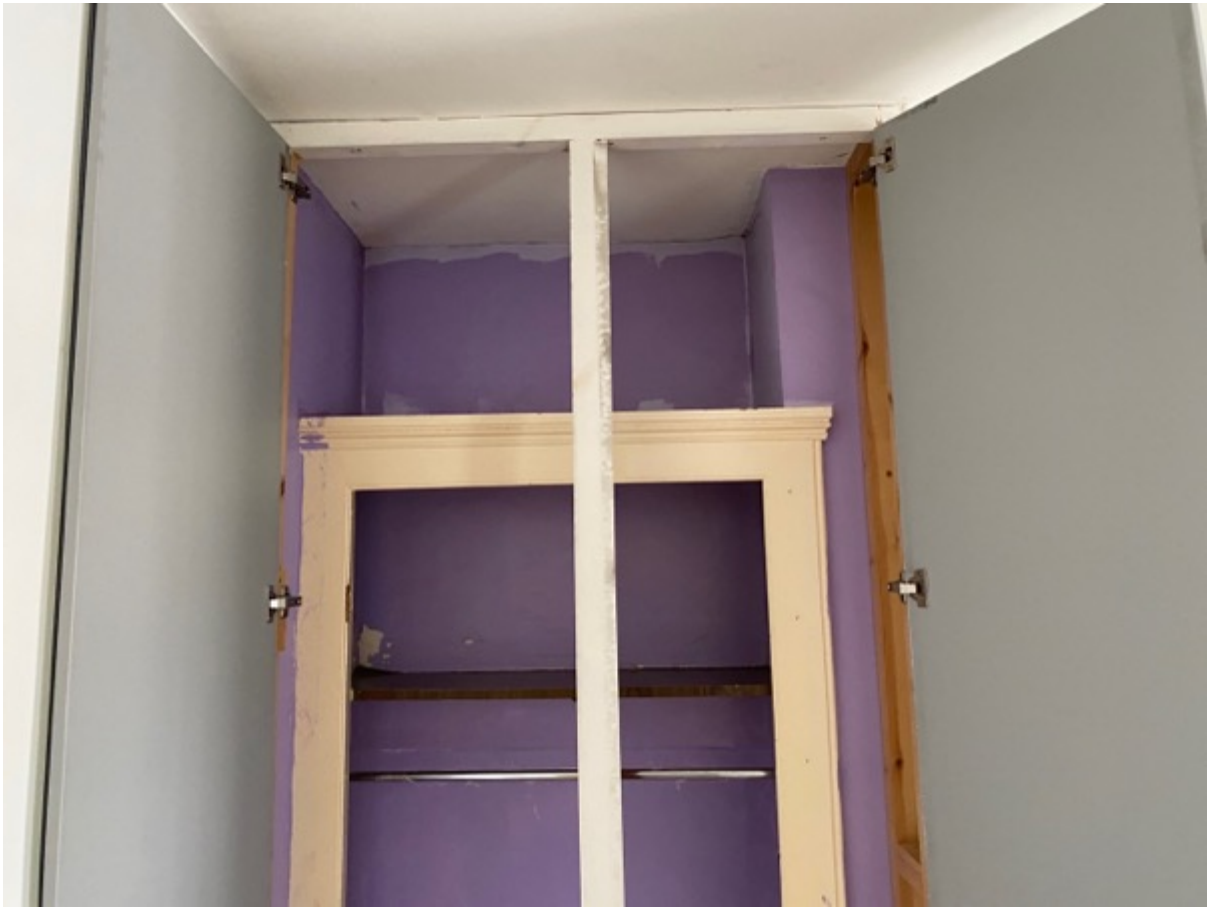
These wardrobes themselves are crudely installed and actually installed over the older fitted wardrobes so that there is an awkward wardrobe within a wardrobe effect.

Should you proceed with the property I would advise that the older wardrobes are removed and that the fitted wardrobes are replaced with a neater and sounder fit to maximise the storage space within the property.

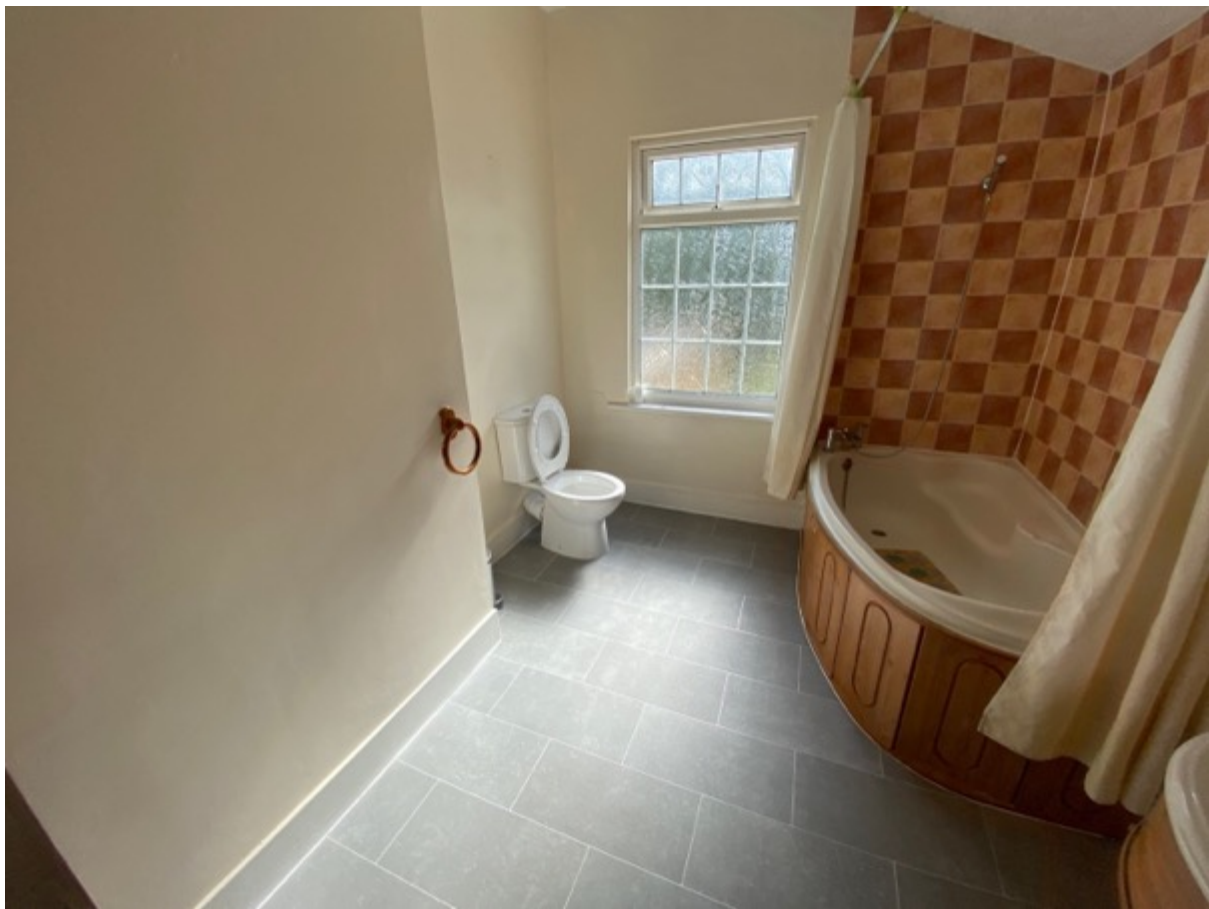
There is one main bathroom within the property itself which is located within the first floor rear addition area. The bathroom itself is slightly dated and is a very large area for the space that is being used.

You could likely comfortably fit a freestanding bathtub and walk-in shower within this area as well as a his and hers sink and therefore, should you proceed with the purchase, I would advise making better use of this space.

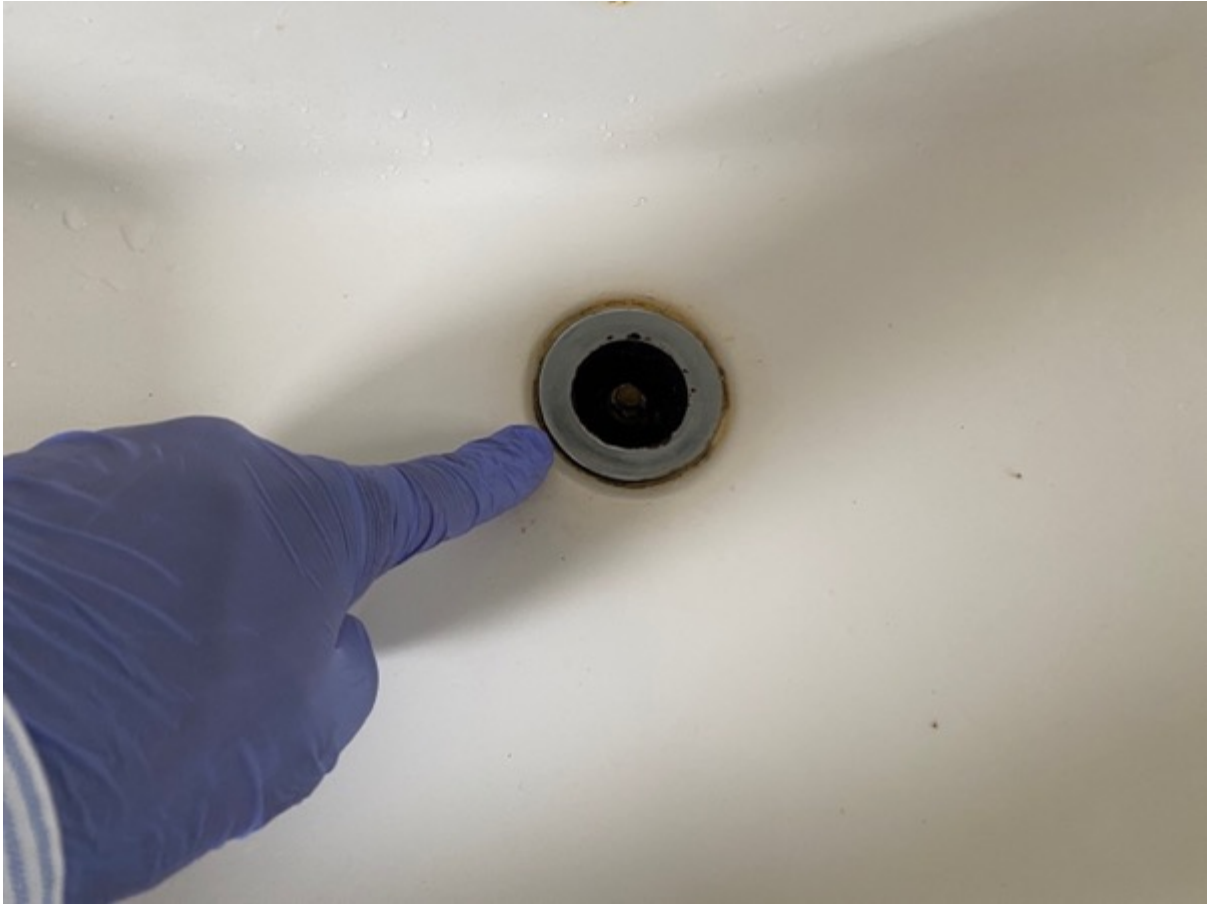
The shower pressure was tested and appeared to be a good reading. Both his and hers sinks are missing the sink plughole covers and these will need to be reinstalled to ensure a neat and smooth finish.

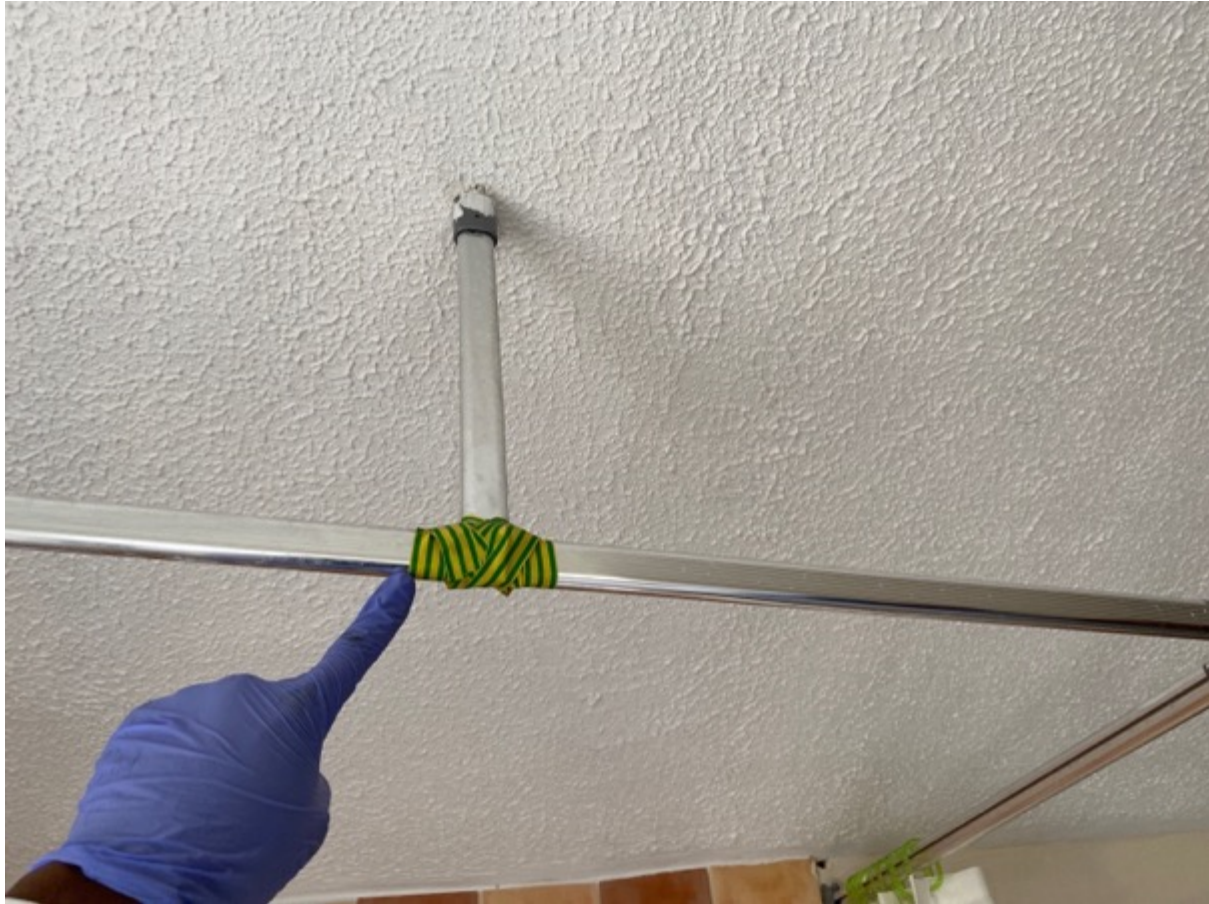
The shower curtain was crudely held in place with electrical tape and is defective and at the end of its useful life and will need to be replaced.

The toilet pipe is running at an odd angle protruding from the rear wall and generally speaking should run against the party wall itself so that it is not projecting into the room itself.

It is also connected with a uPVC expanding pipe which generally speaking is prone to leaking and defect and therefore, given that this is the only toilet that services the entirety of the property, I would advise upgrading this to a more sufficient fitting to safeguard against the toilet going out of use and emergency plumber's costs, visits and repairs.

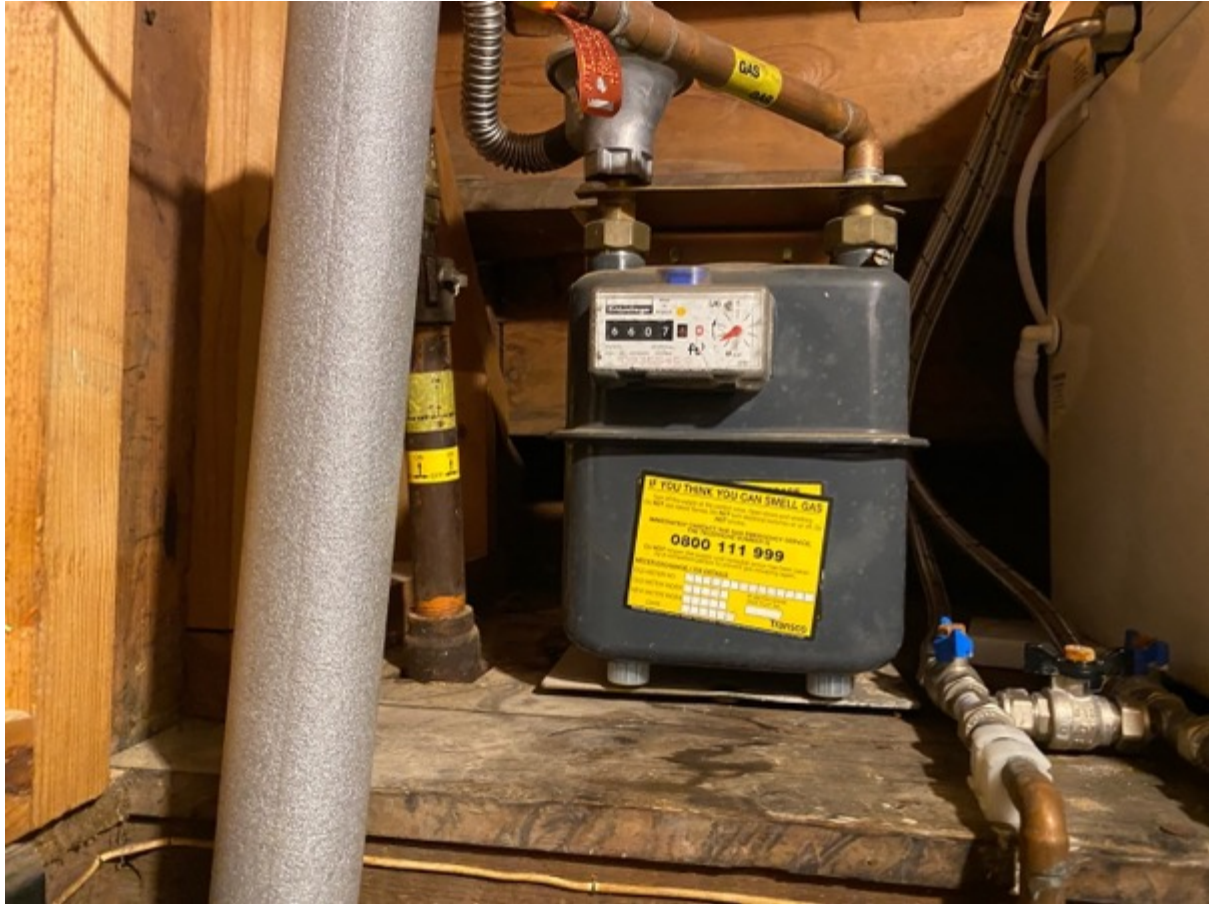
The gas meter was located in the sub-floor void area.

There were no signs of any service records in that regard.
