RICS Full Building Survey Report

(Level 3 Survey)

Full Property Address:

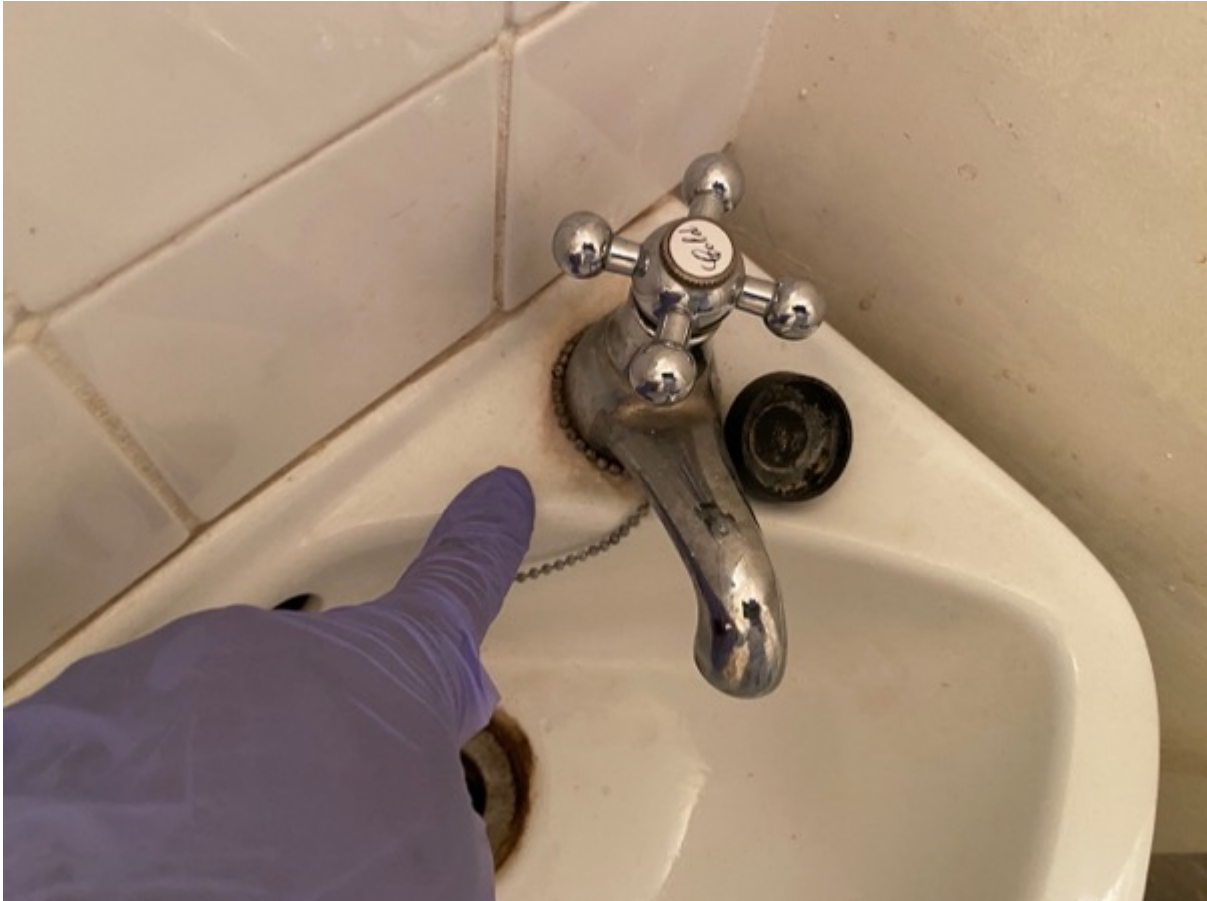
The property benefits from mains fitted water in both the kitchen and bathroom areas. At the time of the inspection the shower was tested and there was no water running as were the taps which likewise had no water running through them.

During the course of the inspection the water was turned back on by the seller and when tested the pressure at bathroom level was fair although, generally speaking, towards the lower end of the spectrum and I suspect that in order to get a good water pressure within the shower you may to consider the installation of a water pump.

The tap to the bath itself was loose and fully rotates which is likely indicative that the fitting will need to be changed and upgraded and replaced. While the water was turned on there was a noticeable vibration and percussive sound within the pipes themselves.

It could be that there is a trapped air within the system resulting from the water being turned off for long periods of time, however, before you proceed with the property purchase I would advise that the water is fully inspected by a plumber to ensure that there are not any defects noted within the system itself.

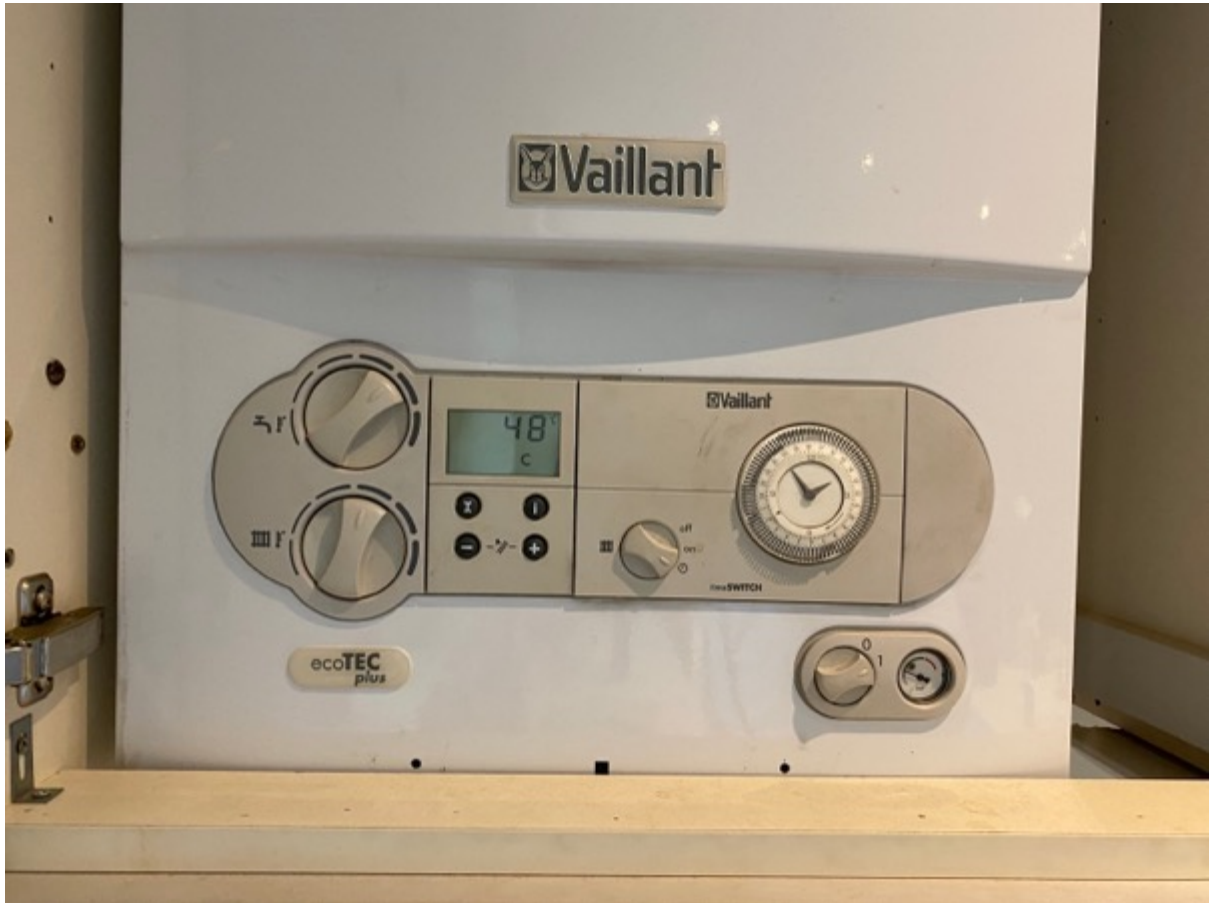
The property is mains gas connected with the heating being provided by a Vaillant boiler which is installed within the kitchen area.

The boiler itself at the time was effective and the heating was working. Hot water was also present when tested.

I would advise that the gas boiler is inspected by a Gas Safe engineer to ensure that it is fully operative and up to current health and safety and Gas Safe requirements.

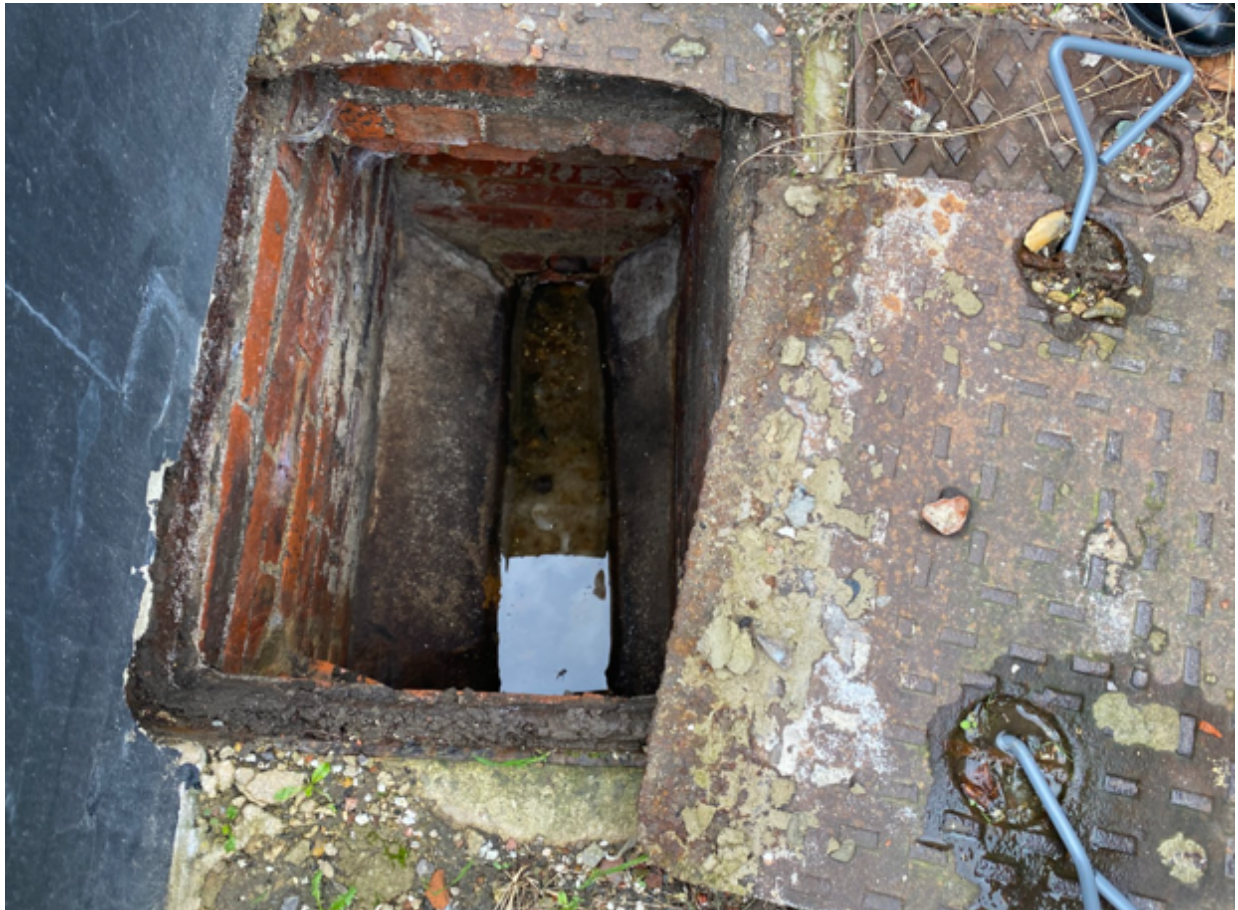
F6 Drainage:

The drainage within the bathroom appeared to be sufficient and the taps did not back up and likewise in the kitchen area.

Towards the rear of the property the drainage and downpipes at the junction where they run into the rear drainage gullies was covered over with a concrete paving slab.

When these slabs were lifted there were signs of blockage noted to both respective rear drains and therefore I would advise, as previously suggested, that the manhole cover is located and potentially a CCTV drain survey is undertaken to ascertain exactly what the condition is of the drain and if there are any signs of blockage or defect noted.
